**KILLICK CREEK
ESTUARY PROCESSES STUDY**

Report No. MHL1125

**NSW Department of Public Works and Services
Manly Hydraulics Laboratory**

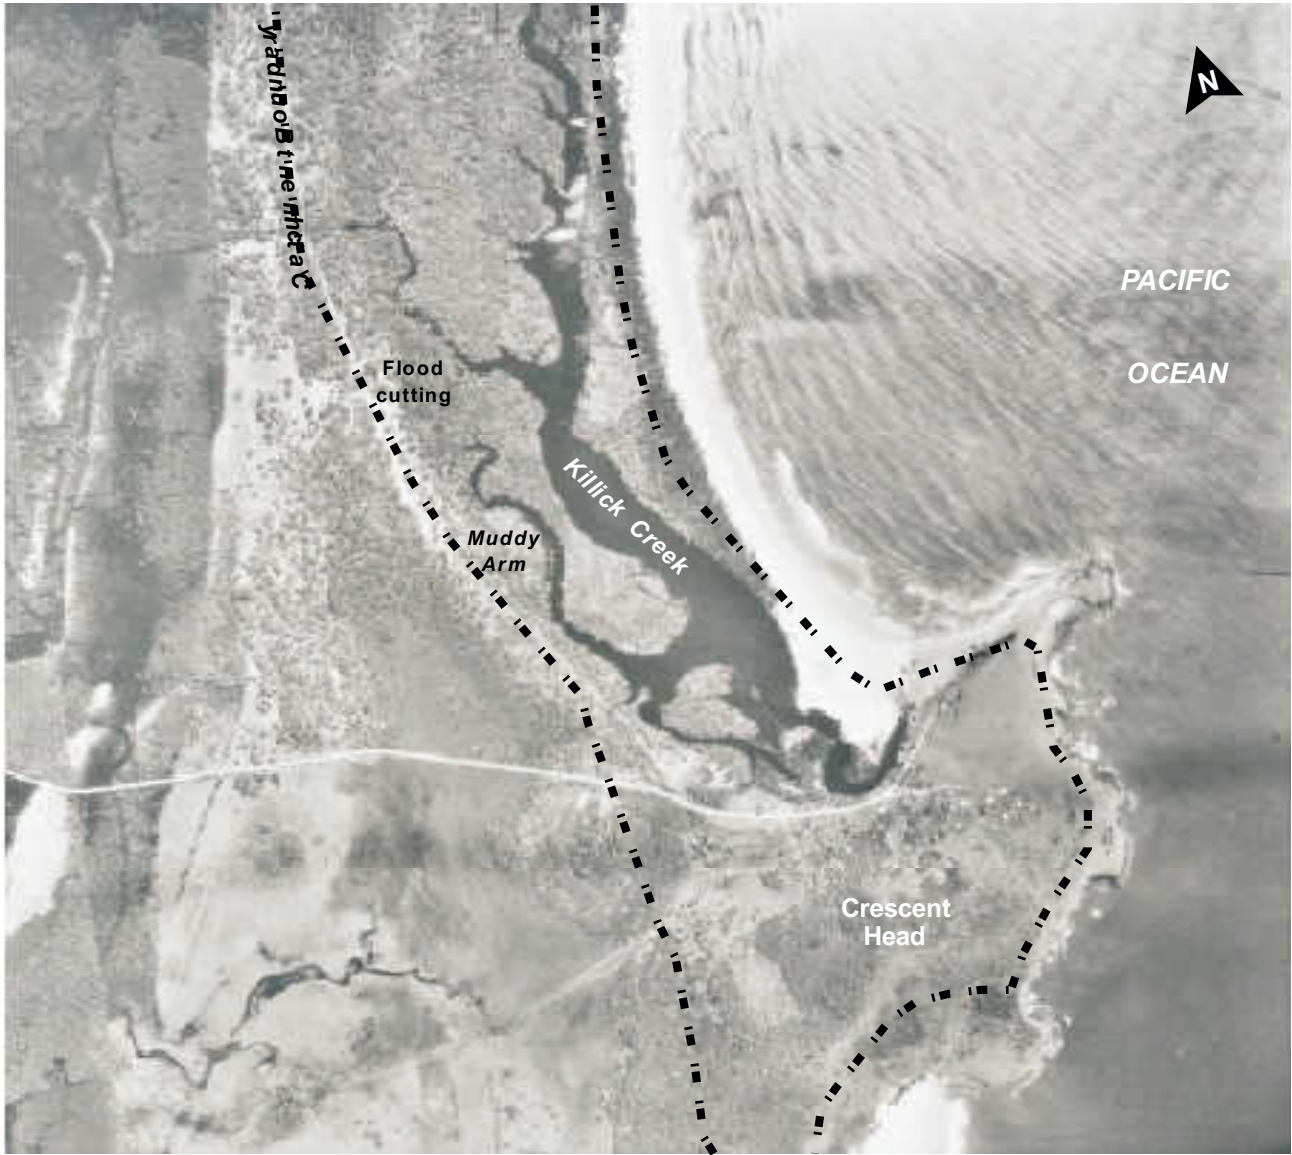
MHL
Report 1125
Figure
2.2

**KILLICK CREEK - 1942 AERIAL PHOTOGRAPH
CLOSED ENTRANCE CONDITIONS**

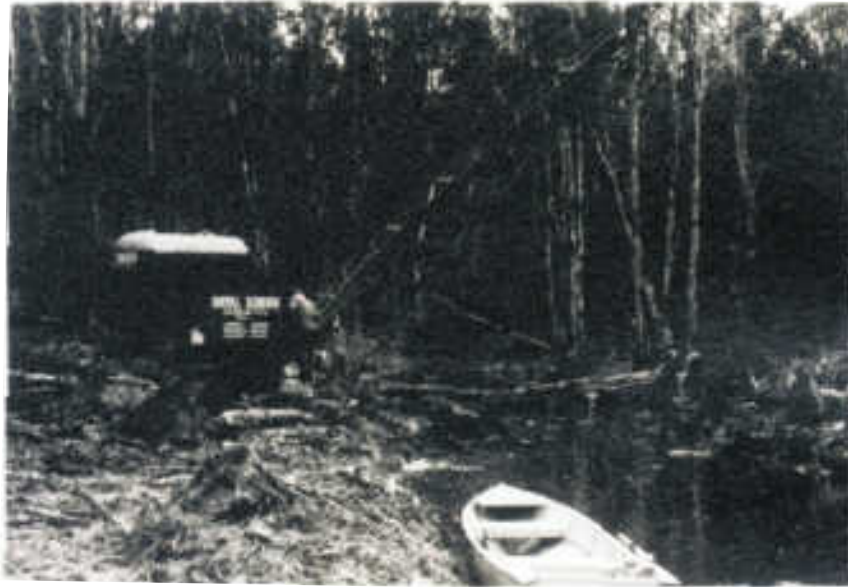
Clearing and excavating waterway through ti-tree jungle

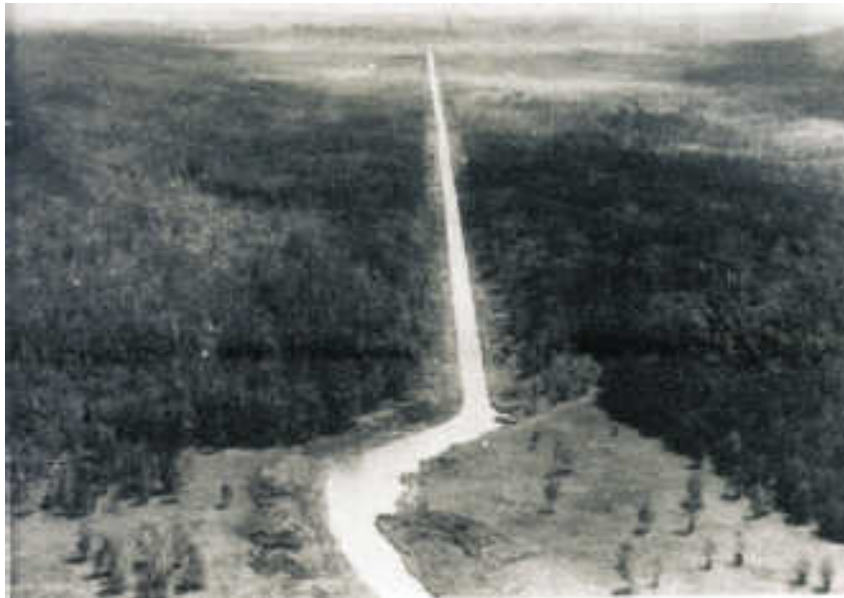
Aerial view of completed waterway
