3. Hydrodynamics

KILLICK CREEK WATER QUALITY SAMPLING SITES AND STORMWATER INPUTS

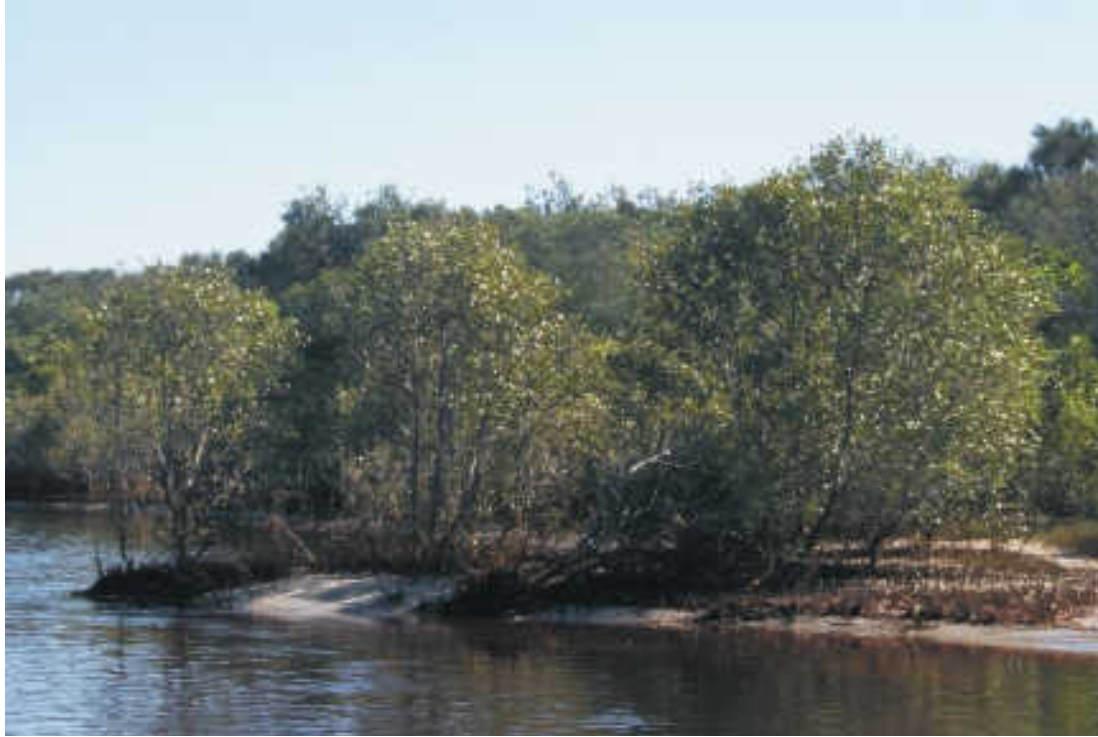
Mangroves along the banks of Killick Creek

Along the western bank of the creek near the entrance is a long rocky breakwall covered in oysters and stained red. The water here was too turbid to identify the presence of seagrass beds. A few small mangrove trees grow out of the breakwater and along the muddy bank upstream of Muddy Arm. The mangroves were more extensive along the eastern bank and there were two large stands downstream of the flood cutting (Figures 2.3 and 5.3). These mangroves were either absent or too small in area to map in 1981 (West et al. 1985) and hence potentially represent a major change in the ecology of Killick Creek over the past two decades. Along both sides of the creek there were clusters of paperbark (*Melaleuca* sp.), rushes (*Juncus* sp.), and swamp she-oaks (*Casuarina glauca*) (Figure 5.3).

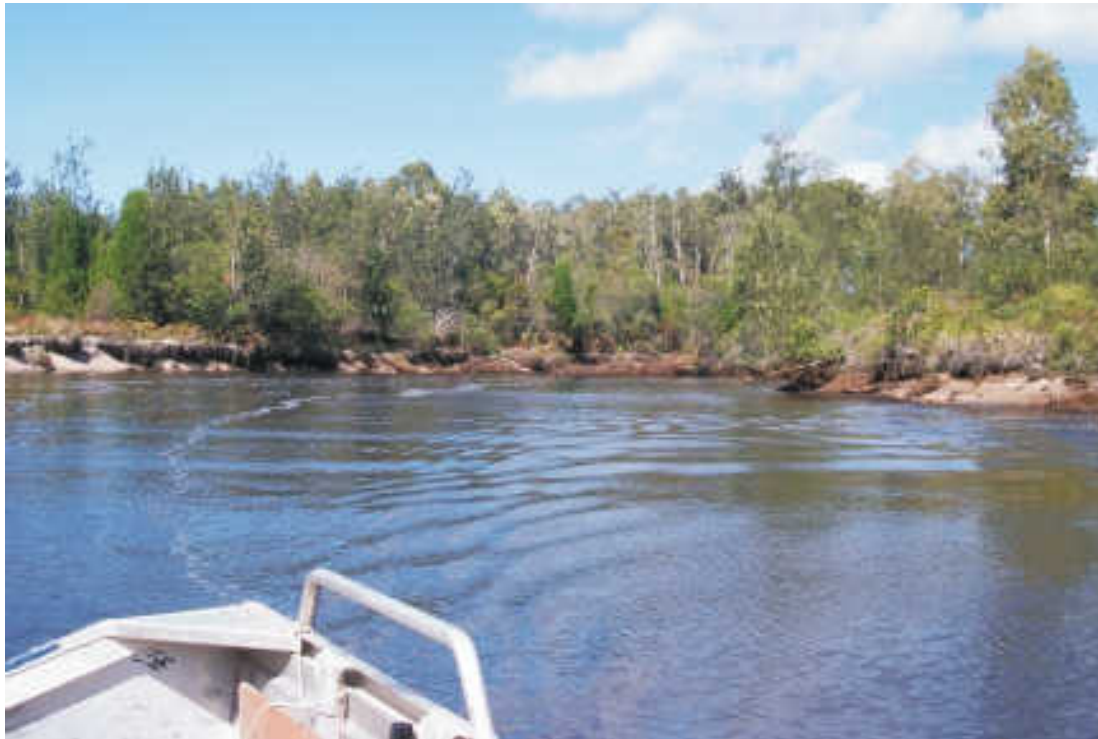
Clusters of paperbark (*Melaleuca* sp.), rushes (*Juncus* sp.) and she-oaks (*Casuarina glauca*) along the banks of the flood drain

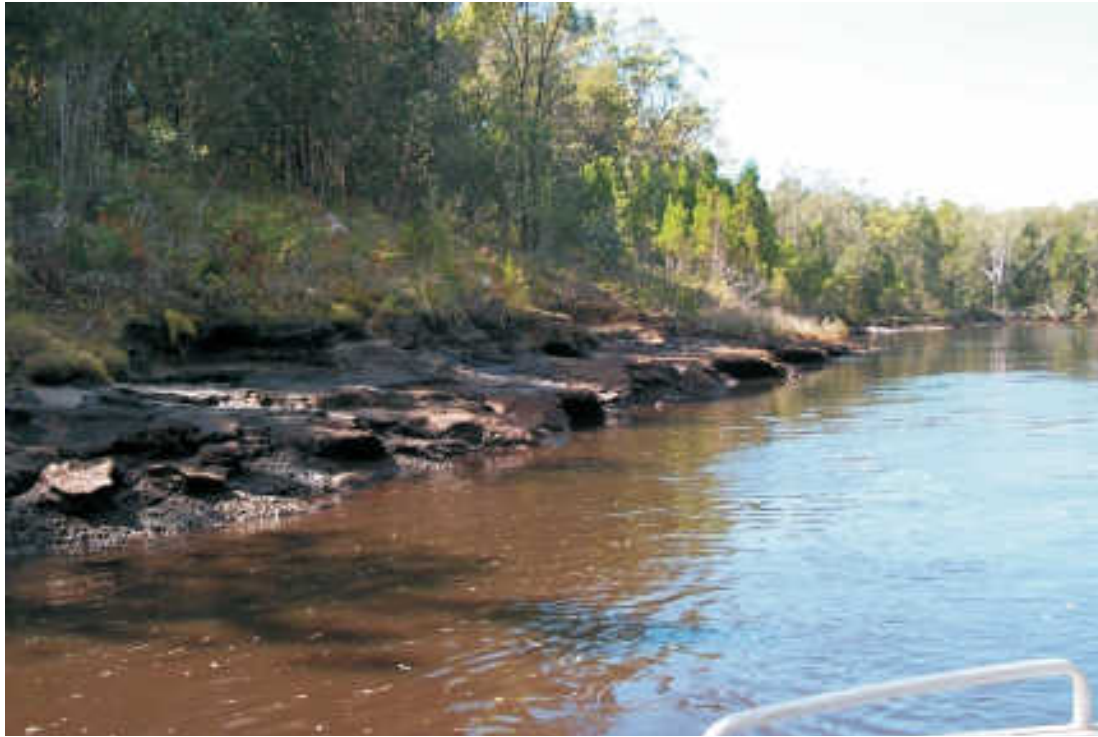
Banks of 'coffee rock' along the banks of the flood drain

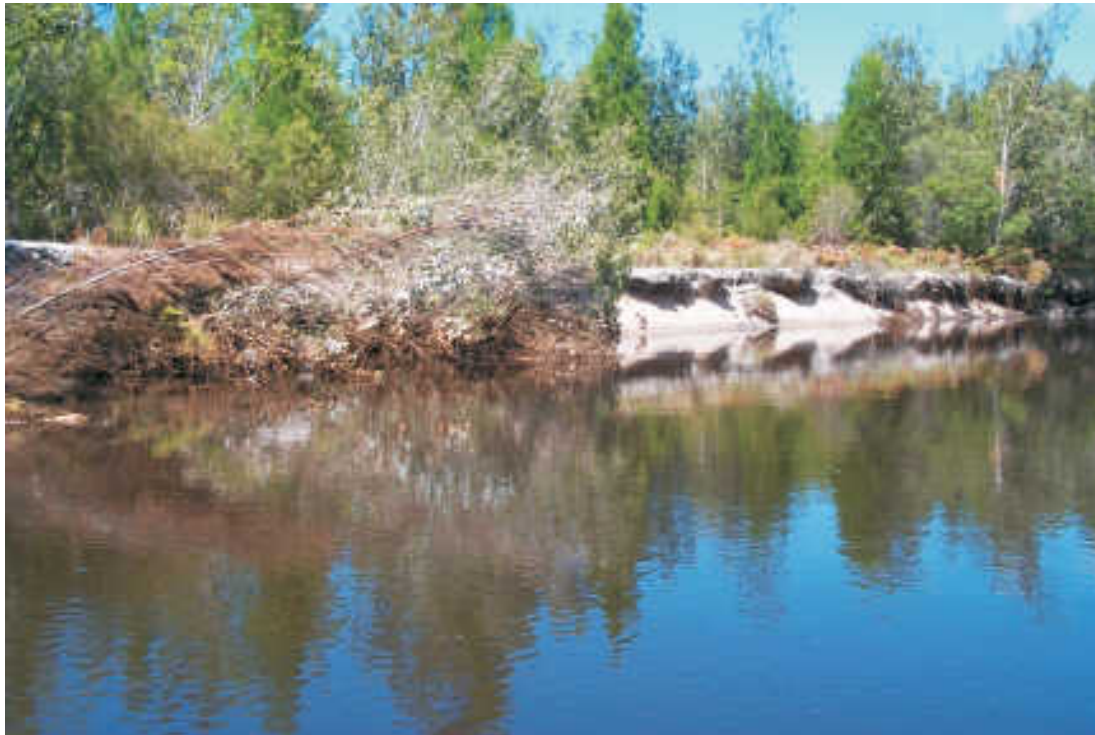
Erosion along the creek downstream of the flood drain

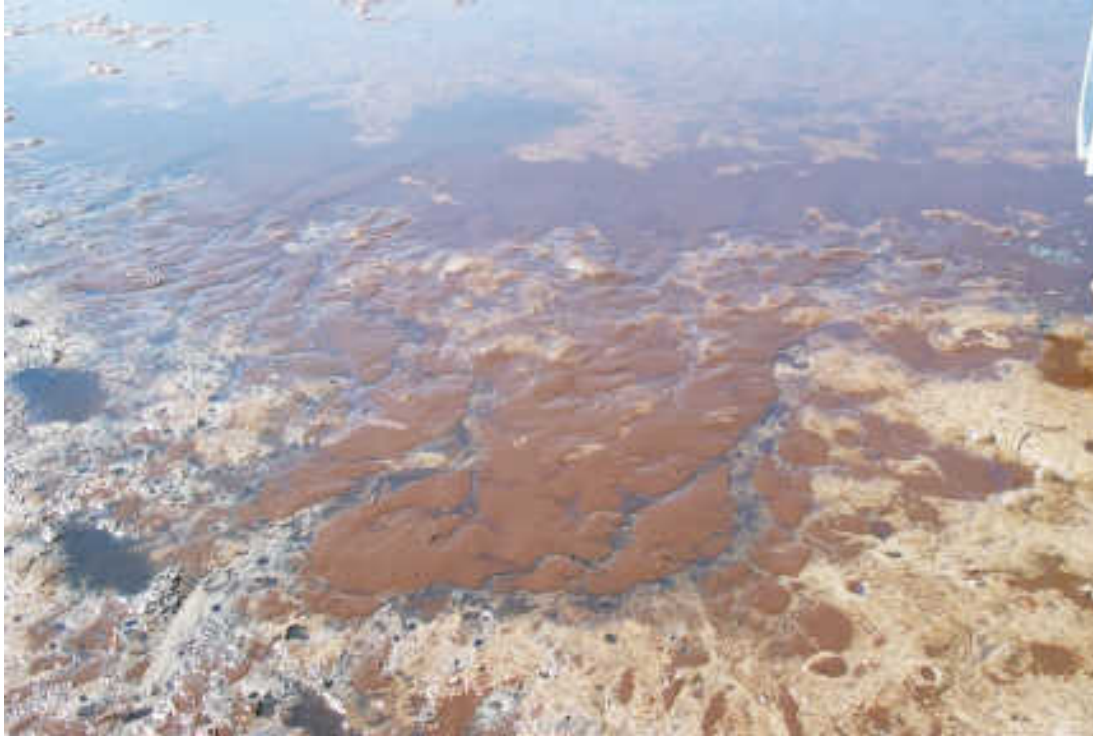
Iron precipitate evident on the surface of the mud at the confluence of the flood drain

Killick Creek was very shallow at the confluence of the flood cutting and was not navigable. The surface of the mud here was covered in an iron precipitate, below which the mud was very black and highly anaerobic (Figure 5.5). Some dead mangrove seedlings were evident along the shore but older trees in the area appeared healthy (Figure 5.5). Many small fish were observed in the water: these fish appeared to be mullet (Mugilidae) but the water was too turbid to make a confident identification.

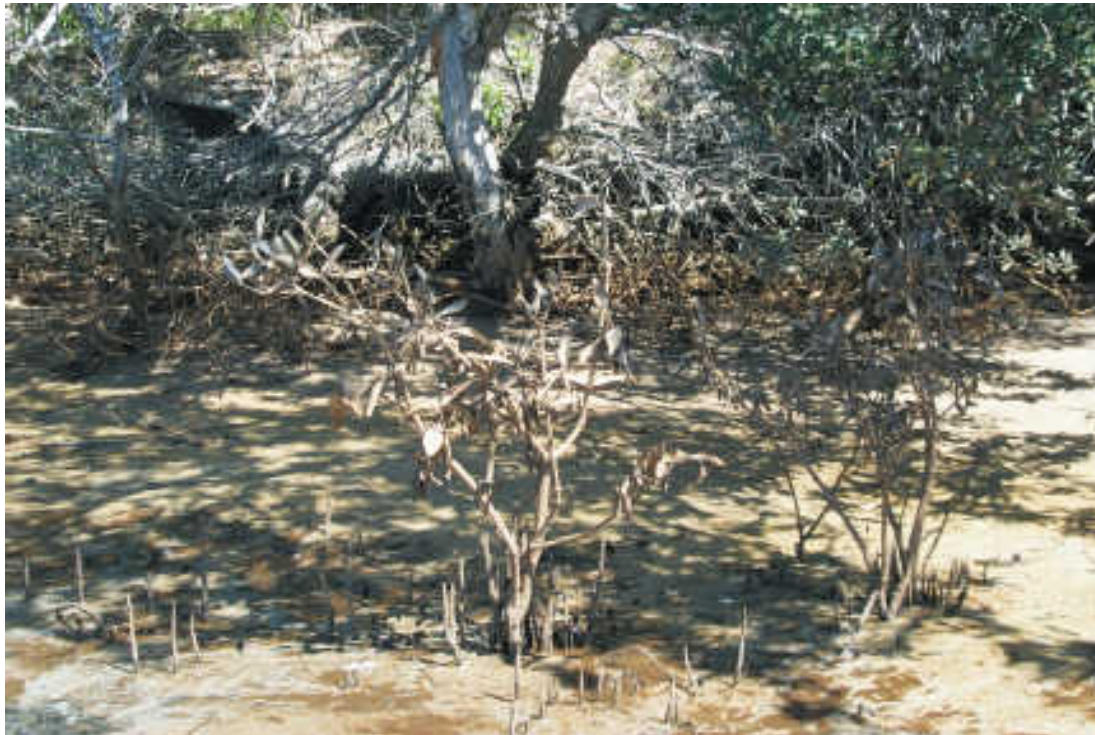
Dead mangrove seedlings along the shore near the flood drain
