PART 2 EXISTING DATA - COMPILATION AND REVIEW

Korogoro Creek estuary is located on the NSW north coast approximately 350 km north of Sydney and 80 km south of Coffs Harbour. Korogoro Creek is a small-sized estuary with no significant tributaries which runs to the ocean at the coastal village of Hat Head. The estuary entrance is untrained and is permanently open. The estuary is approximately 5.4 km long and has a water surface area of approximately 0.2 km². The catchment area is approximately 18 km² which includes Swan Pool to the west, low sand hills and swamps to the south west, the village of Hat Head to the east and south, and a proportion of the headland to the south east of Hat Head (see Figure 1-E, p.9).

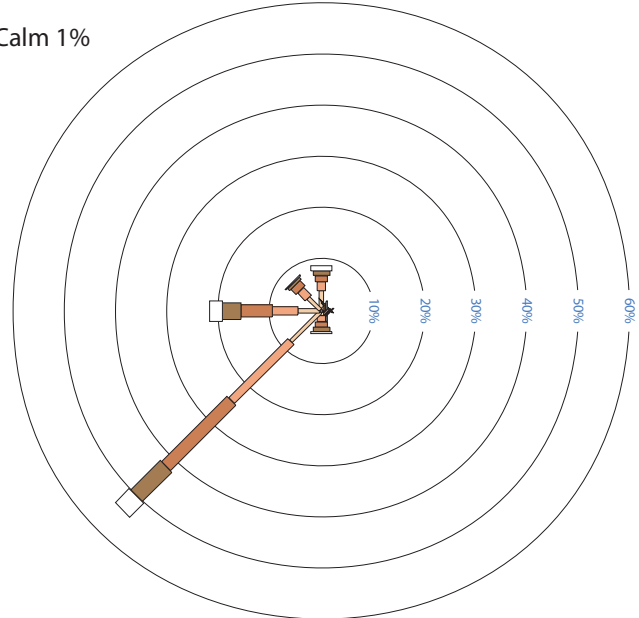
Rose of Wind Direction versus Wind Speed in km/h

In general, the data show that the prevailing climate at Korogoro Creek is warm and temperate with a maritime influence demonstrated by the increased wind speed in the afternoons of the warmer months of the year and stronger morning winds in the cooler months. Figure 2-B (p.28) shows Wind Rose diagrams which indicate the prevailing wind directions and show a strong seasonal pattern. Summer winds are predominantly from the southwest or north in the mornings and strongly onshore from the

north and north-east in the afternoons. Winter winds are from the west and south west in the mornings and south-west and south in the afternoons.

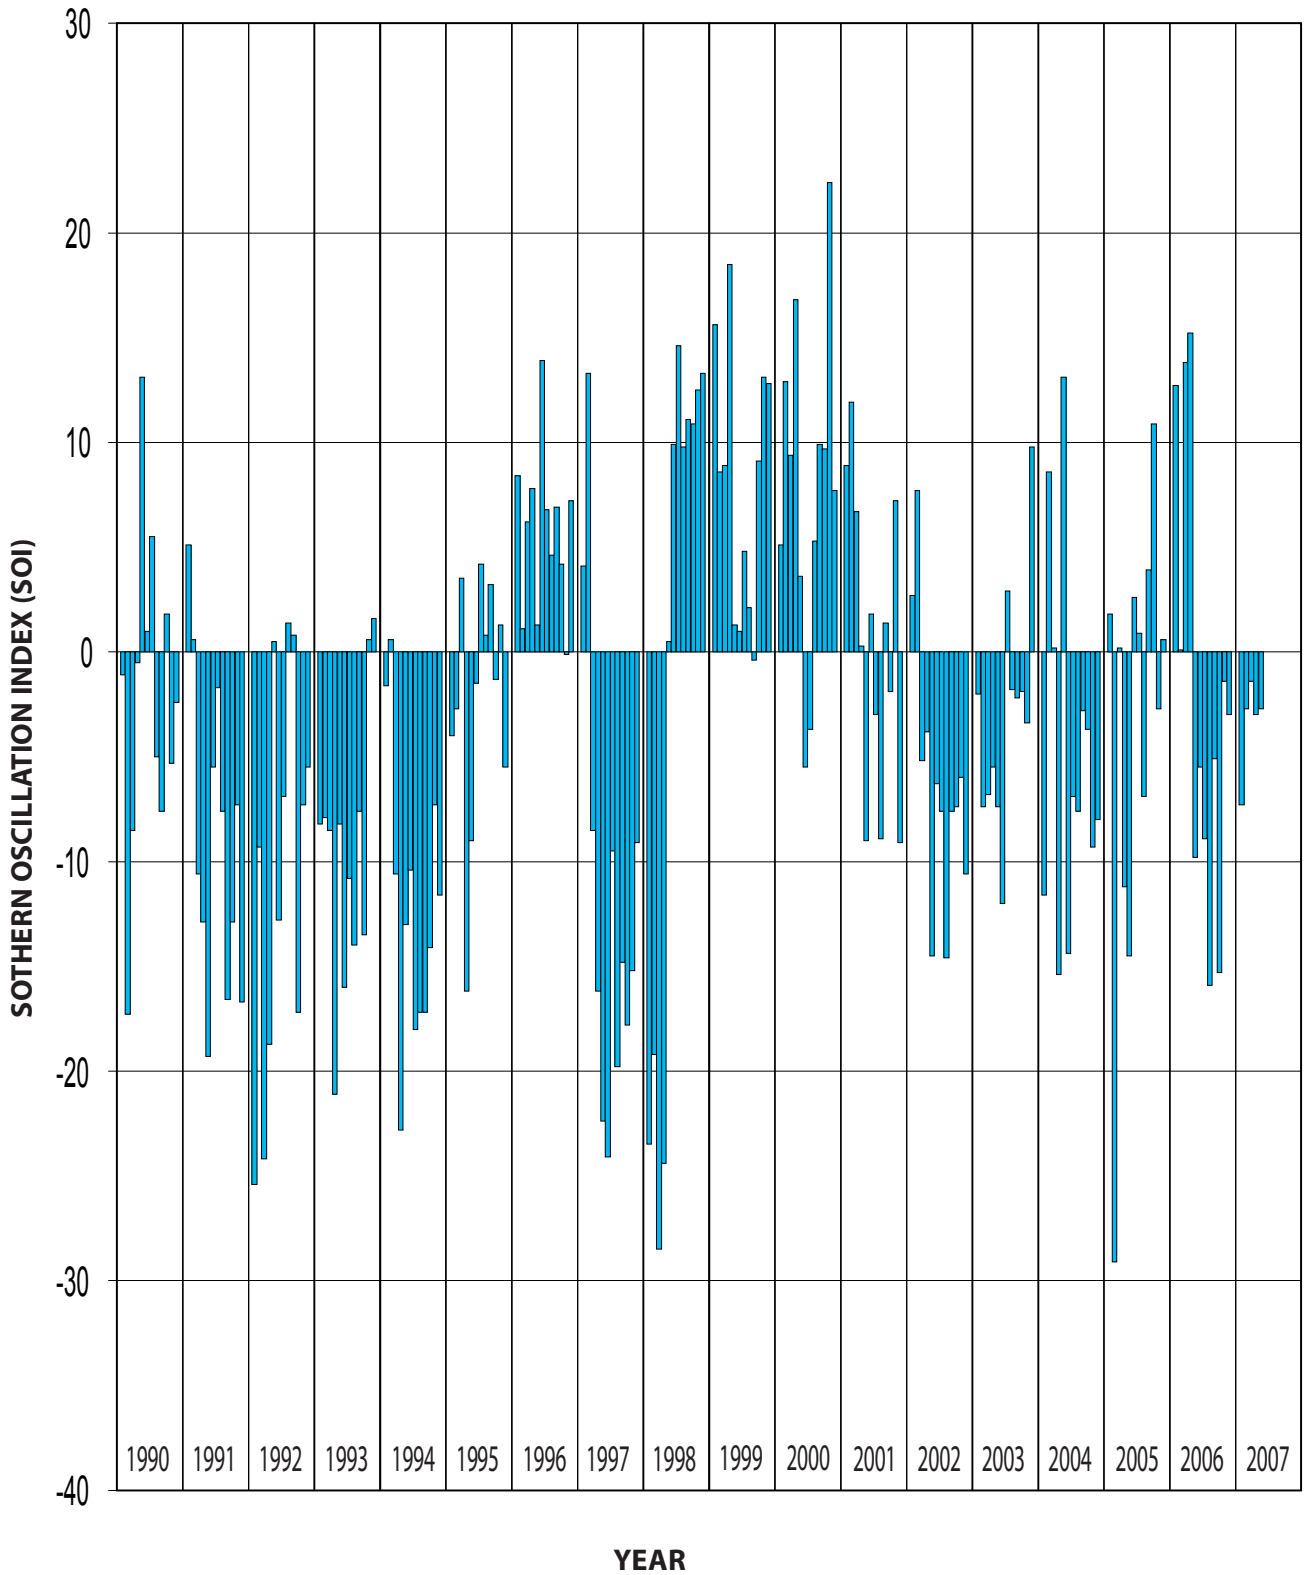
Figure 2-C

Southern Oscillation Index (SOI) 1990 - 2007

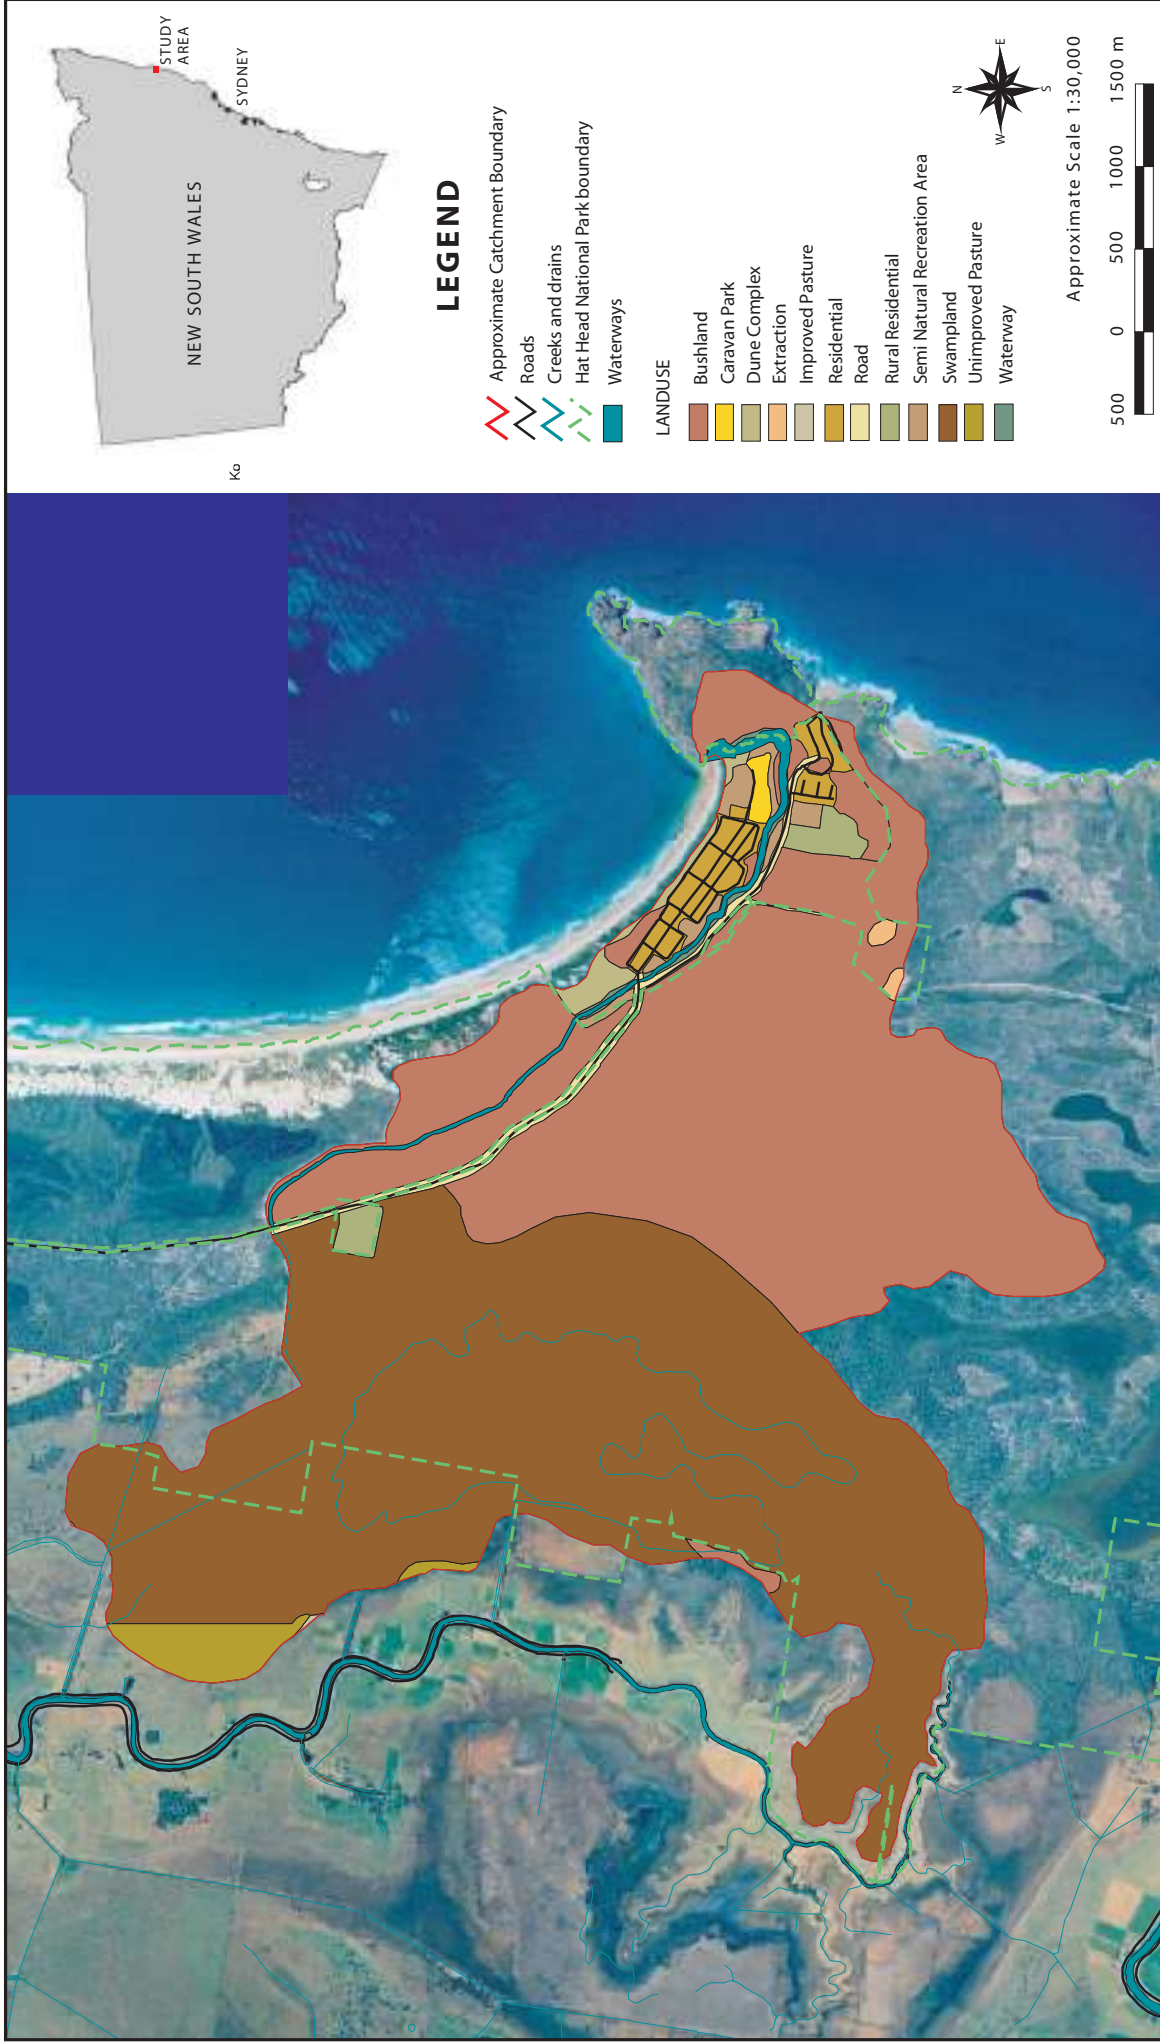
Korogoro Creek Catchment - Distribution of Landuse Types

Catchment landuse reflects the above statistics. Table 2 shows the landuse categories and associated areas and percentage of catchment figures with the distribution of landuse types depicted in Figure 2-E (p.31).

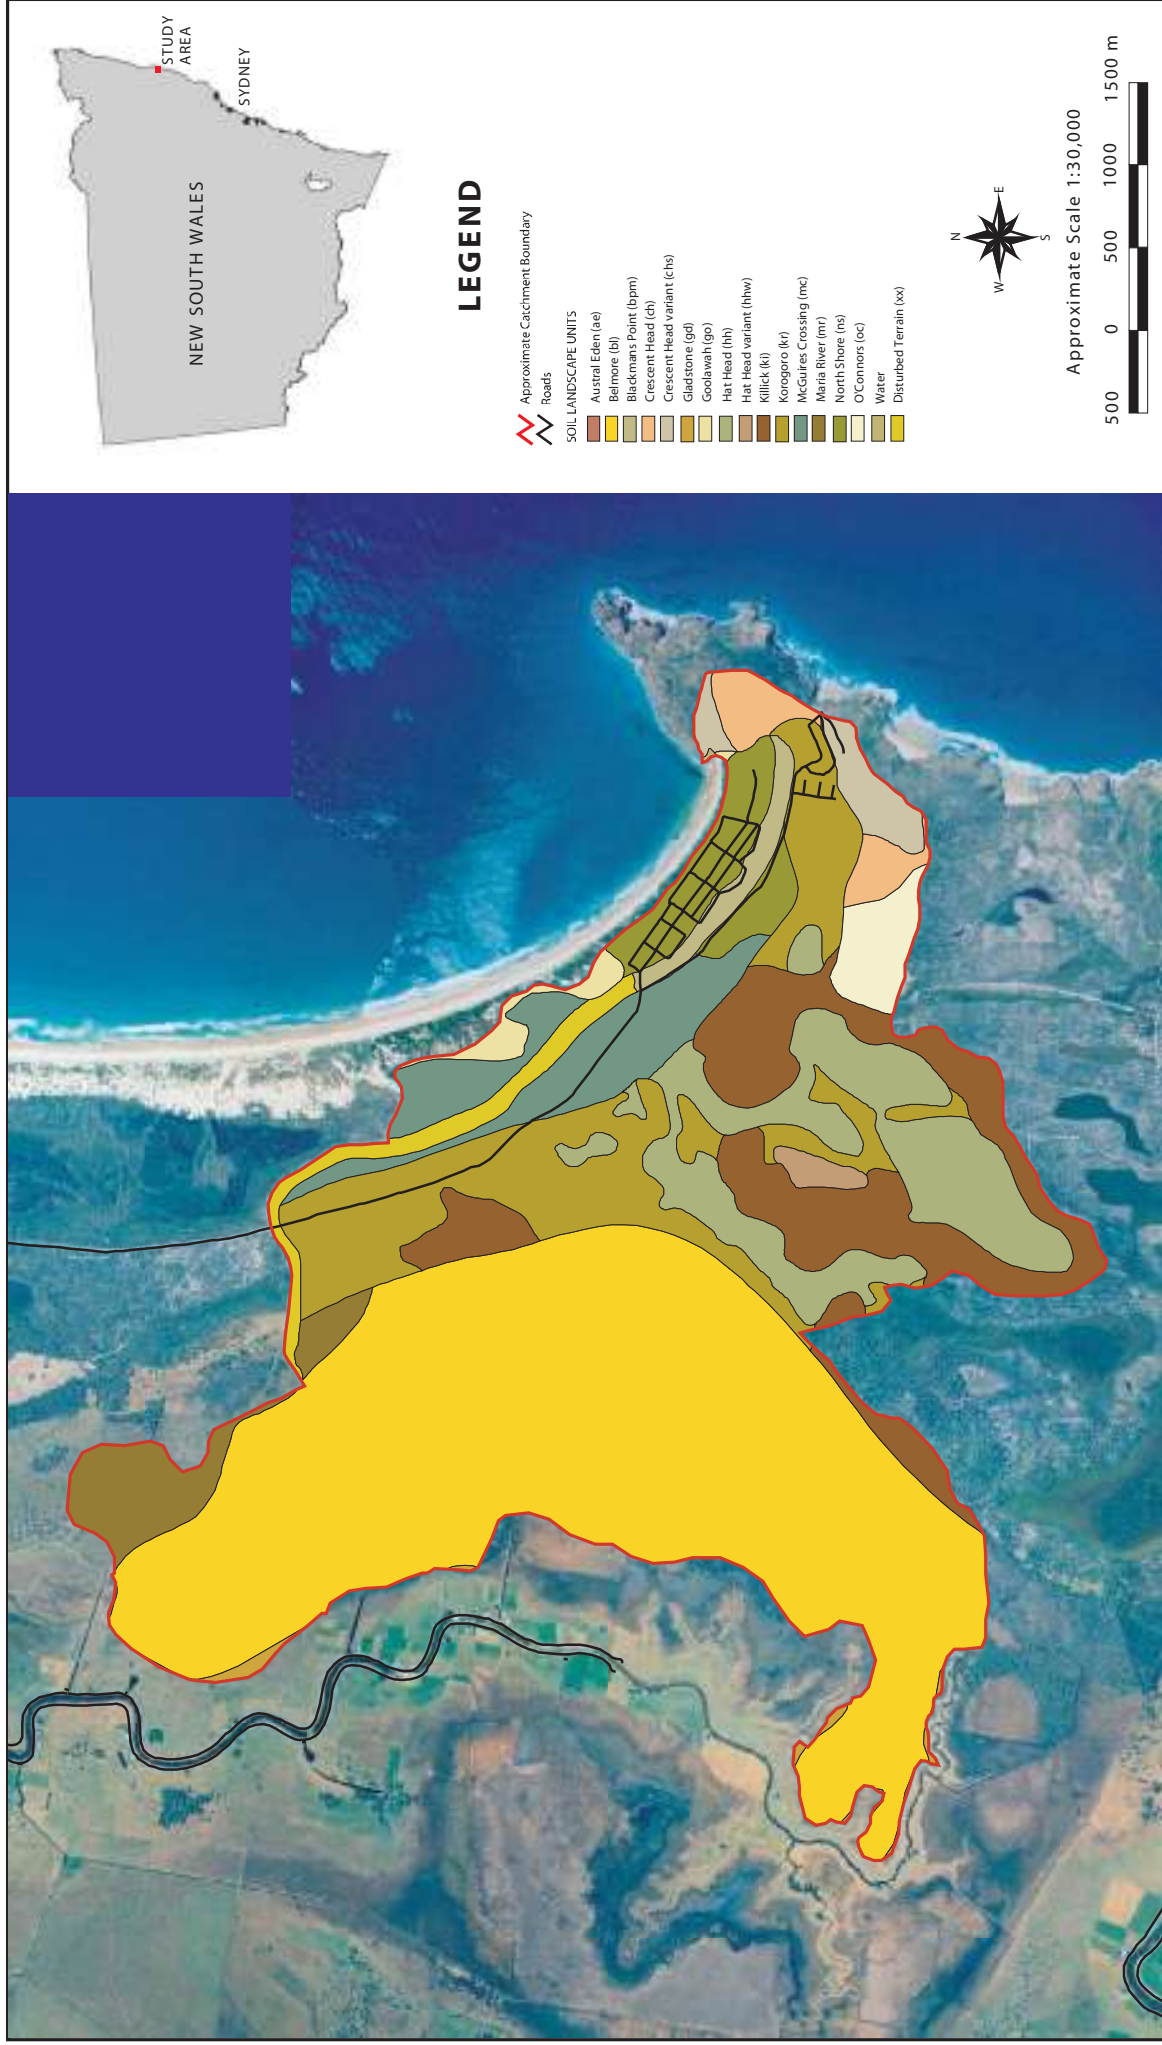
Figure 2-1

Korogoro Creek Catchment - Soil Landscape Units

Figure 2-H (p.34) shows the distribution of Soil Landscape Process Groups in the Korogoro Creek catchment while Figure 2-I (p.35) shows the distribution of identified Soil Landscapes Units.
