## **PART 4 KOROGORO CREEK PROCESSES STUDY**

### **4.1 Community values and issues survey**

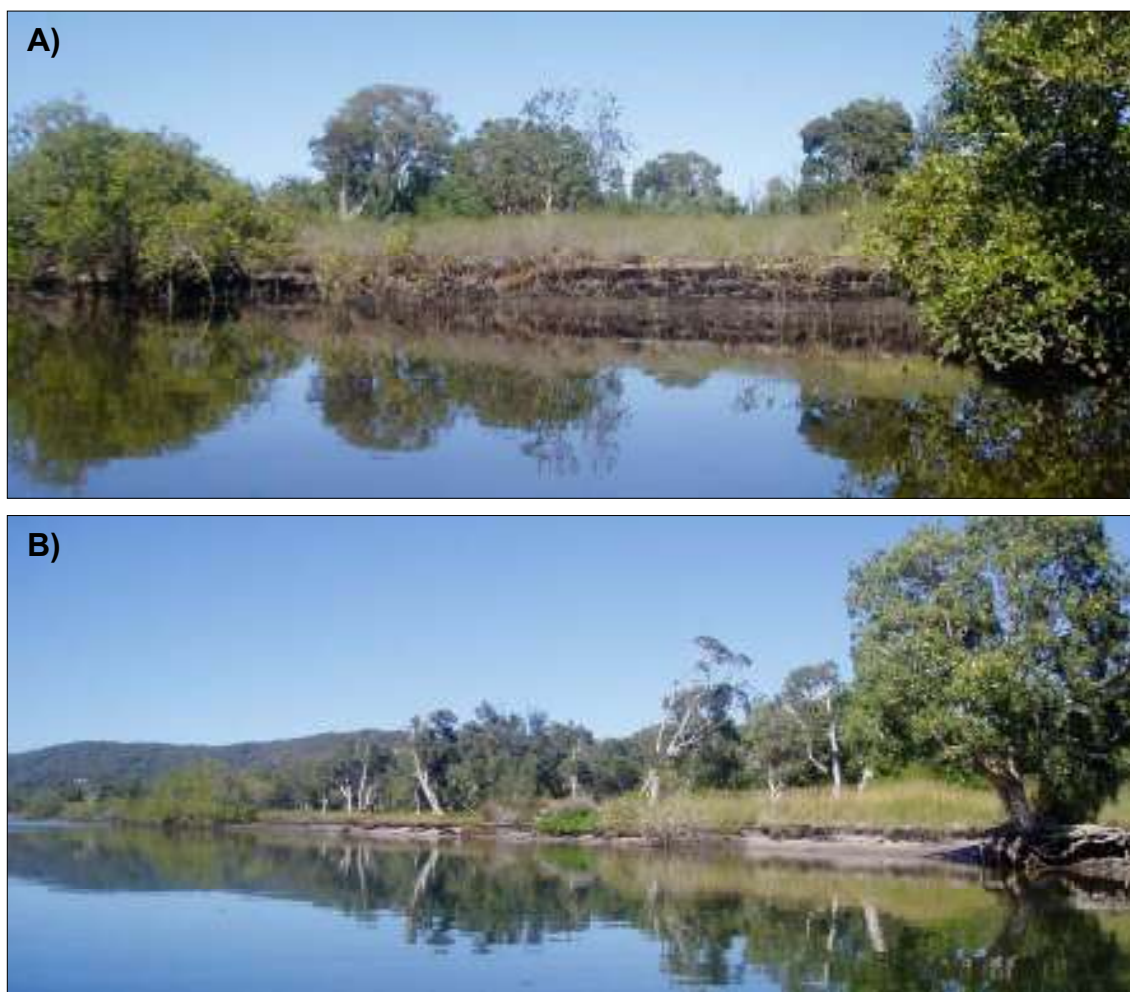
with erosion control works (rock revetment). Plate 3 shows typical examples of minor (A) and moderate (B) severity bank erosion in this process zone. Although mapped as stable, several of the upper reaches of this process zone showed signs of previous scour possibly associated with the March 2001 floods during which the flood mitigation scheme operated.

**Plate 3** *Typical example of minor bank erosion in the Modified Estuarine Basin Process Zone. A) slab type slumping failure; and moderate bank erosion B) Scour and undercutting of vegetation. Note regeneration of mangrove seedlings in A) which is absent from moderate severity bank erosion B).*

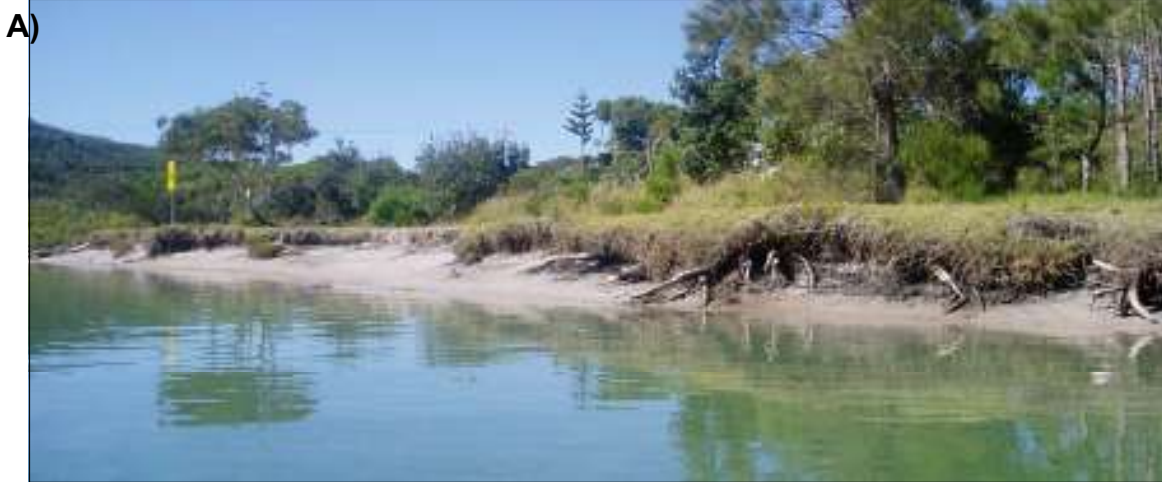
The higher proportion of erosion control works indicate that erosion in this process zone has been more prevalent and perceived as more of an issue than in the upstream reaches of the modified estuarine basin process zone. When combined with the percentage figures for existing minor and moderate bank erosion, 23% of the Marine Tidal Delta process zone has been affected by bank erosion in the recent past (last 3 decades). This figure reflects the higher estuary energy in this zone, the erodible nature of the bank sediments (predominantly sands), and potentially the higher impacts on bank and riparian vegetation associated with recreational access particularly on the southern bank.

**Plate 4**      *Typical example of moderate bank erosion in the Marine Tidal Delta Process Zone*  
*A) slab type block failure and slumping. Note sandy soils, poor vegetation cover and evidence of undercut and dead tree roots in bank.*

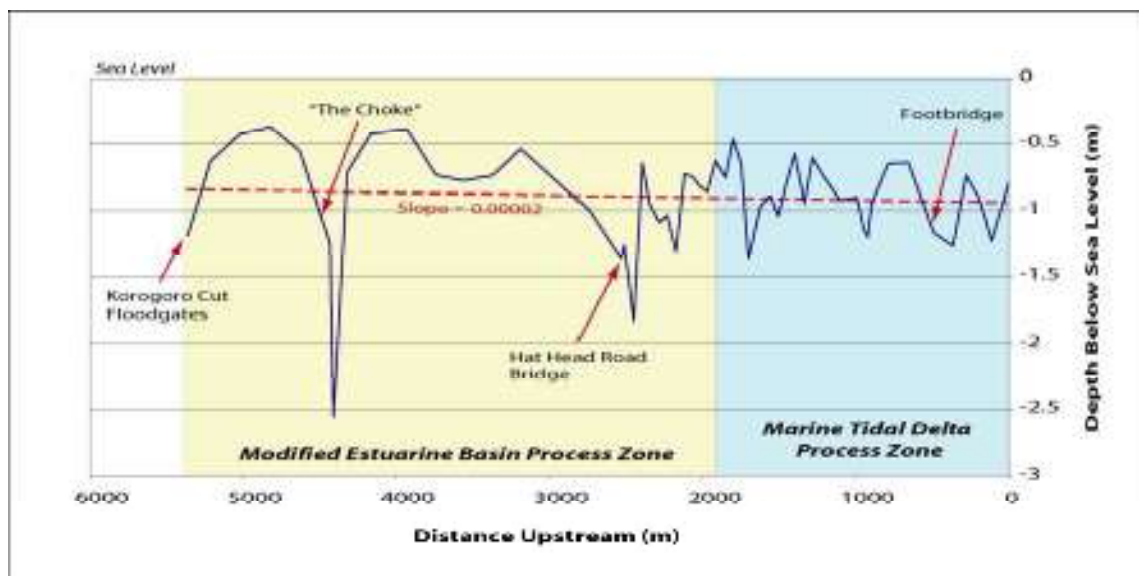
The longitudinal profile highlights the nature of in-channel sediment storage along Korogoro Creek. Areas of the channel bed above the line of best fit (a linear regression with slope of 0.00002) correspond to areas of net sediment storage while areas below this line represent areas of channel scour.

The profile shows that the two identified process zones have distinct sediment storage patterns. The Modified Estuarine Basin Process Zone is predominantly characterised by extensive reaches of sediment accumulation with the major areas of scour correlated with channel constrictions located below “The Choke” and in the vicinity of the Hat Head Road bridge. The channel bed in this zone is relatively planar and homogeneous with sediments dominated by organic muds and sandy muds, often extensively bioturbated by infauna and epifauna. The Marine Tidal Delta Process Zone is characterised by shorter reaches of alternating scour and deposition which represent the extensive shoaling within this zone. Bed features are heterogeneous with multiple dune formations on the bed and sediments mostly composed of coarse-grained marine sands.

**Figure 4-C** 2005 Longitudinal profile of the thalweg (deepest point in the channel) of Korogoro Creek - with linear regression (slope = 0.00002). Topography derived from bathymetric data (source: DoC, 2006).

Although Figure 4-C provides a ‘snap shot’ of sediment storage patterns along Korogoro Creek in 2005 it does not provide an indication of how these longitudinal patterns have changed through time. It is a commonly expressed community view that the estuary has “silted up” in recent years. Whilst there is no historic quantitative data with which to compare to the 2005 bathymetry, an analysis of aerial photographs from 1942 through 2003 certainly indicates extensive changes to the sedimentation patterns of the estuary. Most notably, the ingress of marine sands associated with the Marine Tidal Delta Zone has extended considerably up the channel for some 830m since 1956 (Figure 4-D, p.90). Unfortunately, due to the lack of quantitative data it is not possible to confirm the processes or determine the scale of sedimentation or the rate of infilling. However possible causes for this ingress include;

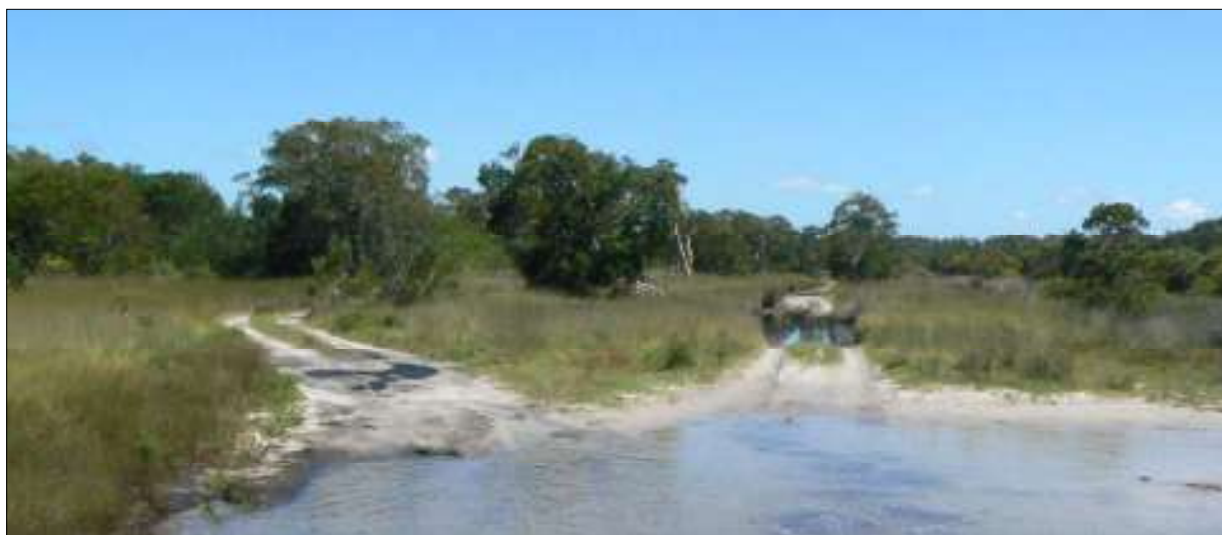
Saltmarsh communities are well represented in the Korogoro Creek estuary. Their distribution is mostly confined to the middle section of the estuary. An inventory of Saltmarsh species can be found in Table 12. Saltmarsh communities are listed as an Endangered Ecological Community under the *Threatened Species Conservation Act 1995*. Saltmarsh communities of the Korogoro Creek estuary are heavily disturbed by vehicle and walking trails (see Plate 5). The natural distribution of Saltmarsh has been influenced by the construction of levees and unnatural drainage patterns have resulted in deep channels through Saltmarsh habitat. These factors, combined with the landward migration of mangroves can lead to significant reductions in Saltmarsh extent (NSW DPI Fisheries 2003). These concerns should be addressed in any future management plans.

**Plate 5** Typical example of disturbance to Saltmarsh communities from vehicles on the southern bank of the creek.

- Extensive damage to Coastal Saltmarsh, an *Endangered Ecological Community* listed under the Threatened Species Conservation Act 1995 (see Plates 5 and 6)
- Impacts on vegetation and low banks particularly where tracks cross small tidally inundated flats (Plate 6). Damage is worse where flow is concentrated during heavy rain and in boggy areas.
- Damage to the levee where vehicles attempt to negotiate the steep climb back onto Gap Road.

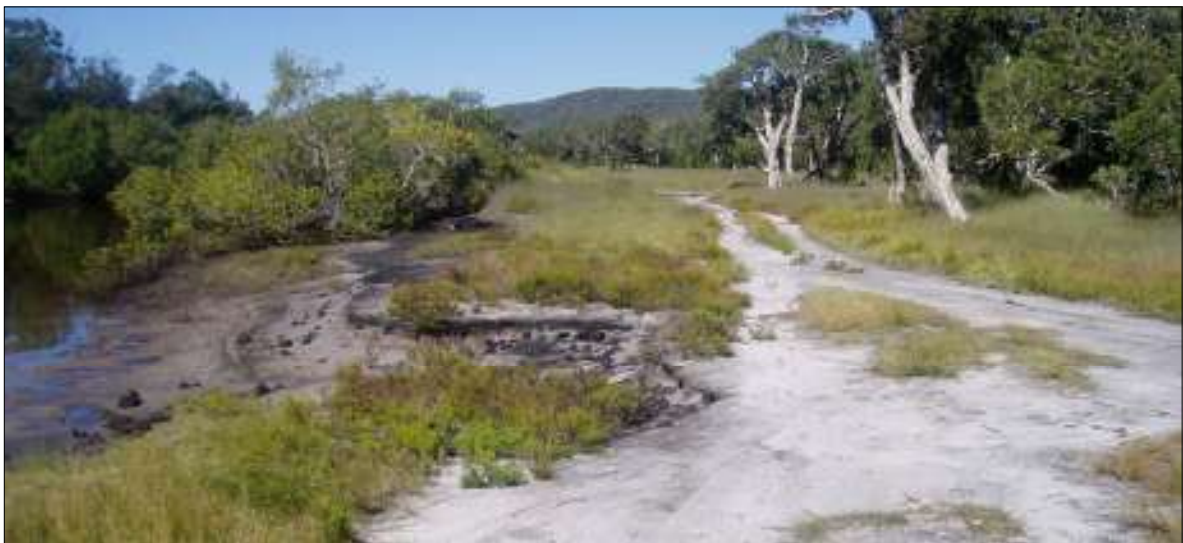
**Plate 6** Typical example of disturbance to Saltmarsh communities from vehicles on the southern bank of the creek.

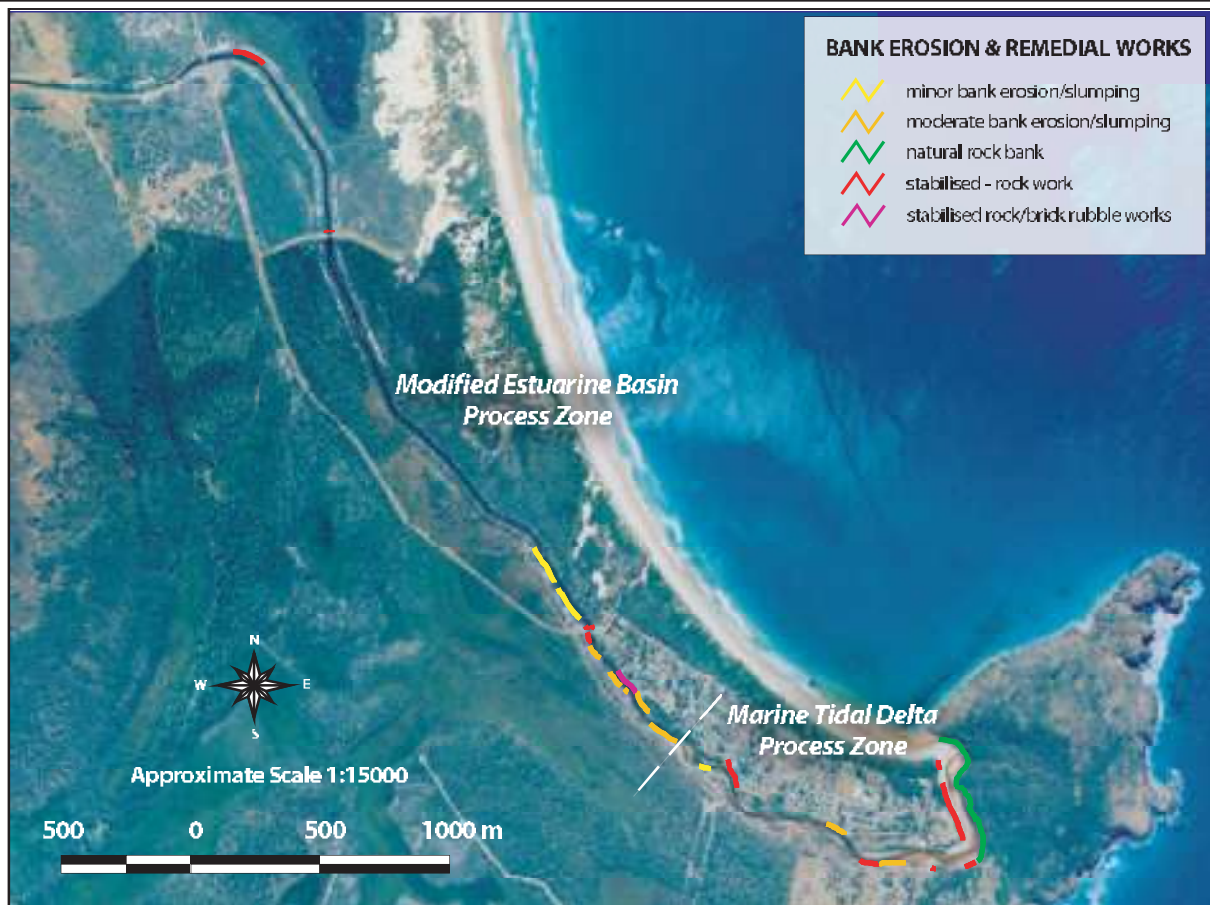
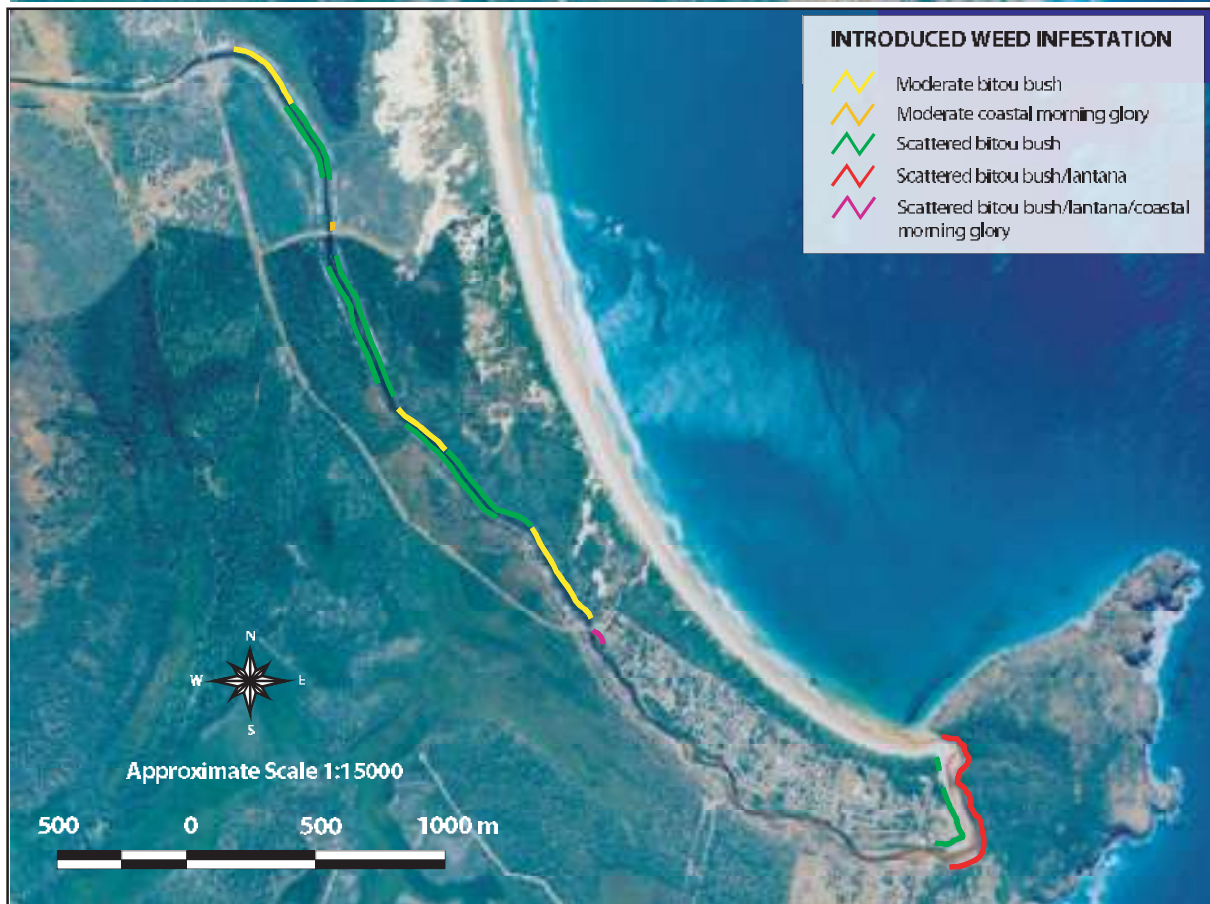
**Korogoro Creek Estuary - Bank Erosion, Remedial Works and Introduced Weed Infestation Levels**

Data Sources:  
Bank erosion, remedial works & weed infestation data - collected using handheld GPS and kayak, May 2007.  
Base Orthophoto - derived from LIP NSW 1:25,000 Coastal Surveillance (2003)

Figure 4-B (p.89) shows the spatial distribution of bank erosion in the modified estuarine basin process zone. Ninety-three percent (6185 m) of this process zone is stable with 4.8 % of this being stabilised

Figure 4-B (p.89) shows the spatial distribution of bank erosion in the modified estuarine basin process zone. Ninety percent (3426 m) of this process zone is stable with 14 % of this being stabilised with erosion control works (rock revetment) and 16.6% naturally stable due to bedrock outcropping on the southern bank. Plate 4 shows a typical example of moderate severity bank erosion found in this process zone.

The distribution of the three major identified environmental weeds found in the riparian (creek bank) zone is provided in Figure 4-B (p.89).

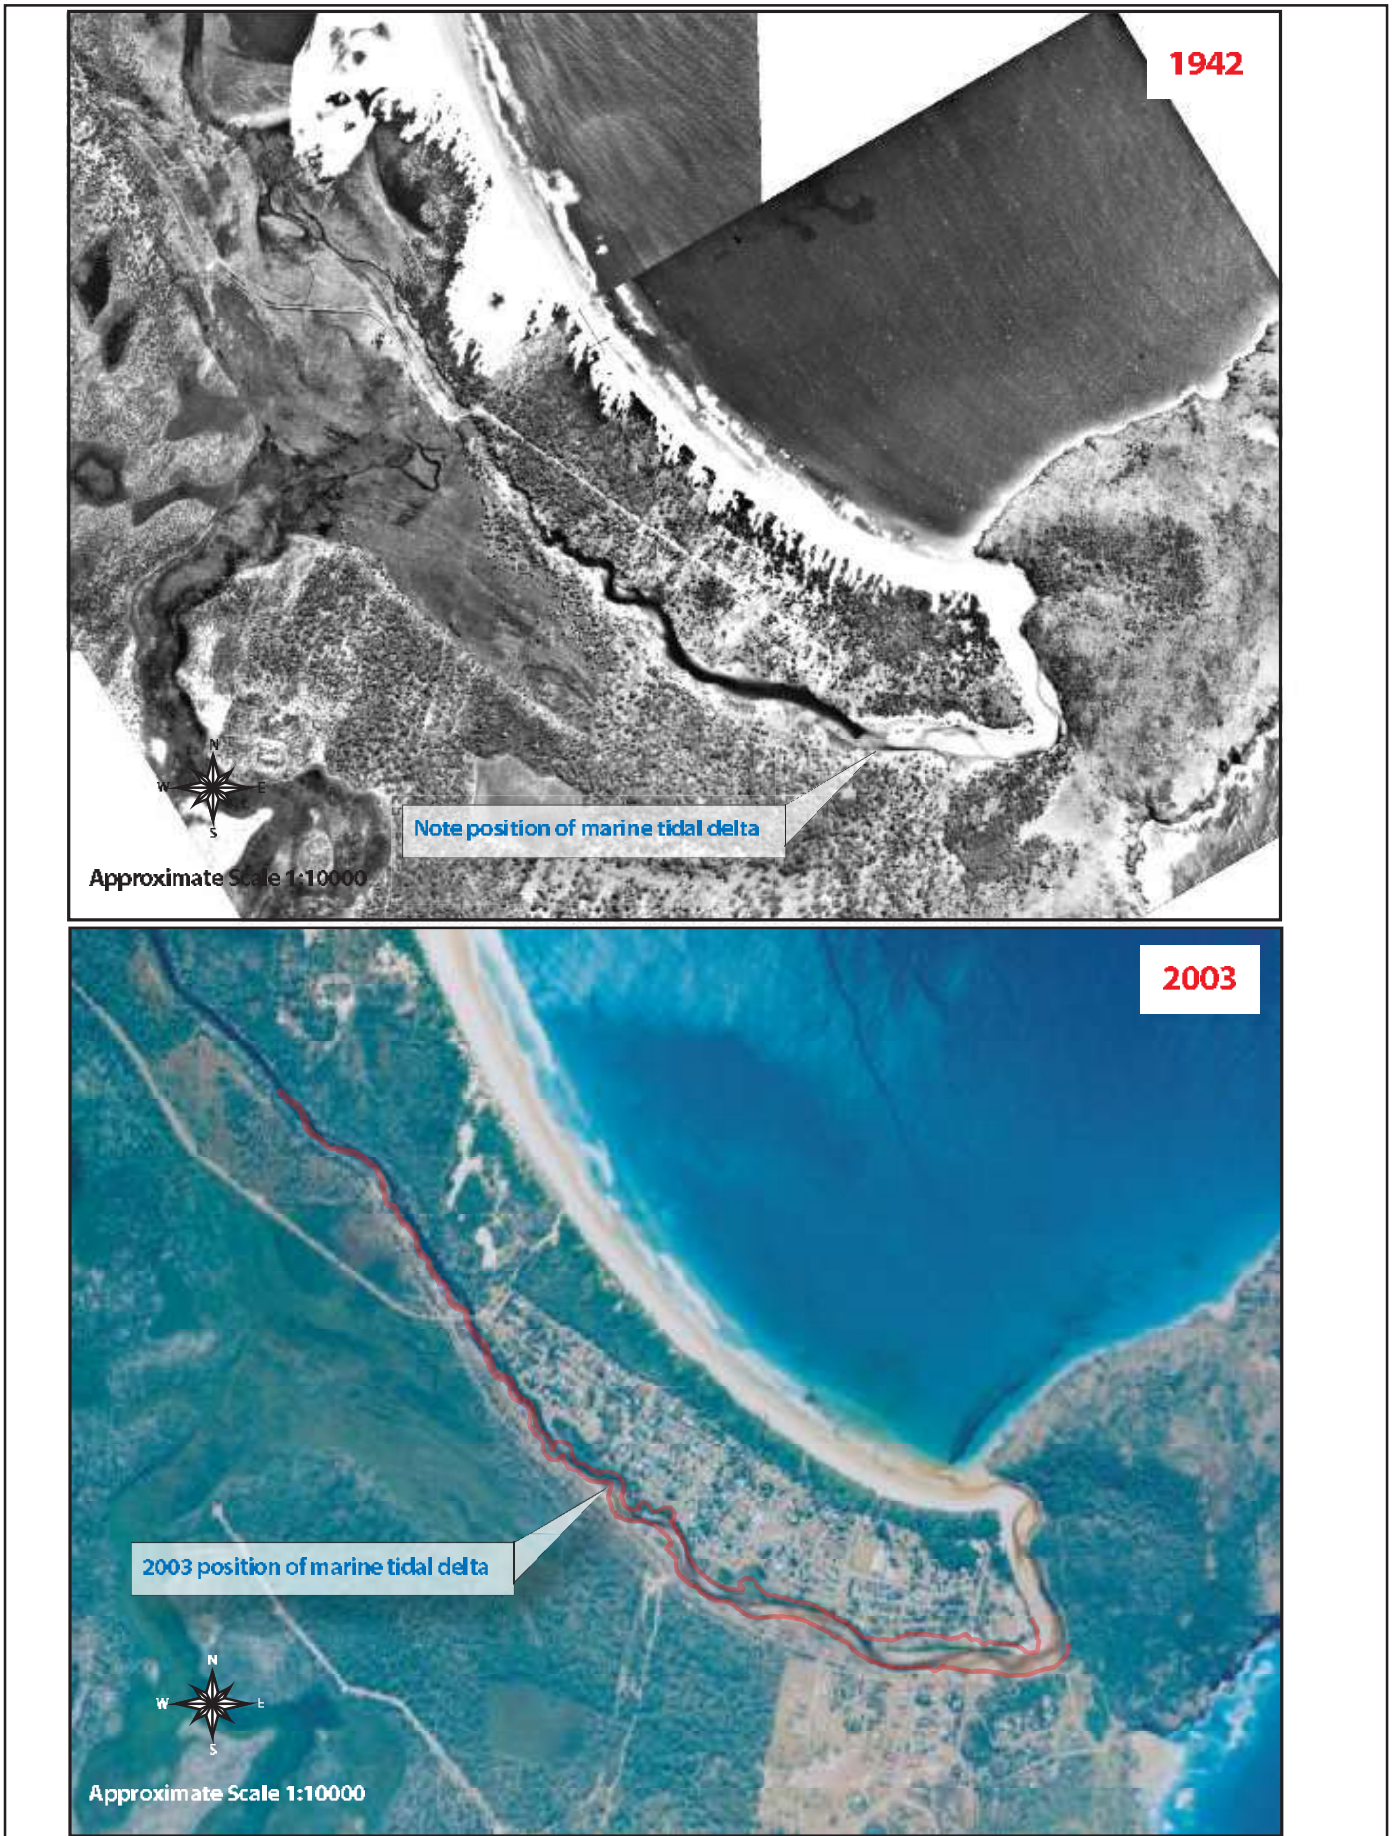
Figure 4-D

**Comparative aerial photographs 1942 (top) to 2003 (bottom)**

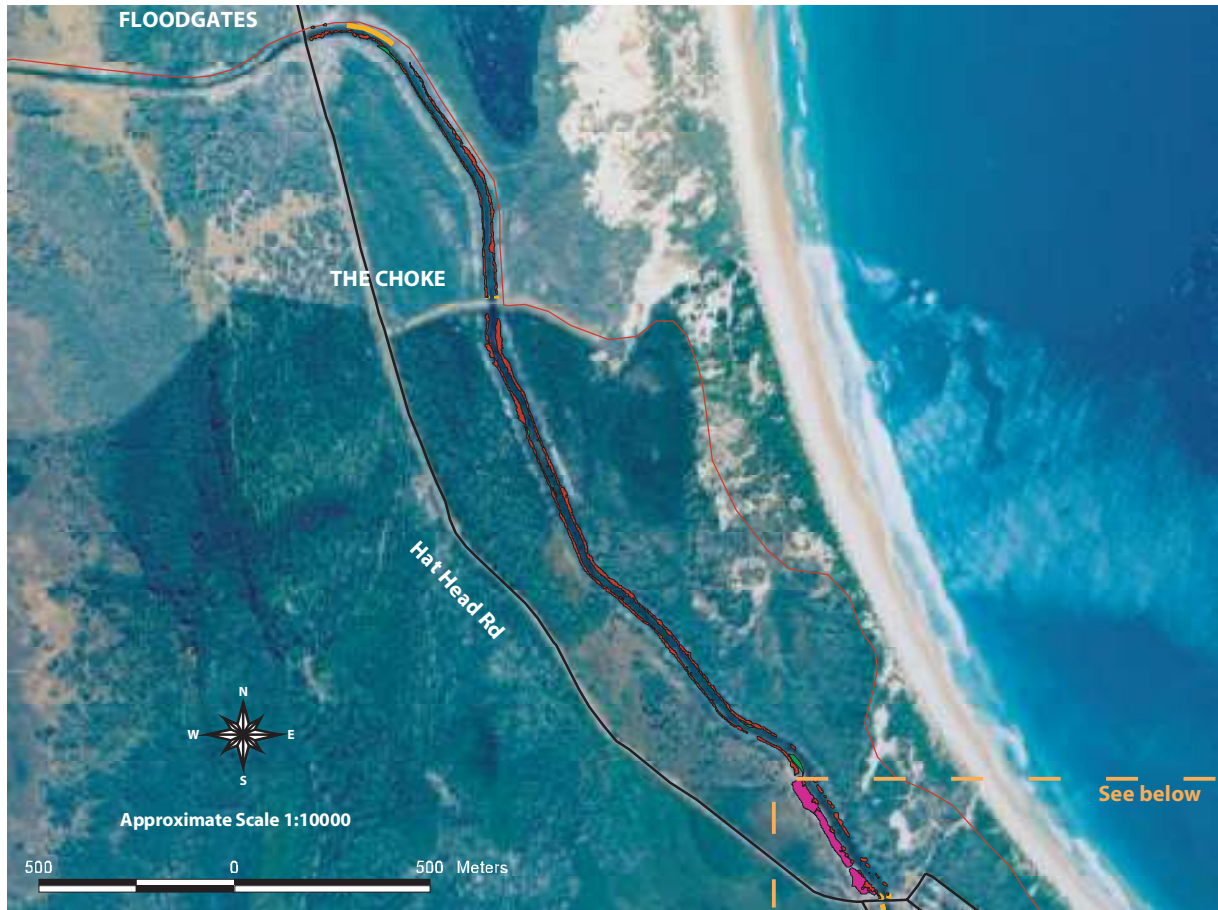
Figure 4-M

**Korogoro Creek Catchment - Survey Estuary Habitat Types**

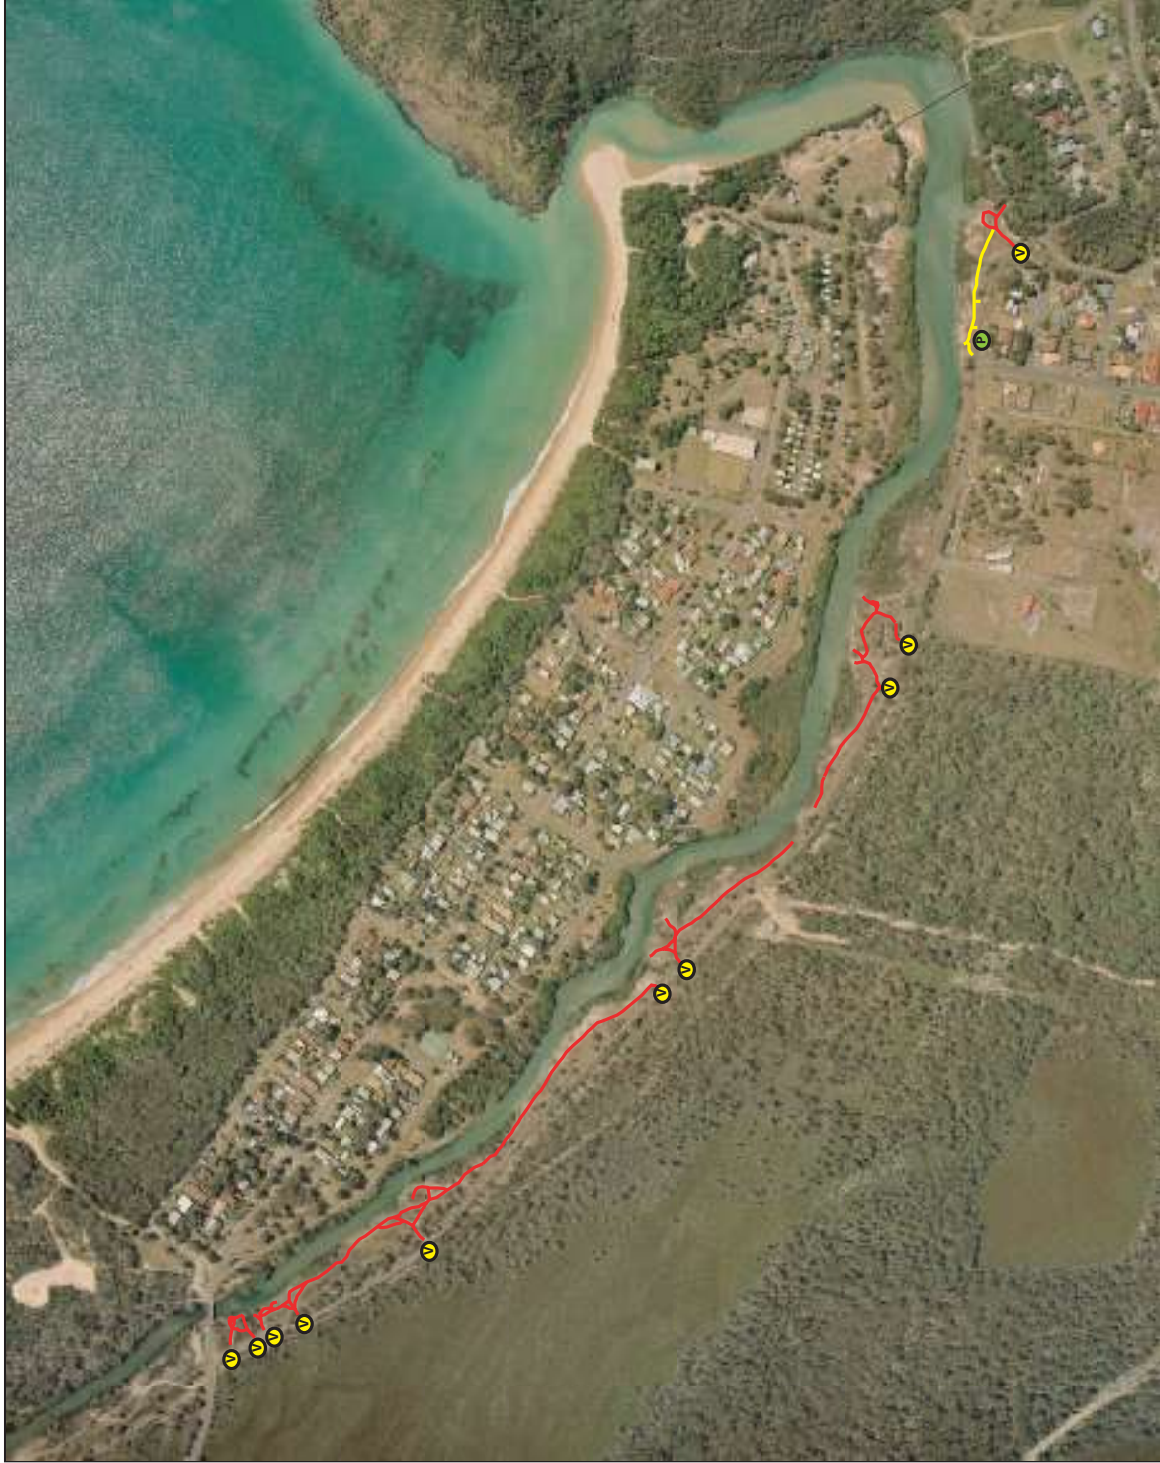
Figure 4-N

### Vehicle and Pedestrian Access Points and Tracks - South Bank of Korogoro Creek, below Hat Head Road Bridge

Sources: Base orthophoto images: created from 2004 1:10,000 coastal surveillance aerial photography LPI, Dept Lands, Bathurst  
Access mapping: derived through aerial photograph interpretation and field recording using handheld GPS
