Ecohealth

A health check for our waterways

Macleay Catchment REPORT CARD 2016

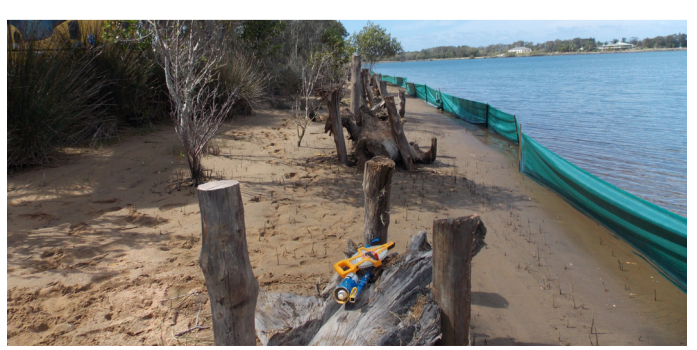
Pelican Island rehabilitation project to improve foreshore habitat. Photo © R. Kemsley, KSC.

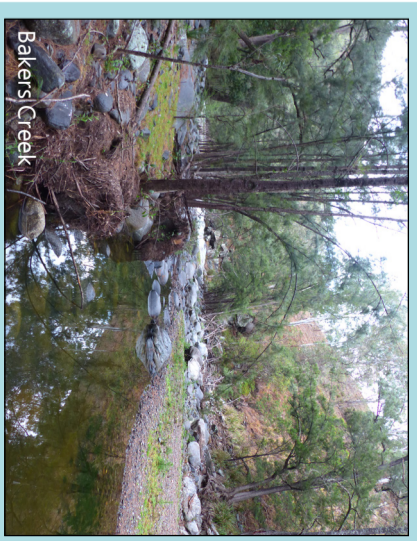
Water column Sb at Bakers Creek ranged from 37 to 96 times the ANZECC guidelines for healthy aquatic ecosystems, but no site on the Macleay River exceeded the ANZECC Sb trigger value for healthy aquatic ecosystems.

Water column As at Bakers Creek ranged from 1.4 to 2.7 times the ANZECC trigger value for healthy aquatic ecosystems. The Macleay River at Jerseyville exceeded the ANZECC As trigger value for healthy aquatic ecosystems once (November 2015).

Sediment Sb at Bakers Creek ranged from 72 to 164 times the national sediment low guideline value. The national sediment low guideline value was exceeded at Georges Junction, Bellbrook, Kinchela and Jerseyville.

Sediment As at Bakers Creek ranged from 4.4 to 7 times the national sediment low guideline value. No site in the Macleay River exceeded the national sediment low guideline value during the study period.

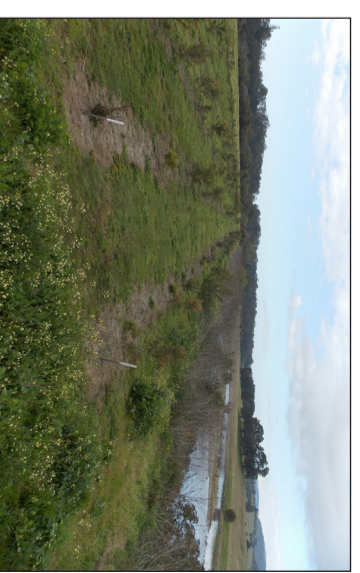
Shenwood - Macleay River riparian revegetation project. © Photo R. Kempsley, KSC.
