Macleay Ecohealth Project 2015-2016

Assessment of River and Estuarine Condition

Final Technical Report

December 2016

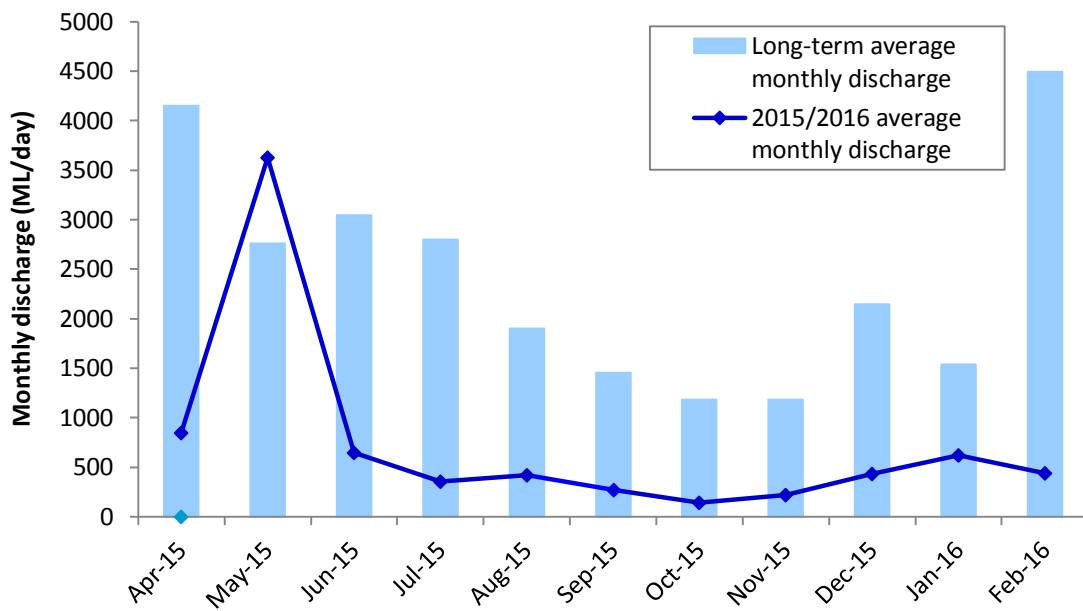
Figure 2.6a Average monthly discharge over the 2015/2016 study period (April 2015 to February 2016) in comparison to the long-term average monthly discharge of the Macleay River at Georges Junction in the Macleay River main stem (NOW gauge 206024).

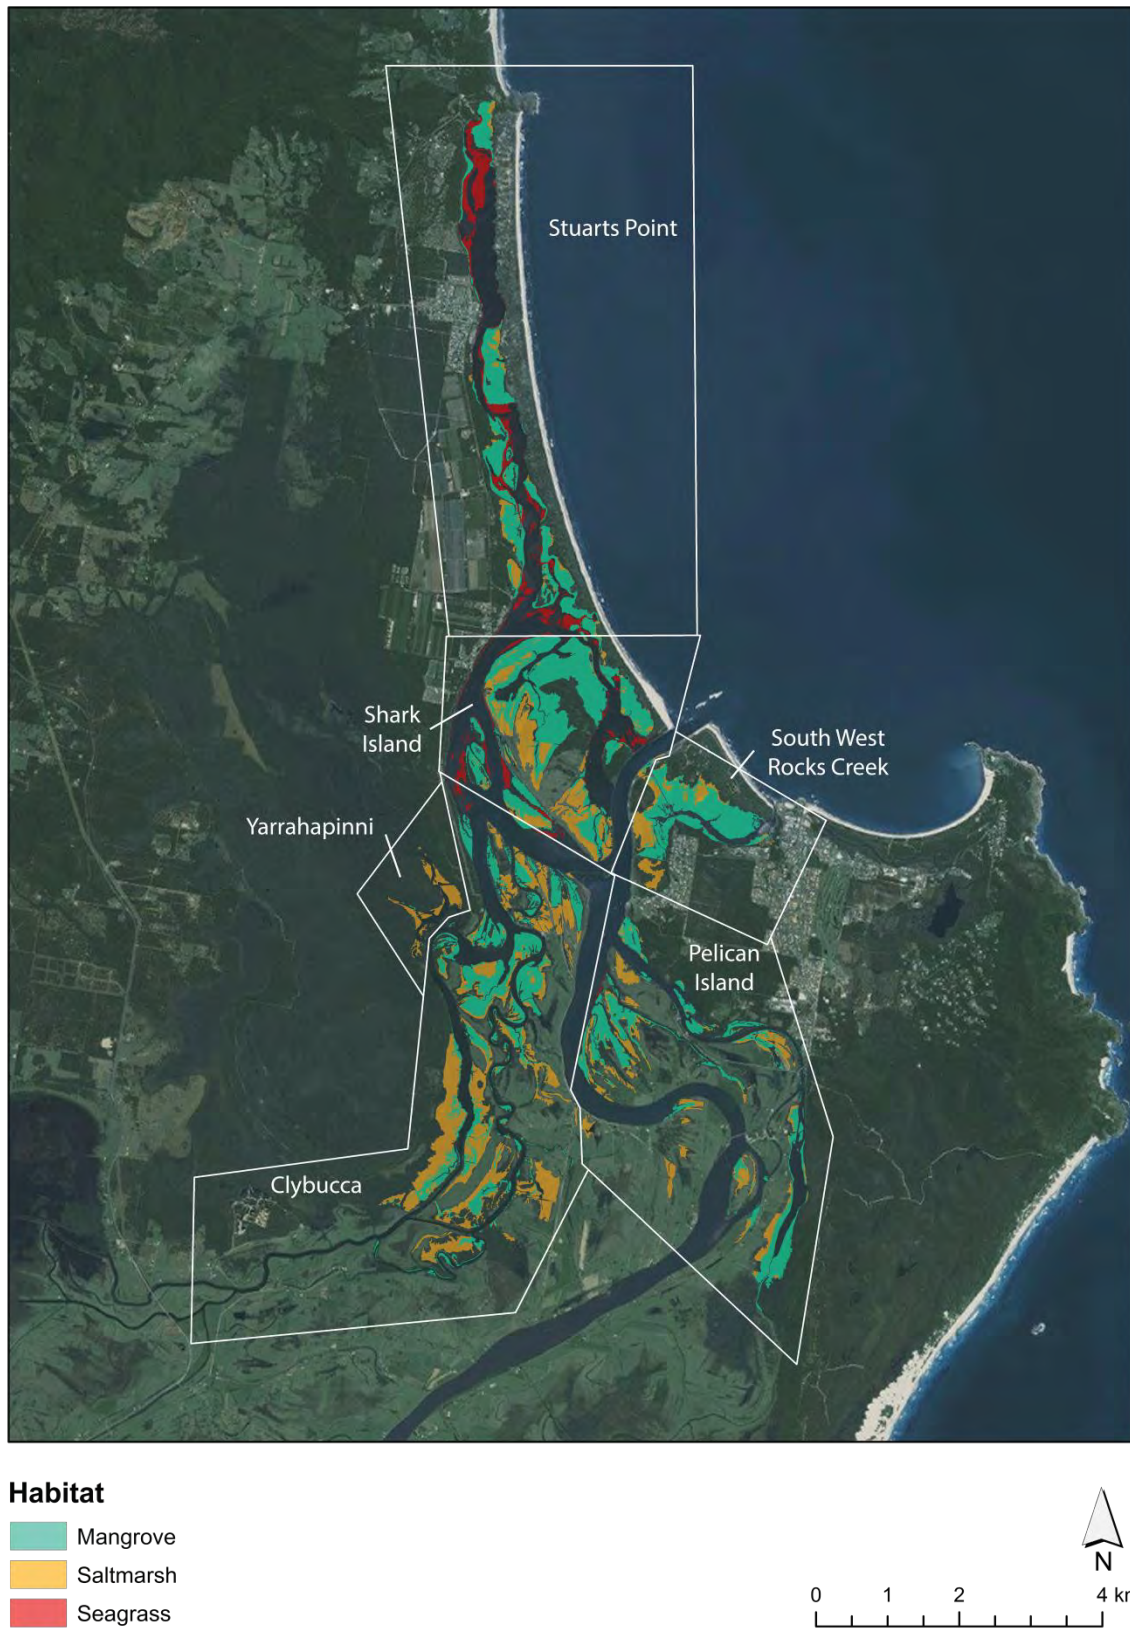
Figure 3.4 Mangrove, seagrass and saltmarsh habitats in the Macleay River and South West Rocks Creek estuaries (NSW Department of Industry and Investment – Primary Industries and Energy 2011). The estuaries are divided into six zones for more detailed temporal analysis.

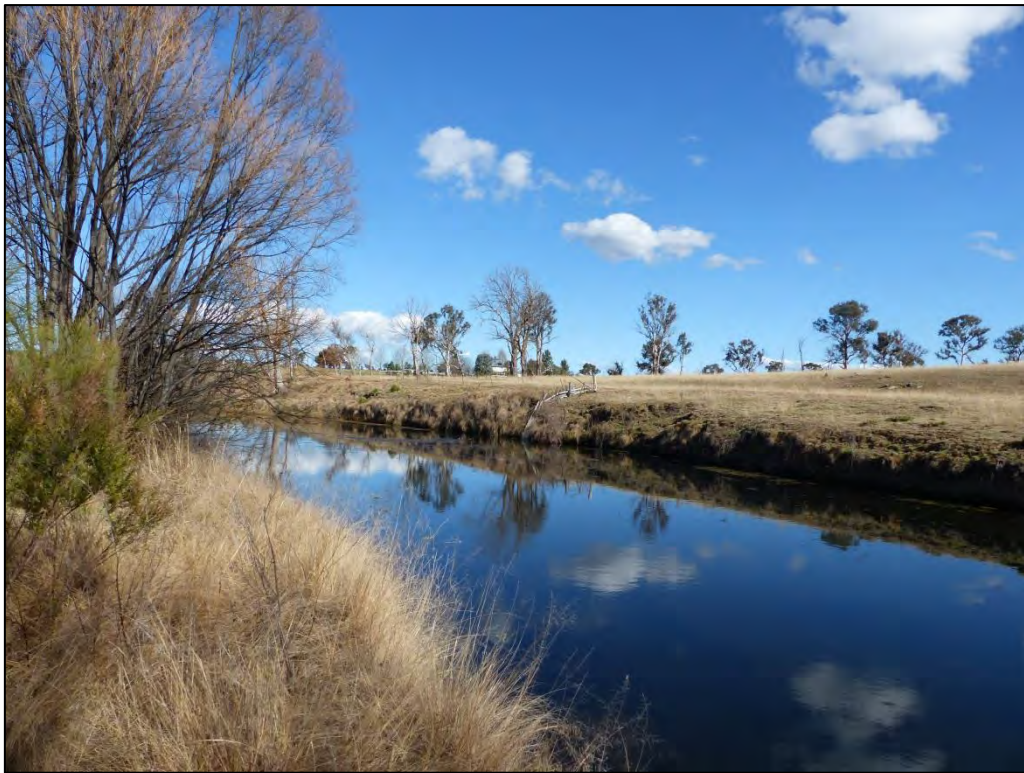
Plate 3.4 Site COMW1 on Commissioners Waters (looking upstream).

There were 10 sites located at or close to end-of-system tributaries of the Macleay River. COMW1 on Commissioners Waters (Plate 3.4) is a gravel-bed river in a confined valley setting with discontinuous floodplain pockets. The site is 420m upstream of the confluence of Commissioners Waters and the Gara River. SALW1 on Salisbury Waters (Plate 3.5) is a bedrock controlled, fine grained channel in a partially confined valley setting. The site is 8km upstream of where Salisbury Waters enters the Macleay gorges. APSR1 on the Apsley River (Plate 3.6) is a bedrock controlled, fine grained channel in a partially confined valley setting. The site is 2.4km upstream of the first waterfall at the entrance to the Apsley gorge. TIAR1 on the Tia River (Plate 3.7) is a bedrock controlled, fine grained channel in a partially confined valley setting. The site is 7.4km upstream of the first waterfall at the entrance to the Tia gorge. YARR1 on the Yarrowitch River (Plate 3.8) is a planform controlled, meandering, fine grained channel in a partially confined valley setting. The site is 1.2km upstream of the entrance to the Yarrowitch gorge.

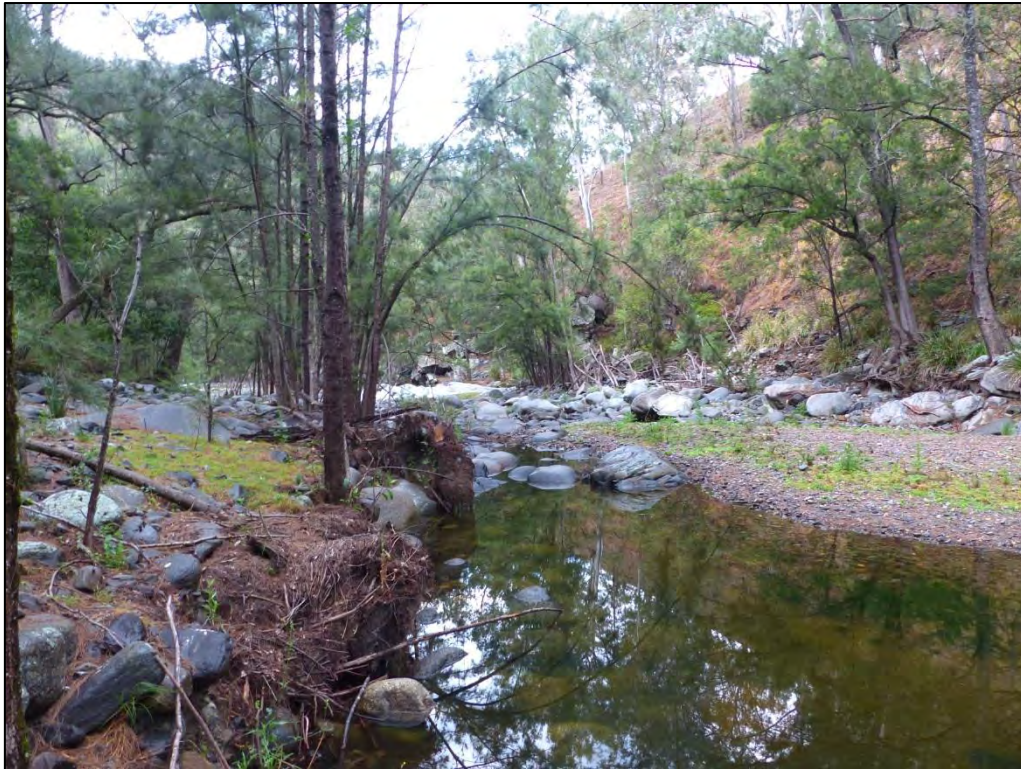
Plate 3.9 Site BAKC1 on Bakers Creek downstream of Hillgrove Mine (looking downstream).

BAKC1 (Plate 3.9) is in the Bakers Creek gorge (confined valley setting) 14km upstream of its confluence with the Macleay River. WOLR1 is in the Wollomombi River gorge (Plate 3.10) located 3.6km upstream of its confluence with the Chandler River. CHAR1 is in the Chandler River gorge (Plate 3.11) located 5.6km upstream of its confluence with the Wollomombi River. OAKR1 is in the Oaky River gorge (Plate 3.12) located 2.2km upstream of the Oaky Dam and 20km upstream of its confluence with the Chandler River. STYR1 is in the Styx River gorge (Plate 3.13) located 26.5km upstream of its confluence with the Chandler River.

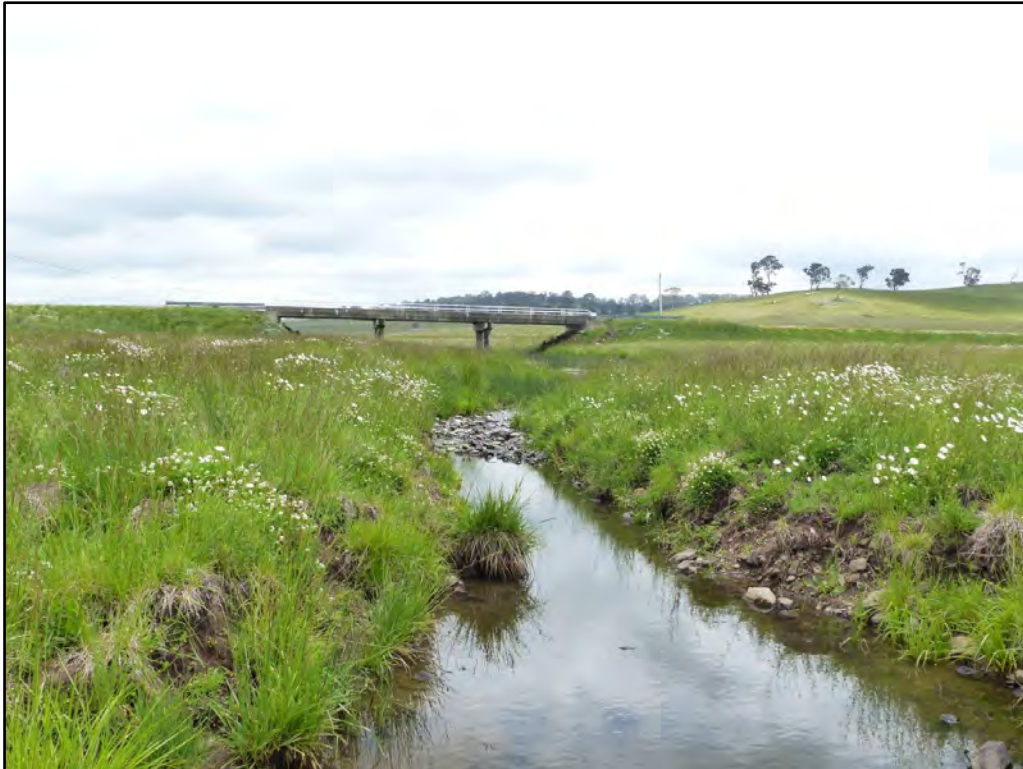
Plate 3.14 Riparian vegetation at GARR3 was extremely disturbed. Riparian condition would be improved by removing weed and noxious weed species such as Blackberry (*Rubus* sp.), undertaking native plantings, introducing woody debris and fencing off the riparian zone.

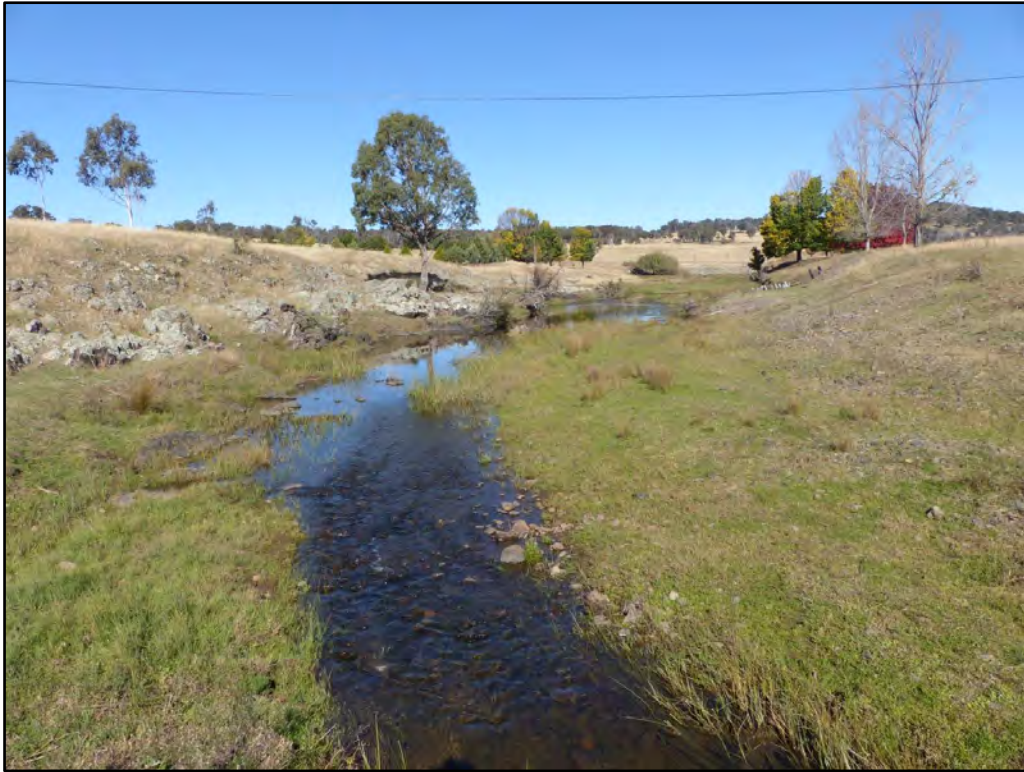
Plate 3.15 Riparian vegetation at GARR2 was extremely disturbed. Riparian condition would be improved by removing weed and noxious weed species such as Blackberry (*Rubus* sp.), strategically phasing out Willow (*Salix* sp.), undertaking native plantings, introducing woody debris and fencing off the riparian zone.

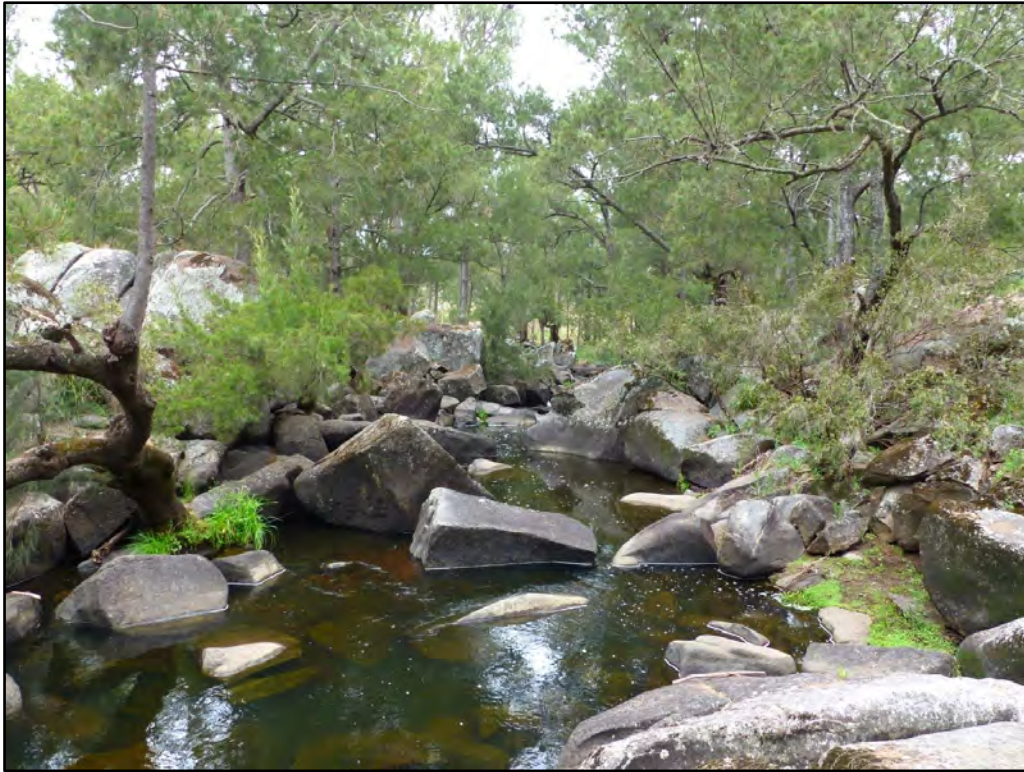
Plate 3.16 Riparian vegetation at GARR1 was of low disturbance. Riparian condition would be improved through the continued control and removal of weed species such as Willow (*Salix* sp.), Small-leaved Privet (*Ligustrum sinense*) and Blackberry (*Rubus* sp.).

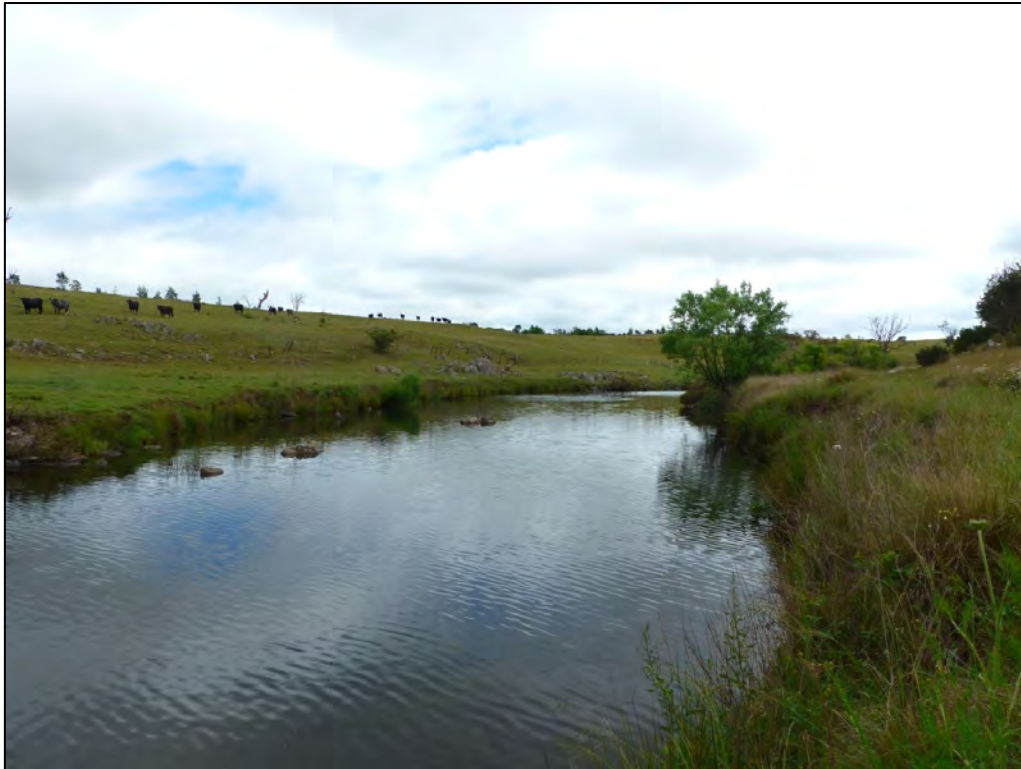
Plate 3.17 *Riparian vegetation at COMW1 was extremely disturbed. Riparian condition would be improved through the monitoring and removal of weed and noxious weed species such as Blackberry (Rubus sp.), strategically phasing out Willow (Salix sp.), undertaking native plantings, introducing woody debris and fencing off the riparian zone.*

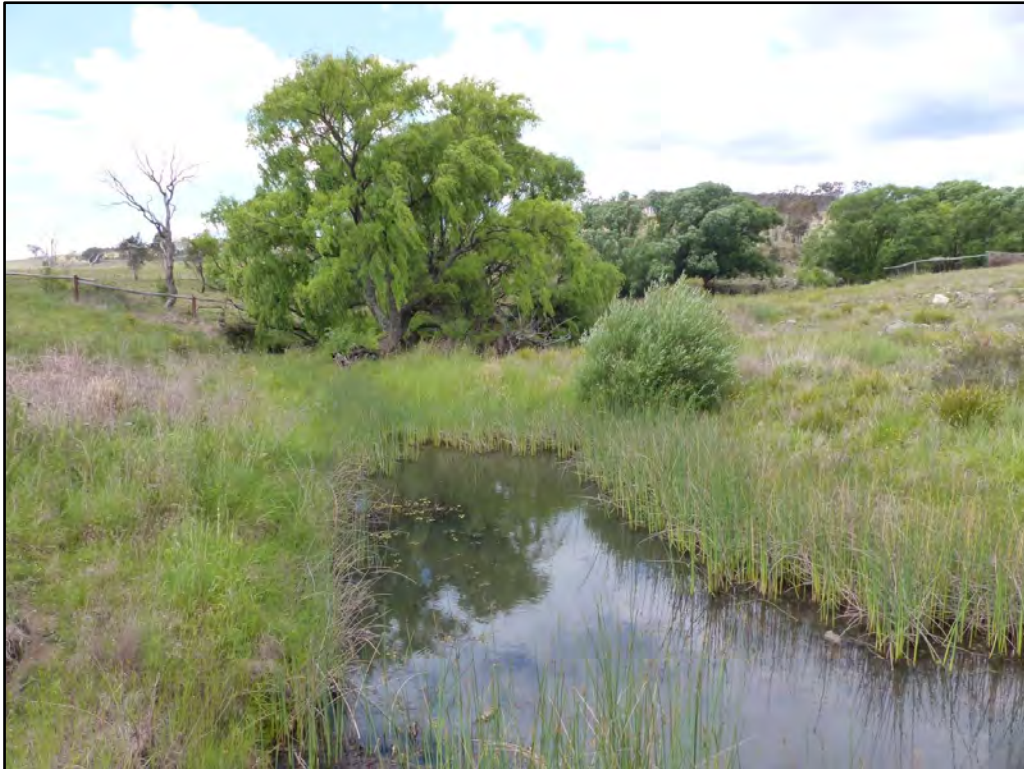
Plate 3.18 Riparian vegetation at SALW1 was extremely disturbed. Riparian condition would be improved by removing weed and noxious weed species such as Blackberry (*Rubus* sp.), strategically phasing out Willow (*Salix* sp.), undertaking native plantings, introducing woody debris and fencing off the riparian zone.

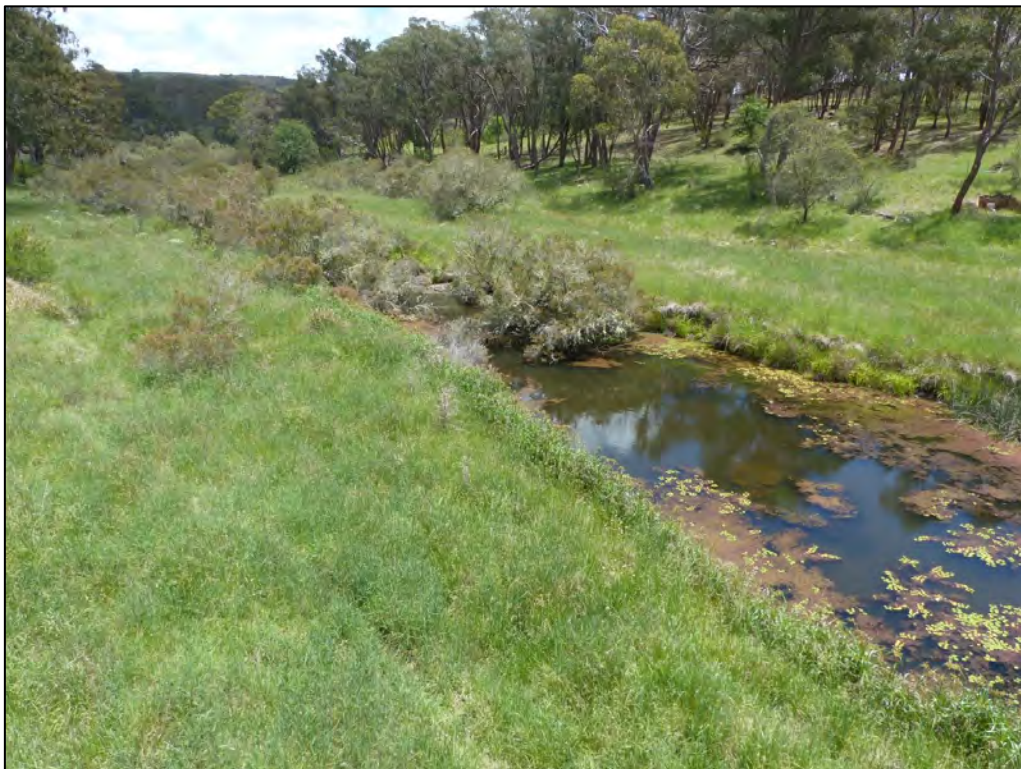
Plate 3.19 Riparian vegetation at APSR1 was mildly disturbed. Riparian condition would be improved through the monitoring and removal of weed and noxious weed species such as Willow (*Salix* sp.) and Blackberry (*Rubus* sp.), and by undertaking native plantings.

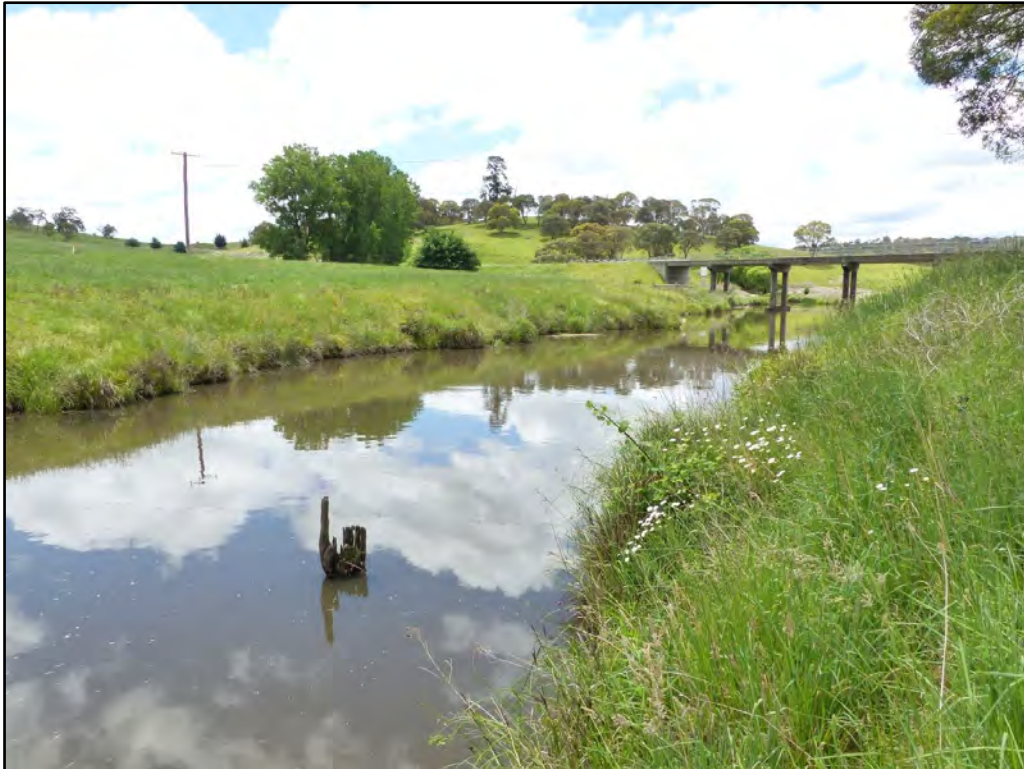
Plate 3.20 Riparian vegetation at TIAR1 was extremely disturbed. Riparian condition would be improved through the monitoring and removal of weed and noxious weed species such as Blackberry (*Rubus* sp.) and Japanese Honeysuckle (*Lonicera japonica*), strategically phasing out Willow (*Salix* sp.), undertaking native plantings, introducing woody debris and fencing off the riparian zone.

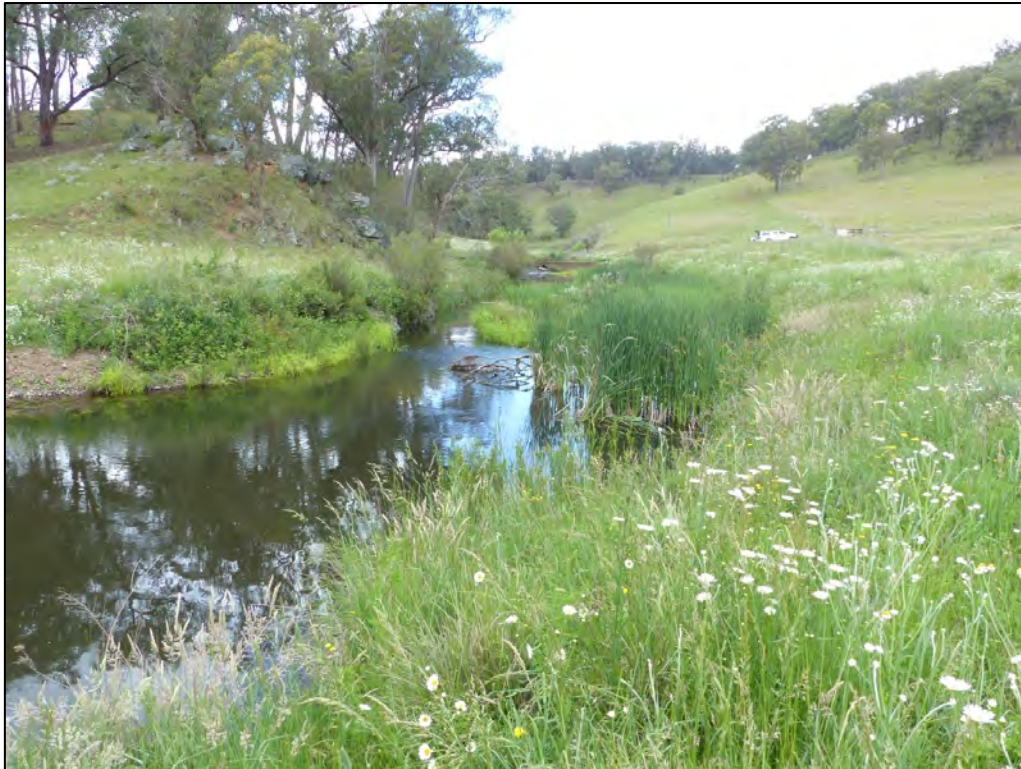
Plate 3.21 Riparian vegetation at YARR1 was highly disturbed. Riparian condition would be improved through the monitoring and removal of weed and noxious weed species such as Blackberry (*Rubus* sp.), strategically phasing out Willow (*Salix* sp.), undertaking native plantings, introducing woody debris and fencing off the riparian zone.

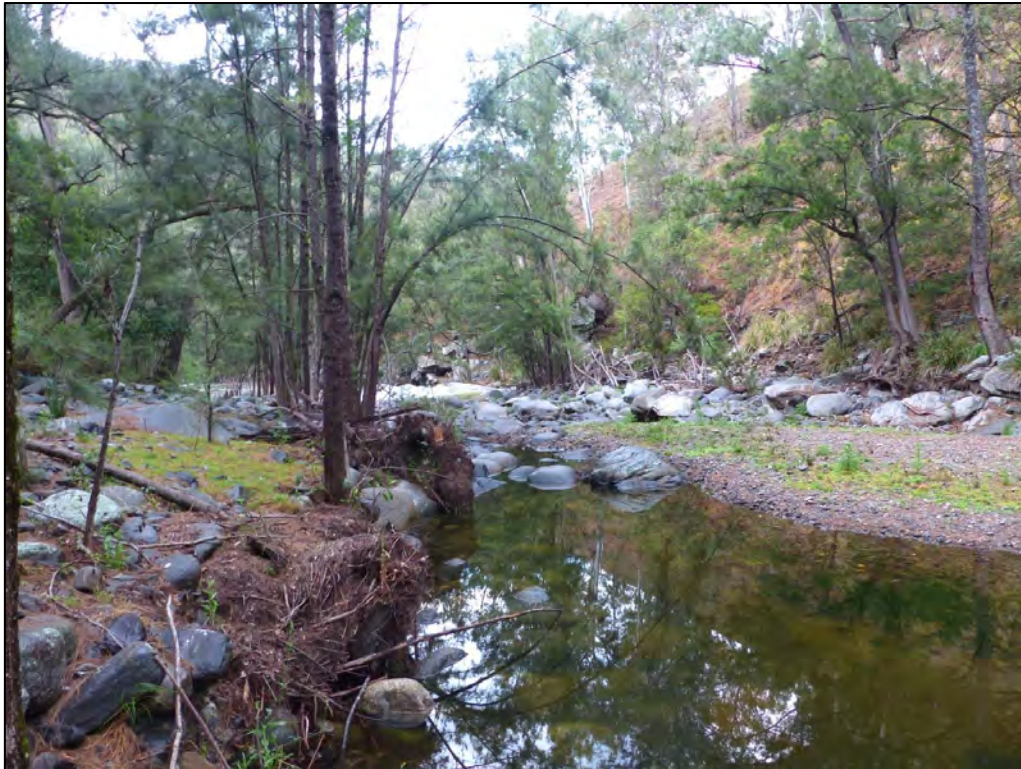
Plate 3.22 *Riparian vegetation at BAKC1 was of low disturbance. Riparian condition would be improved through control and removal of weed and noxious weed species specifically Blackberry (Rubus sp.) and by limiting animal impact by feral species.*

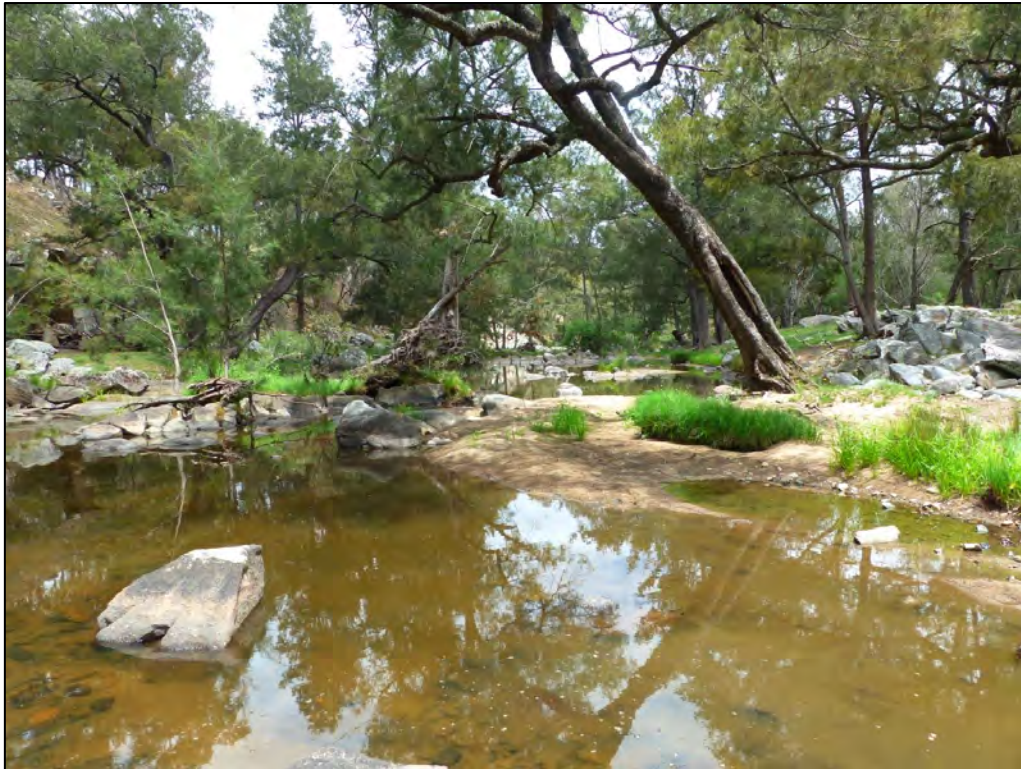
Plate 3.23 Riparian vegetation at WOLR1 was moderately disturbed. Riparian condition would be improved through the monitoring and removal of weed and noxious weed species such as Blackberry (*Rubus* sp.), strategically phasing out Willow (*Salix* sp.) and by fencing off the riparian zone.

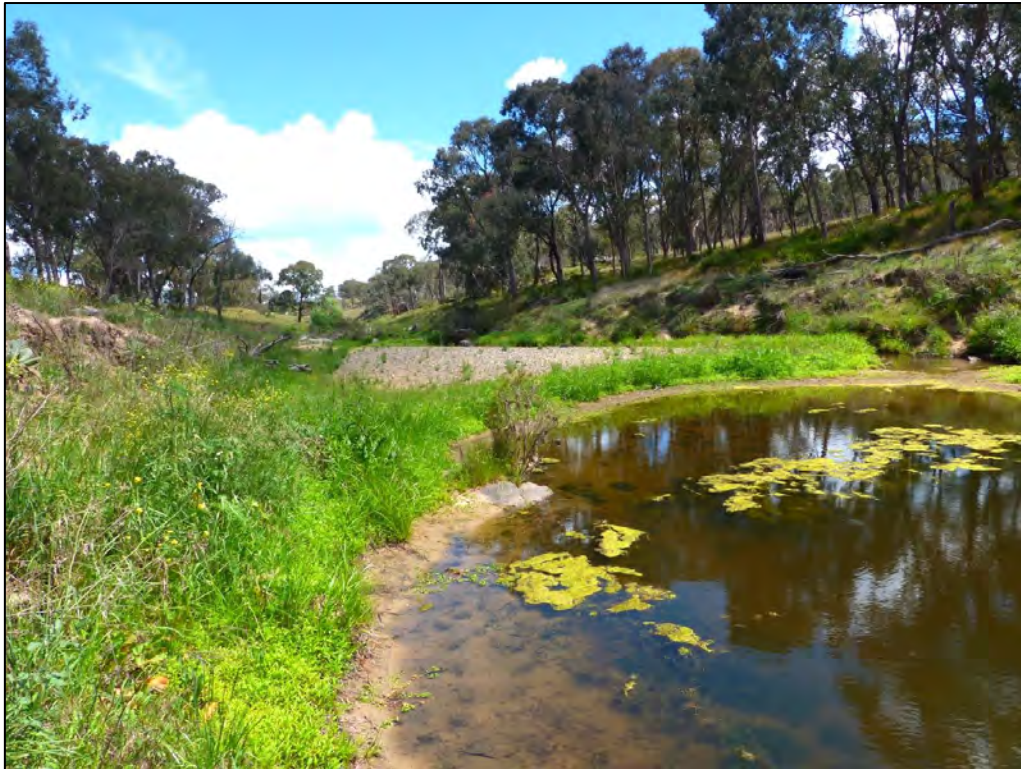
Plate 3.24 Riparian vegetation at CHAR1 was moderately disturbed. Riparian condition would be improved through the monitoring and removal of weed and noxious weed species such as Willow (*Salix* sp.) and Blackberry (*Rubus* sp.), undertaking native plantings and fencing off the riparian zone.

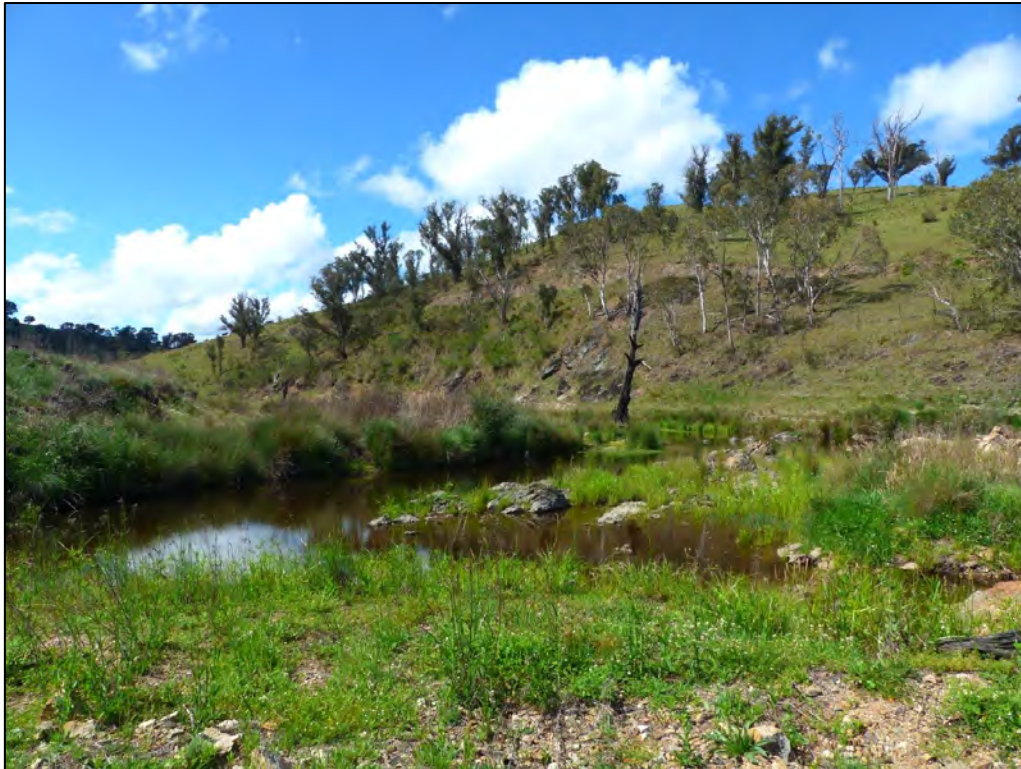
Plate 3.25 Riparian vegetation at OAKR1 was very highly disturbed. Riparian condition would be improved through the control and removal of weed and noxious weed species such as Blackberry (*Rubus* sp.), undertaking native plantings, introducing woody debris and fencing off the riparian zone.

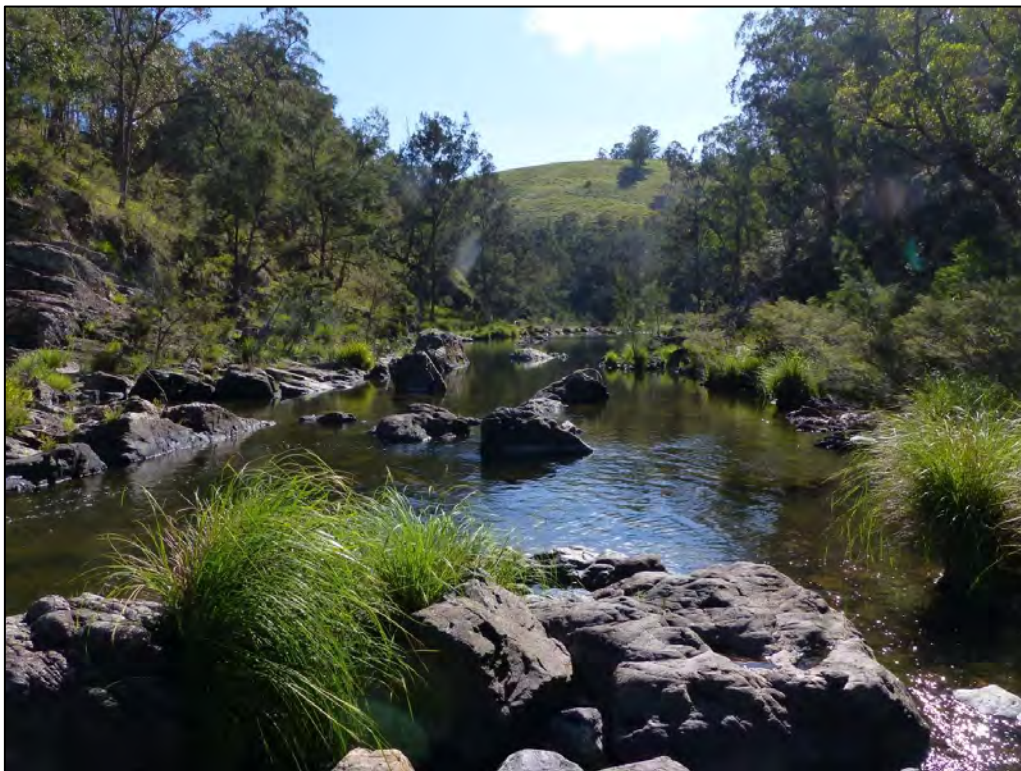
Plate 3.26 Riparian vegetation at STYR1 was of low disturbance. Riparian condition would be improved through control and removal of weed and noxious weed species, specifically Willow (*Salix* sp.) and *Egeria* (*Egeria densa*).

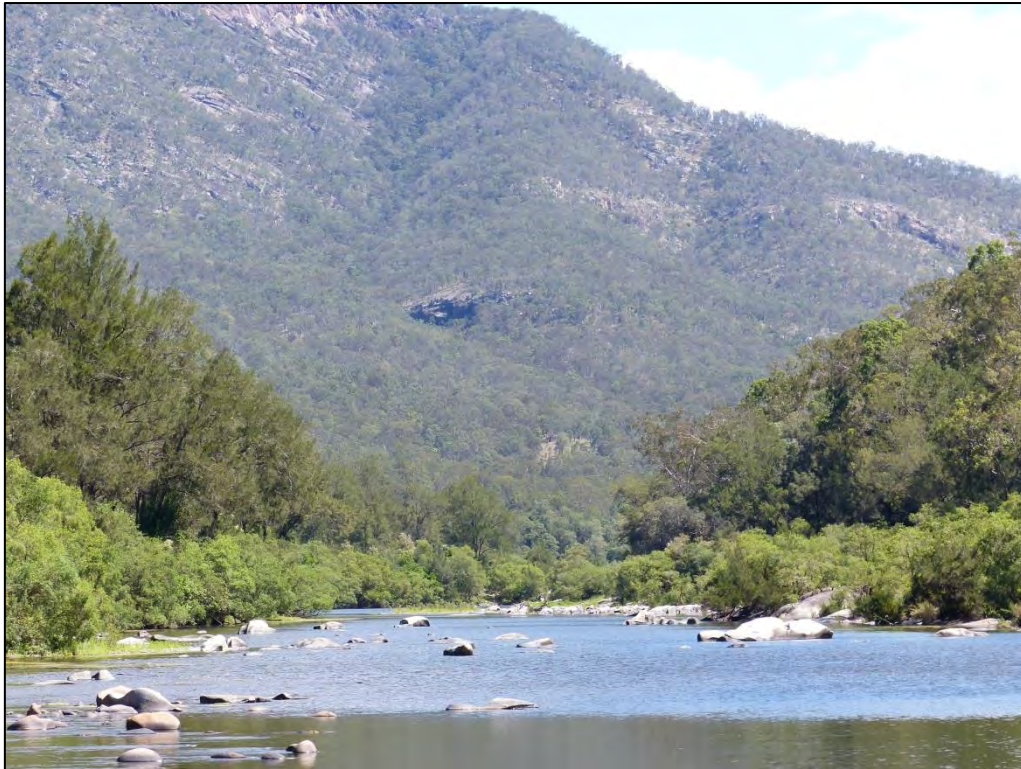
Plate 3.27 Site MACR10 on the freshwater Macleay River immediately upstream of Georges Junction (looking upstream).

There were four sites in the freshwater reach of the Macleay River (Figure 3.9). MACR10 at Georges Junction on the Macleay River (Plate 3.27) is a bedrock controlled gravel-bed channel in a partially confined valley setting located 46km downstream of the Macleay gorge and 50m downstream of the confluence of the Macleay River and Georges Creek. MACR9 (Plate 3.28) is a planform controlled, low sinuosity gravel-bed channel in a partially confined valley setting. MACR9 is at Bellbrook, 61.5km downstream of MACR10. MACR8 at Toorooka (Plate 3.29) is a planform controlled, low sinuosity gravel-bed channel in a partially confined valley setting. MACR8 is 29.2km downstream of MACR9. MACR7 at Turners Flat (Plate 3.30) is a planform controlled, low sinuosity gravel-bed channel in a partially confined valley setting. MACR7 is 27km downstream of MACR8.

The freshwater reach received a score of 72 (C+) with the best water quality recorded at MACR7 (Turners Flat) (76, B-). MACR10 at Georges Junction received a score of 56 (D+), MACR9 at Bellbrook received a score of 72 (C+) and MACR8 at Toorooka received a score of 69 (C). Figures 3.11 and 3.12 show the key physicochemical and nutrient variables used in the assessment of water quality for the main stem of the Macleay River. ANZECC guidelines are shown as red reference lines in each of the graphs. Ranges and means for these variables are given in Table 3.57 and the exceedances are given in Table 3.58. These variables do not include the analysis of heavy metal contamination due to historical mining; this is reported separately in Section 3.3.5.

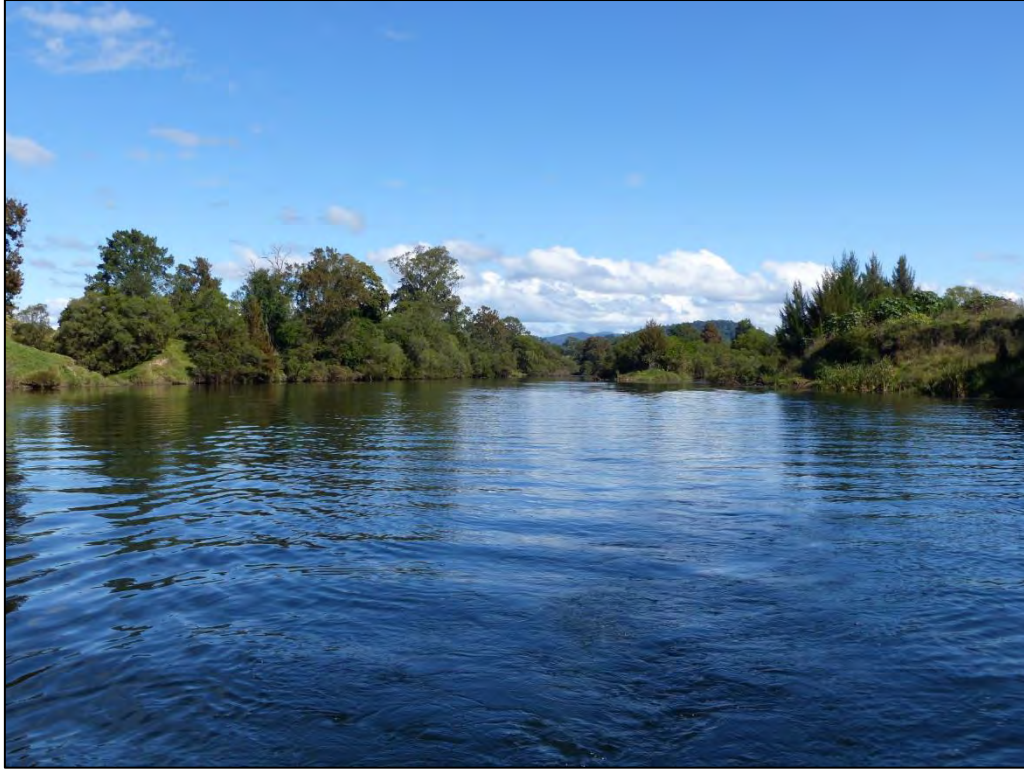
Plate 3.31 Site MACR6 at the tidal limit of the Macleay River (looking upstream).

There were six sites in the estuarine reach of the Macleay River (Figure 3.9). MACR6 (Plate 3.31) is a planform controlled, low sinuosity gravel-bed channel in a partially confined valley setting at the tidal limit of the Macleay estuary with a salinity range of 0-15ppt. MACR6 was located 1.6km downstream of Bellgrave Falls and 21.4km downstream from MACR7. MACR5 (Plate 3.32) is in the upper estuary with a salinity range of 0-15ppt. MACR5 is a tidal laterally unconfined continuous channel located immediately downstream of Kempsey, 13km downstream of MACR6. MACR4 is in the mid estuary with a salinity range of 15-30ppt. MACR4 (Plate 3.33) is a tidal laterally unconfined continuous channel located immediately downstream of Smithtown, 16km downstream of MACR5. MACR3 is in the mid estuary with a salinity range of 15-30ppt. MACR3 (Plate 3.34) is a tidal laterally unconfined continuous channel located 1km downstream of the confluence with Kinchela Creek and 6.3km downstream of MACR4. MACR2 is in the lower estuary in the marine-influenced zone with a salinity range of +30ppt. MACR2 (Plate 3.35) is a tidal laterally unconfined continuous channel located at Jerseyville, 9.7km downstream of MACR3. MACR1 is in the lower estuary in the marine-influenced zone with a salinity range of +30ppt. MACR1 (Plate 3.36) is a tidal laterally unconfined continuous channel located adjacent to South West Rocks and 8km downstream of MACR2.

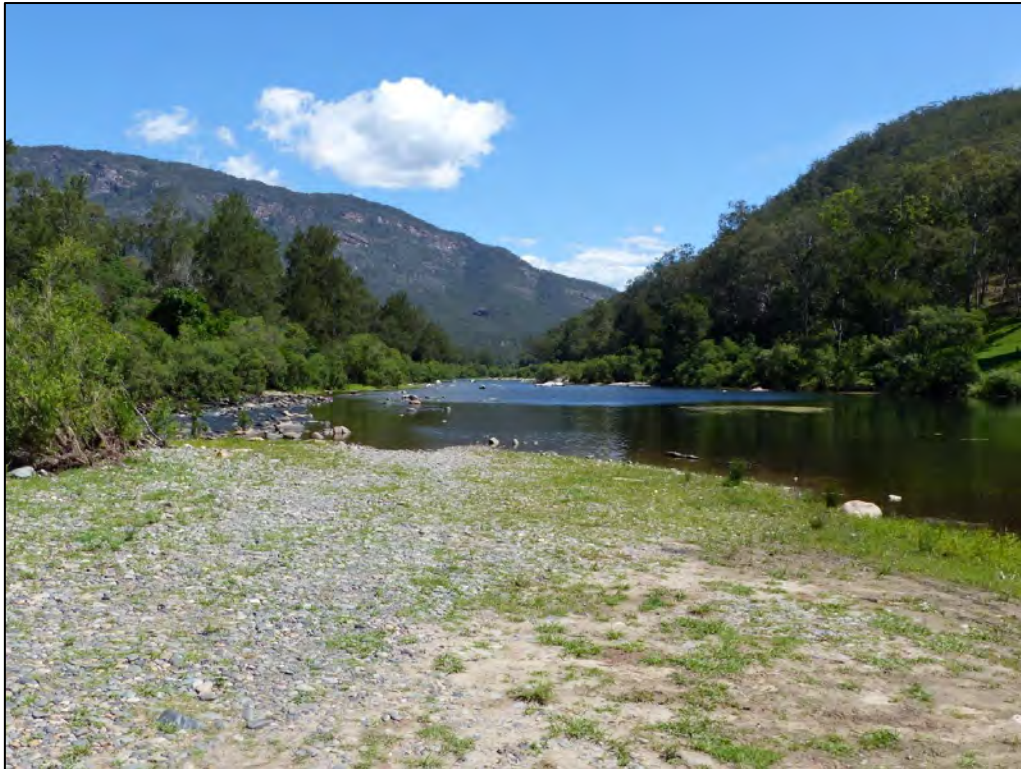
Plate 3.37 Riparian vegetation at MACR10 was mildly disturbed. Riparian condition would be improved through control and removal of weed and noxious weed species specifically Willow (*Salix* sp.), *Lantana* (*Lantana camara*), *Noogoora Burr* (*Xanthium occidentale*), *Spiny Pest Pear* (*Opuntia stricta*) and *Blackberry* (*Rubus* sp.) and by limiting animal impact by fencing off the riparian zone.

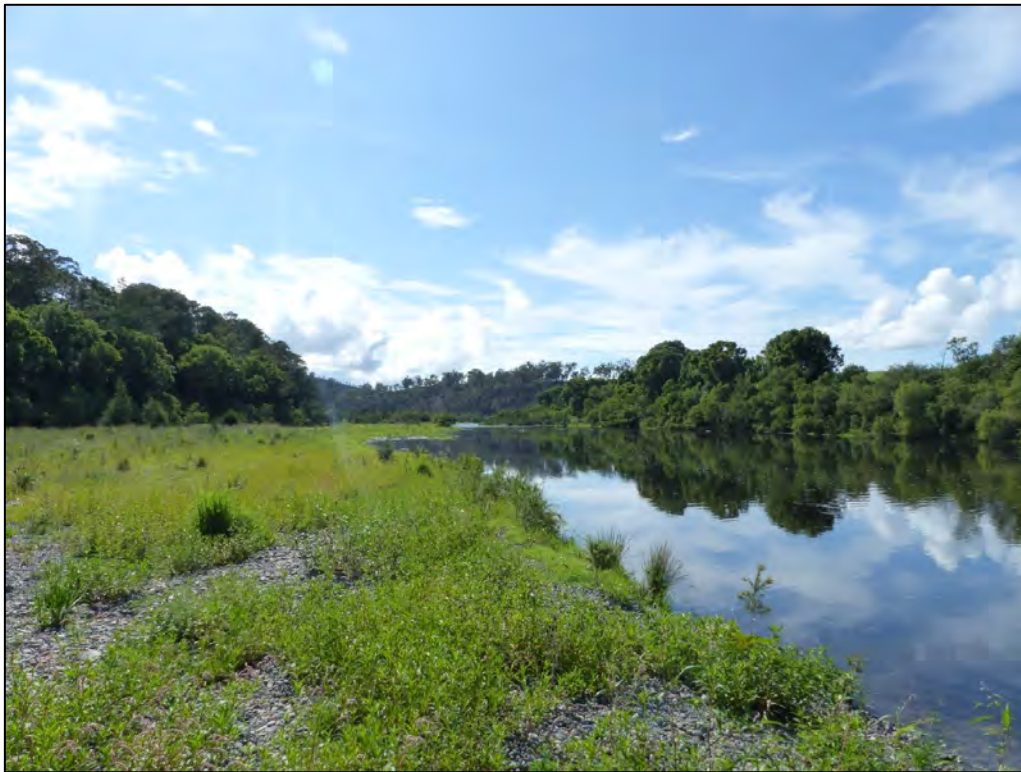
Plate 3.38 Riparian vegetation at MACR9 was highly disturbed. Riparian condition would be improved through control and removal of weed and noxious weed species specifically Cat's Claw Creeper (*Dolichandra unguis-cati*), Camphor Laurel (*Cinnamomum camphora*), Lantana (*Lantana camara*), undertaking native plantings and by limiting animal impact by fencing off the riparian zone.

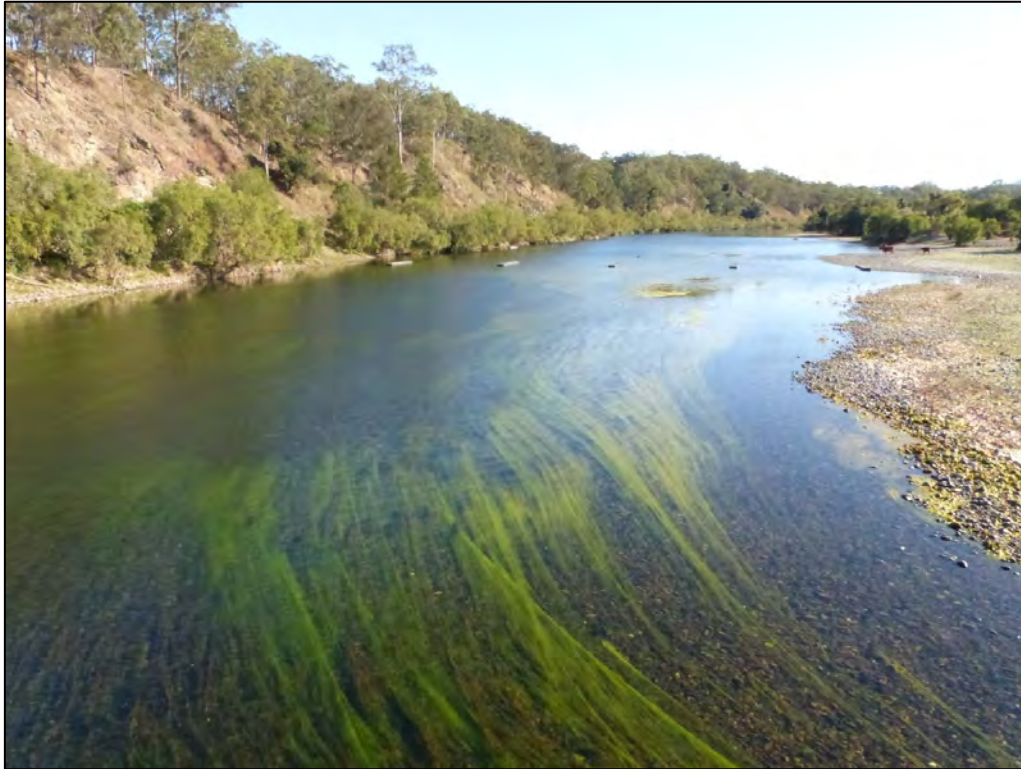
Plate 3.39 Riparian vegetation at MACR8 was highly disturbed. Riparian condition would be improved through control and removal of weed and noxious weed species specifically Lantana (*Lantana camara*) and Mother of Millions (*Bryophyllum delagoense*), undertaking native plantings and by limiting animal impact by fencing off the riparian zone.

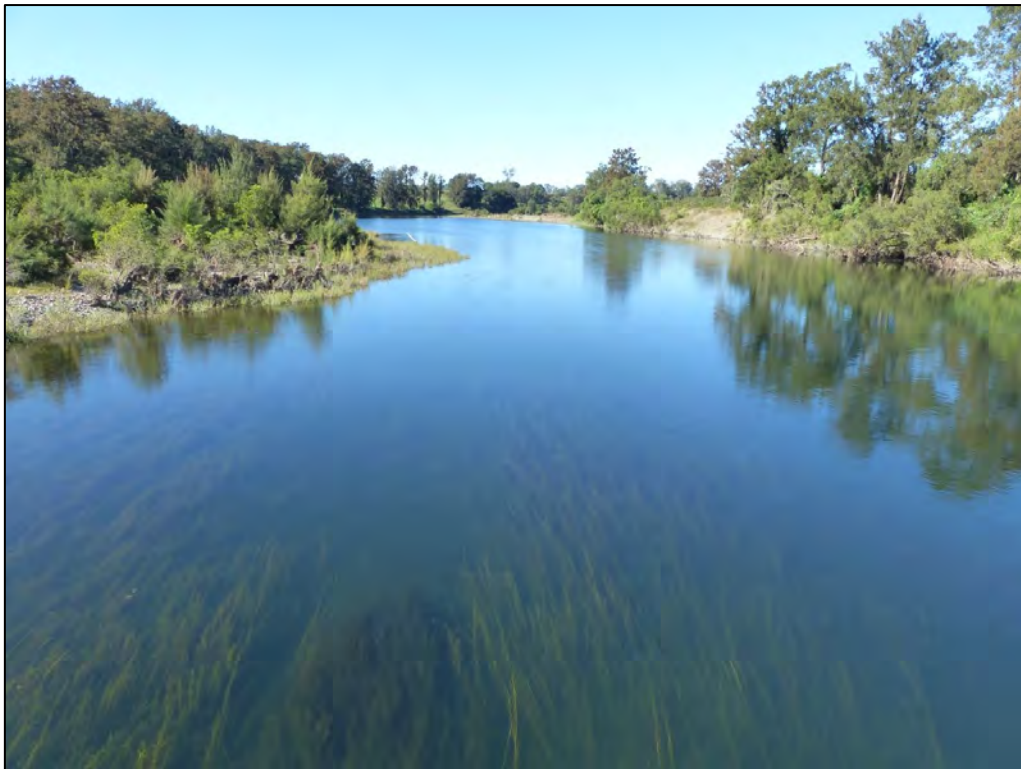
Plate 3.40 Riparian vegetation at MACR7 was highly disturbed. Riparian condition would be improved through control and removal of weed and noxious weed species specifically Cat's Claw Creeper (*Dolichandra unguis-cati*), *Lantana* (*Lantana camara*) and Balloon Vine (*Cardiospermum grandiflorum*), undertaking native plantings and by limiting animal impact by fencing off the riparian zone.

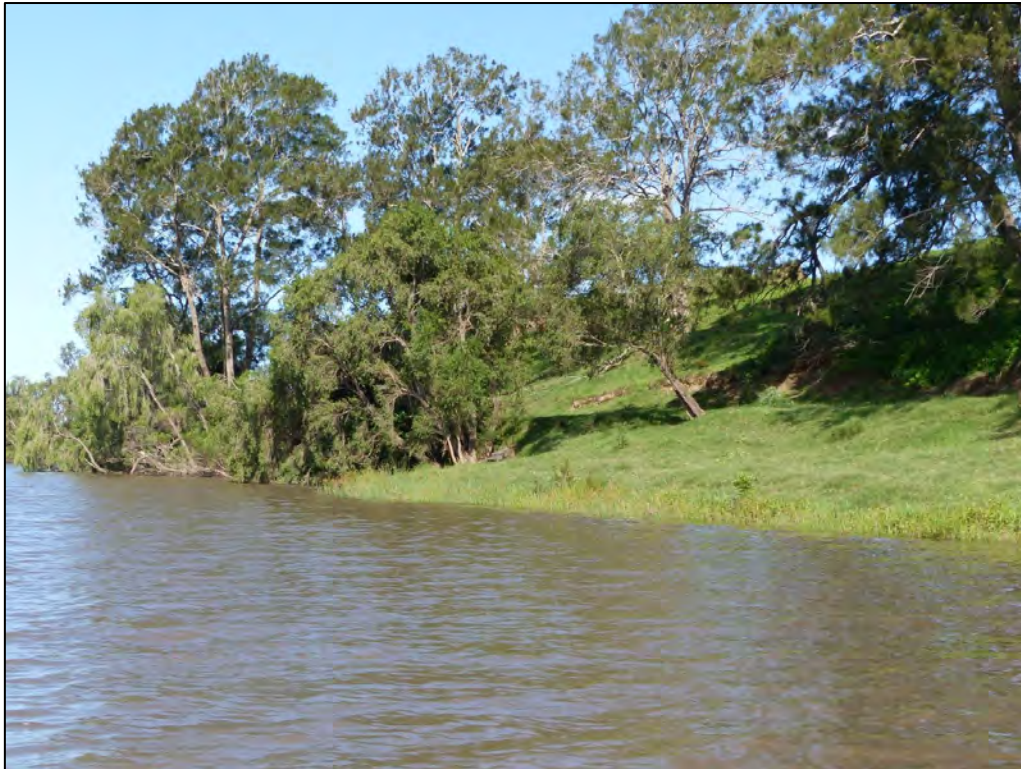
Plate 3.41 Riparian vegetation at MACR6 was very highly disturbed. Riparian condition would be improved through control and removal of weed and noxious weed species specifically Camphor Laurel (*Cinnamomum camphora*), Lantana (*Lantana camara*) and Small-leaved Privet (*Ligustrum sinense*), undertaking native plantings and by limiting animal impact by fencing off the riparian zone.
