Macleay Ecohealth Project 2015-2016

Assessment of River and Estuarine Condition

Final Technical Report

December 2016

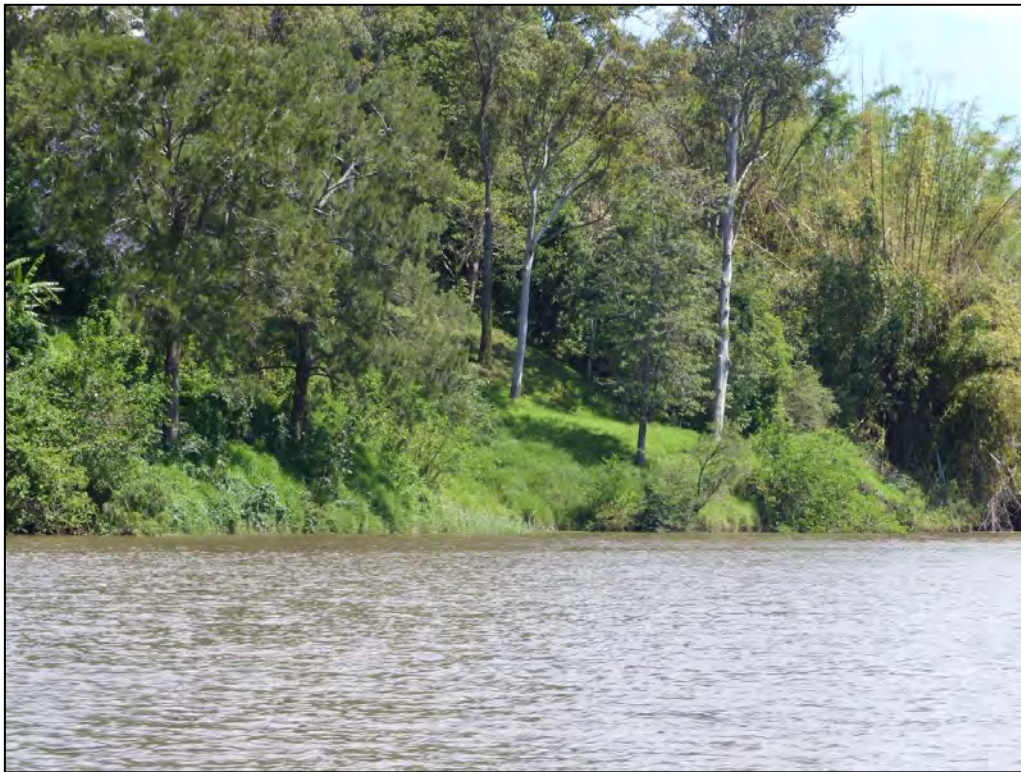
Plate 3.42 Riparian vegetation at MACR5 was very highly disturbed. Riparian condition would be improved through control and removal of weed and noxious weed species specifically Camphor Laurel (*Cinnamomum camphora*), Lantana (*Lantana camara*), Small-leaved Privet (*Ligustrum sinense*) and Coastal Morning Glory (*Ipomoea cairica*) and by undertaking native plantings.

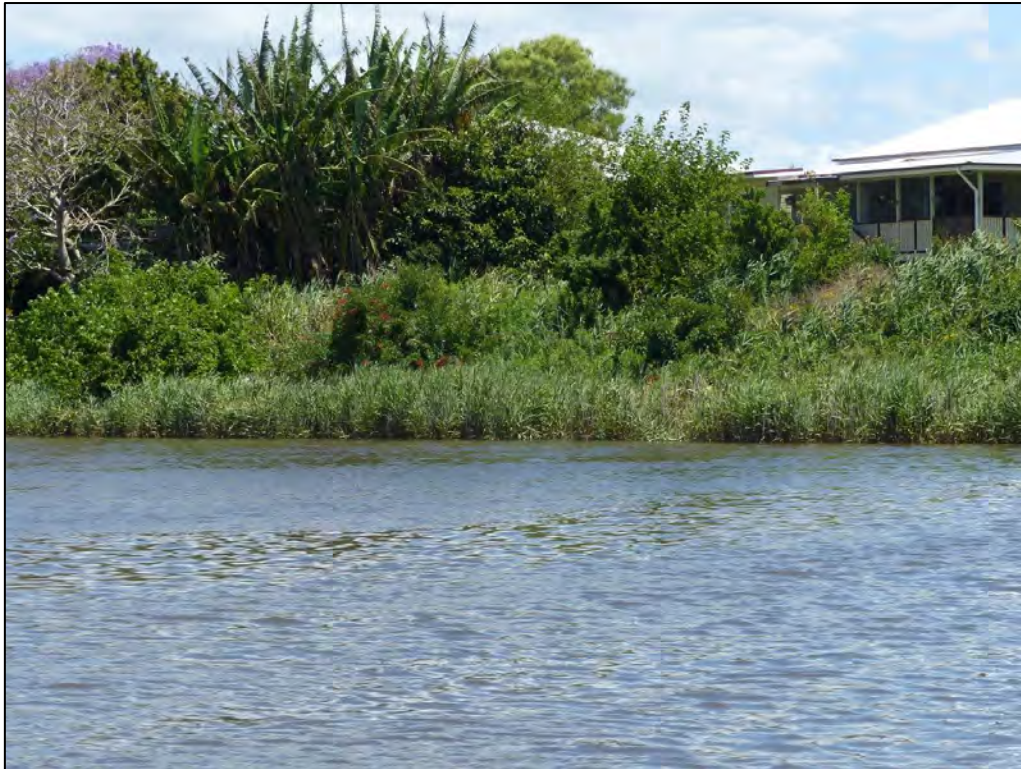
Plate 3.43 Riparian vegetation at MACR4 was extremely disturbed. Riparian condition would be improved through control and removal of weed and noxious weed species specifically Coral Tree (*Erythrina x sykesii*), *Lantana* (*Lantana camara*), *Coastal Morning Glory* (*Ipomoea cairica*) and *Baloon Vine* (*Cardiospermum grandiflorum*) and by undertaking native plantings.

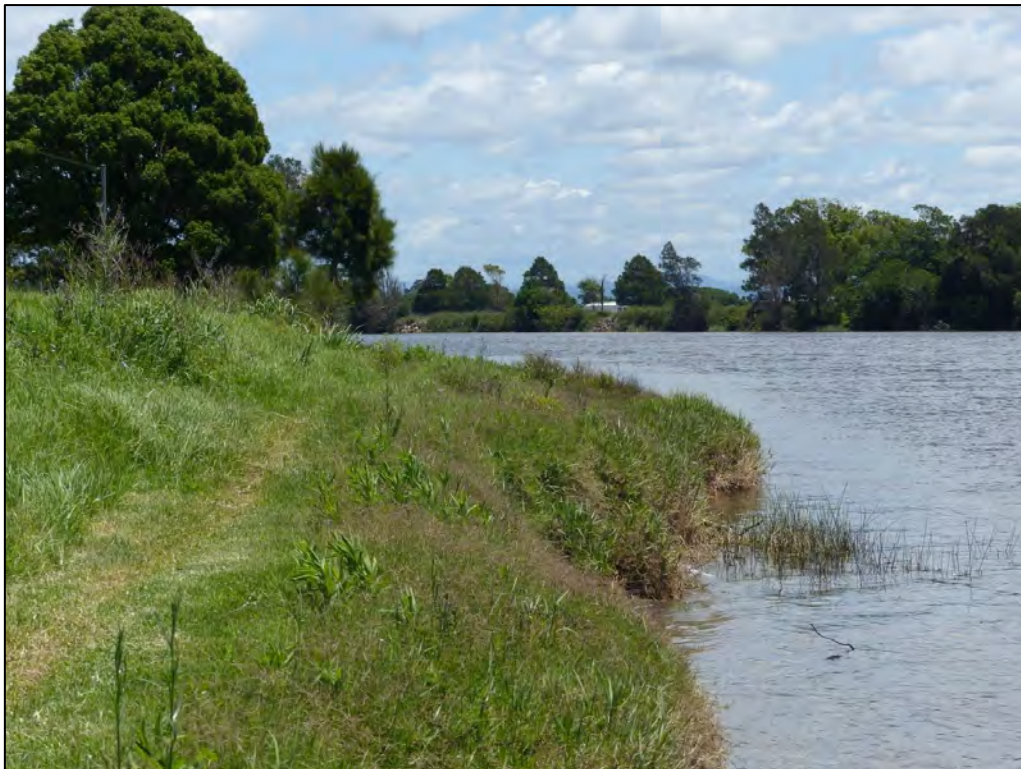
Plate 3.44 Riparian vegetation at MACR3 was extremely disturbed. Riparian condition would be improved through control and removal of weed and noxious weed species specifically Coral Tree (*Erythrina x sykesii*), *Lantana* (*Lantana camara*), *Coastal Morning Glory* (*Ipomoea cairica*), by undertaking native plantings and fencing off the riparian zone.

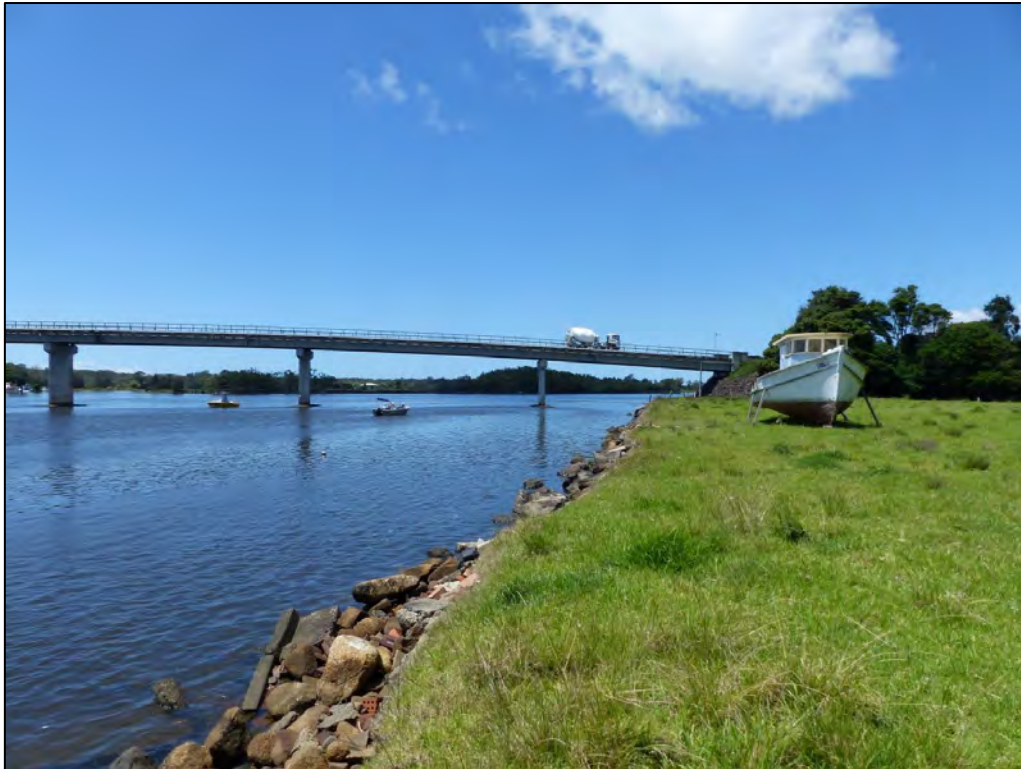
Plate 3.45 Riparian vegetation at MACR2 was extremely disturbed. Riparian condition would be improved through control and removal of weed and noxious weed species, by undertaking native plantings and fencing off the riparian zone.

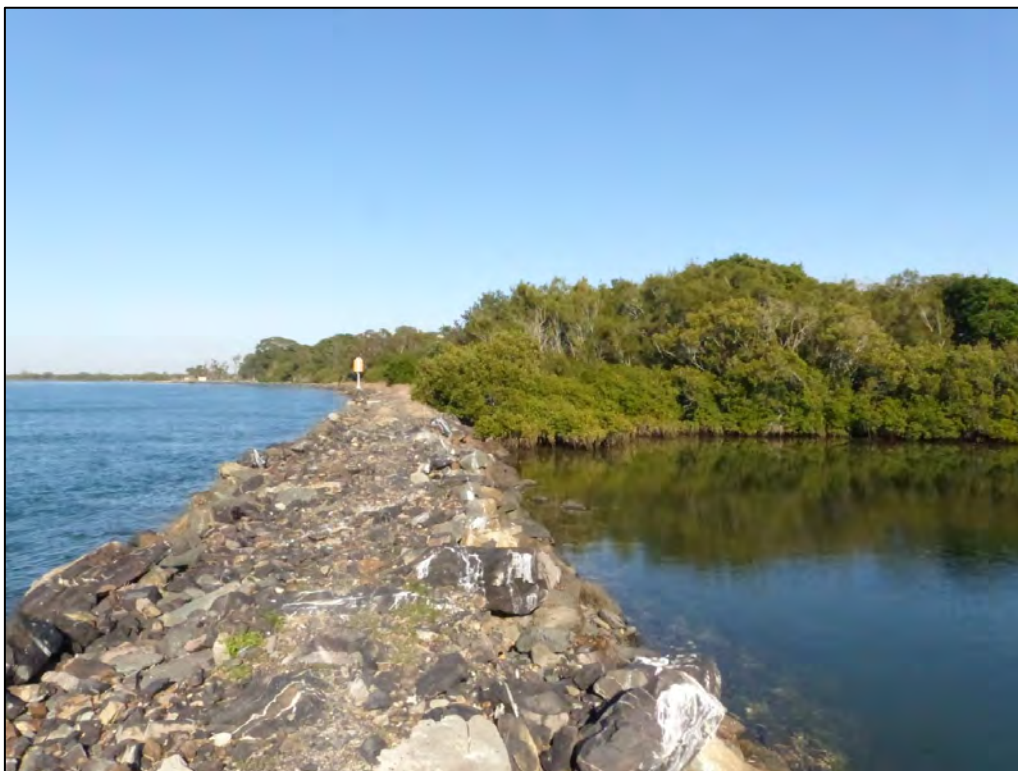
Plate 3.46 Riparian vegetation at MACR1 was highly disturbed. Riparian condition would be improved through control and removal of weed and noxious weed species such as were *Lantana* (*Lantana camara*), *Bitou Bush* (*Chrysanthemoides monilifera* subsp. *rotundata*), *Mother of Millions* (*Bryophyllum delagoense*), *Spiny Pest Pear* (*Opuntia stricta*) and *Coastal Morning Glory* (*Ipomoea cairica*), and by undertaking native plantings.

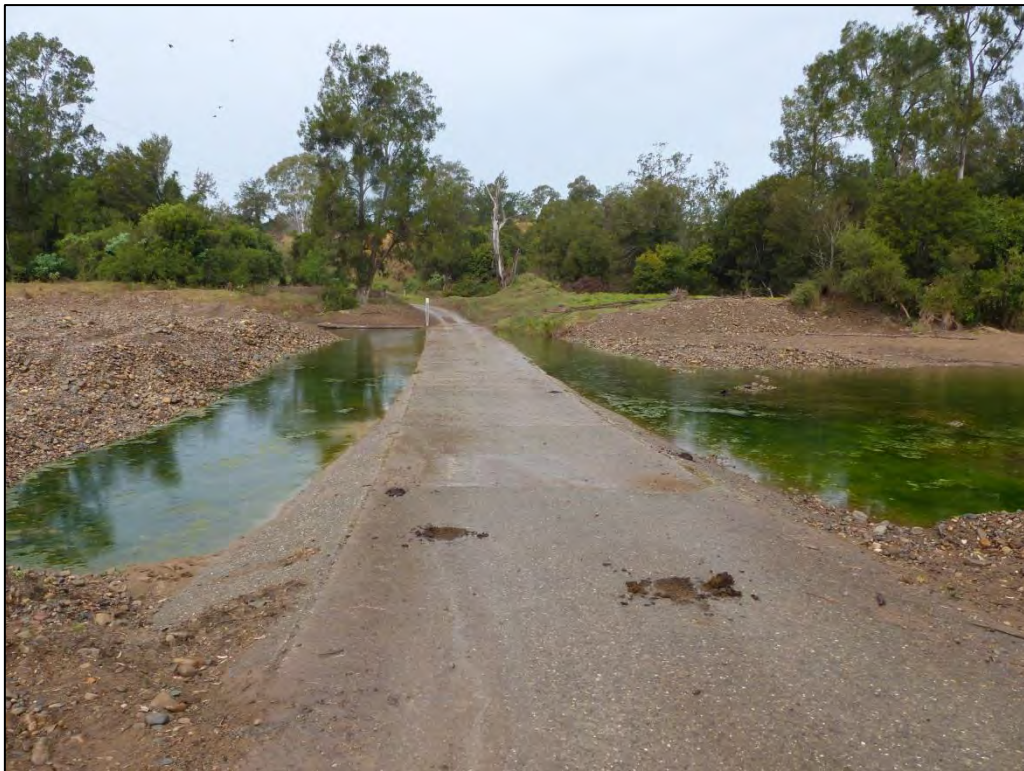
Plate 3.50 Site TOOC1 on Toorumbree Creek (looking from the left bank across to the right bank).

In Toorumbree Creek subcatchment, TOOC1 (Plate 3.50) is a planform controlled, meandering fine-grained channel in a partially confined valley setting located 500m from the confluence of Toorumbree Creek and the Macleay River. TOOC2 (Plate 3.51) is a planform controlled, low sinuosity, gravel-bed channel located 12.2km upstream of TOOC1. TOOC3 (Plate 3.52) is a planform controlled, low sinuosity, gravel-bed channel located 11.8km upstream of TOOC2. In Dungay Creek subcatchment, DUNC1 (Plate 3.53) is a planform controlled, low sinuosity, gravel-bed river in a partially confined valley setting located at Dongdingalong 4.2km from the confluence of Dungay Creek and the Macleay River. DUNC2 (Plate 3.54) is a planform controlled, low sinuosity, gravel-bed channel in a partially confined valley setting located at Wittittrin, 12.1km upstream of DUNC1. DUNC3 (Plate 3.55) is a gorge (confined valley setting) located 9.8km upstream of DUNC2.

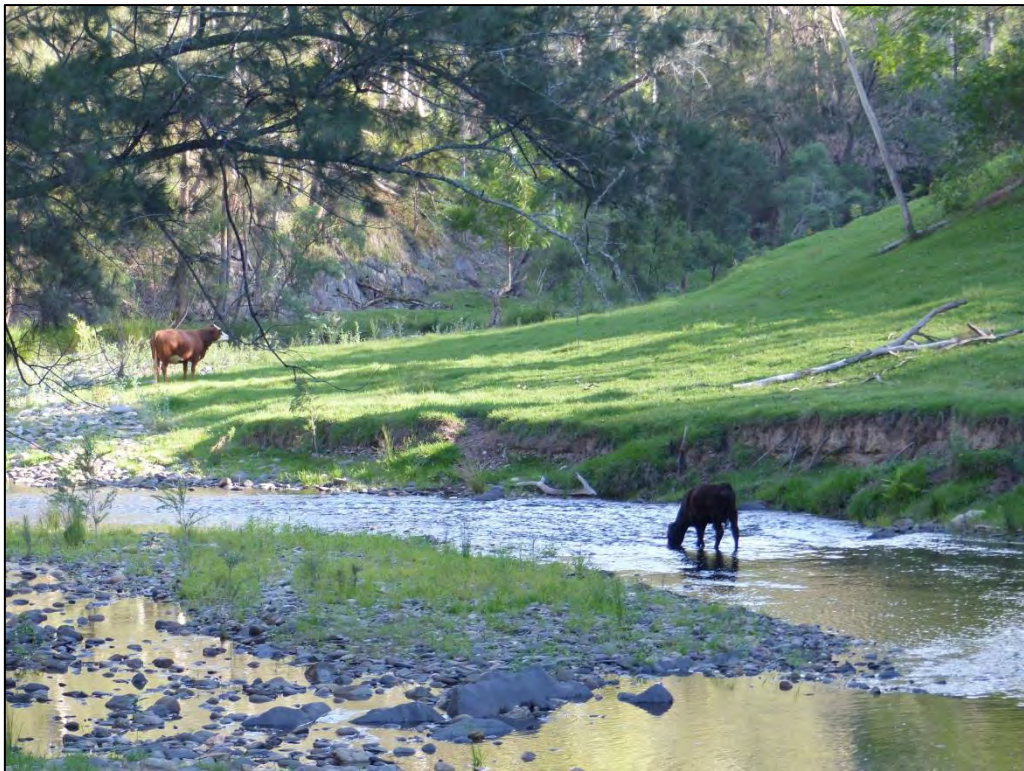
Plate 3.56 Site GEOC1 on Georges Creek (looking downstream across to the right bank).

There were six sites located at or close to end-of-system tributaries of the Macleay River. GEOC1 (Plate 3.56) is a planform controlled, low sinuosity, gravel-bed channel in a partially confined valley setting located on Georges Creek 900m upstream of its confluence with the Macleay River. NULC1 (Plate 3.57) is a planform controlled, low sinuosity, gravel-bed channel in a partially confined valley setting located on Nulla Nulla Creek 7.6km upstream of its confluence with the Macleay River. WARB1 (Plate 3.58) is a planform controlled, low sinuosity, gravel-bed channel in a partially confined valley setting located on Warbro Brook 2.5km from its confluence with the Macleay River. HICC1 (Plate 3.59) is a planform controlled, meandering fine grained channel in a partially confined valley setting located on Hickeys Creek 8.5km upstream of its confluence with the Macleay River. MUNC1 (Plate 3.60) is a planform controlled, low sinuosity, gravel-bed channel in a partially confined valley setting located on Mungay Creek 4.4km upstream of its confluence with the Macleay River. COLC1 (Plate 3.61) is a meandering, fine grained, continuous channel in a laterally unconfined valley setting located on Collombatti Creek immediately downstream of the bridge on Collombatti-Fredrickton Road.

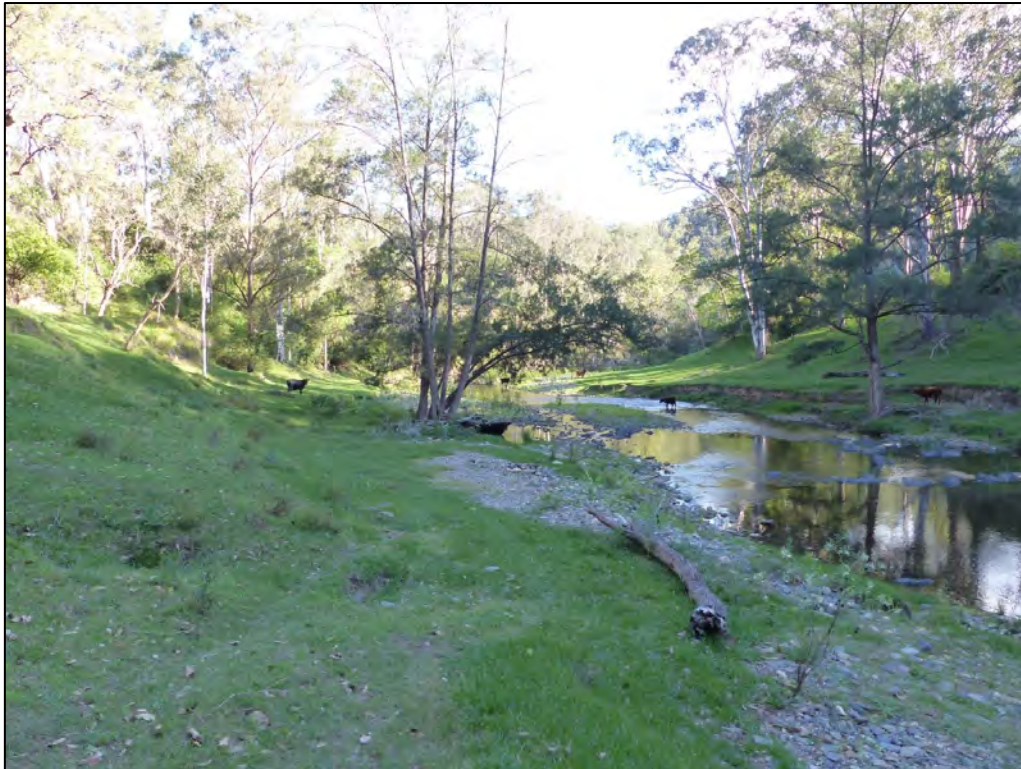
Plate 3.62 Riparian vegetation at GEOC1 was moderately disturbed. Riparian condition would be improved through control and removal of weed and noxious weed species specifically Willow (*Salix* sp.), Lantana (*Lantana camara*) and Blackberry (*Rubus* sp.) and by limiting animal impact by fencing off the riparian zone.

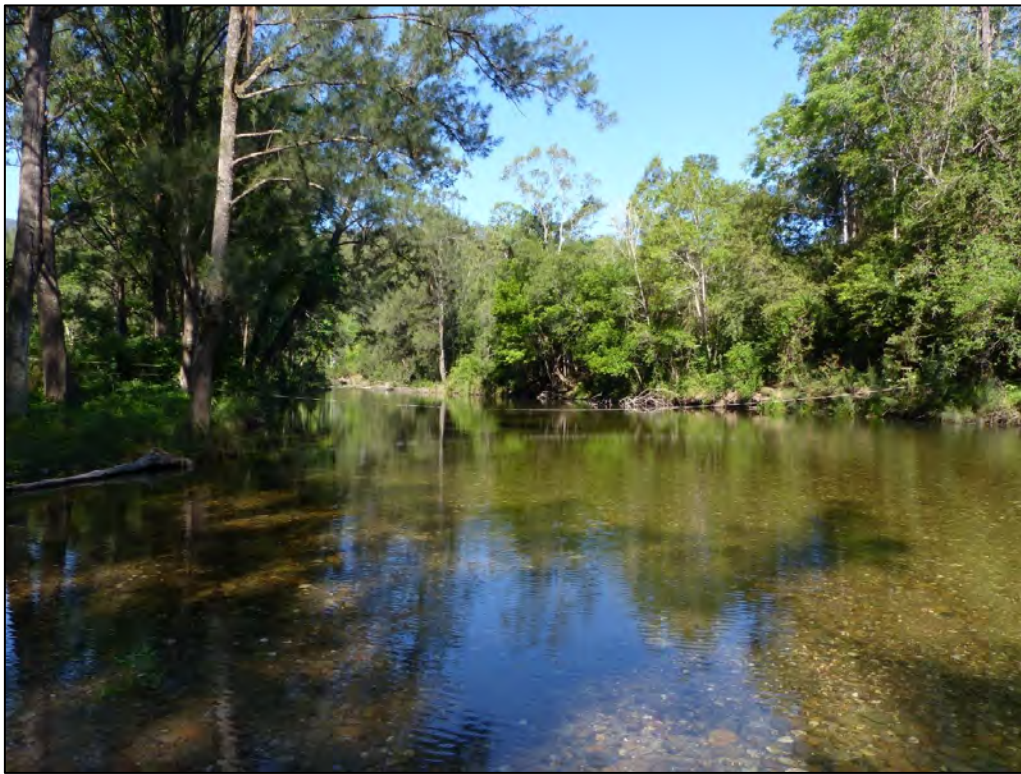
Plate 3.63 Riparian vegetation at FIVC3 was moderately disturbed. Riparian condition would be improved through control and removal of weed and noxious weed species such as Cat's Claw Creeper (*Dolichandra unguis-cati*), *Lantana* (*Lantana camara*), *Small-leaved Privet* (*Ligustrum sinense*), and by fencing off the riparian zone.

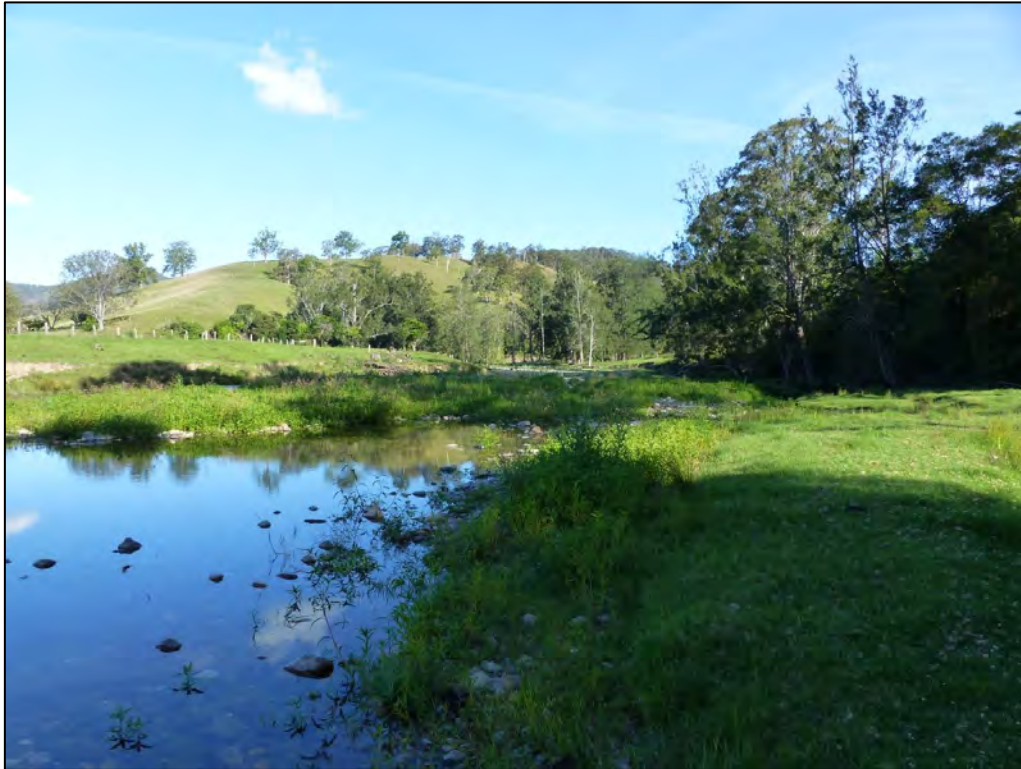
Plate 3.64 Riparian vegetation at FIVC2 was highly disturbed. Riparian condition would be improved through control and removal of weed and noxious weed species such as *Lantana* (*Lantana camara*), *Small-leaved Privet* (*Ligustrum sinense*) and *Blackberry* (*Rubus* sp.), undertaking native plantings, and fencing off the riparian zone.

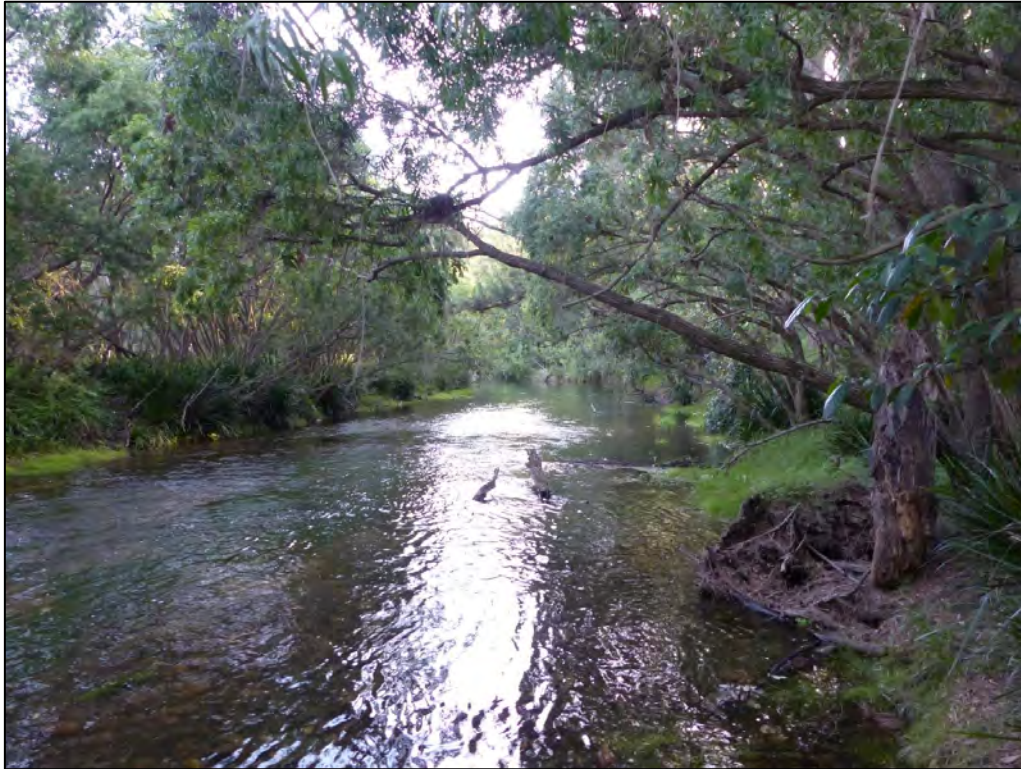
Plate 3.65 Riparian vegetation at FIVC1 was moderately disturbed. Riparian condition would be improved through control and removal of weed and noxious weed species such as Tropical Soda Apple (*Solanum viarum*), Cat's Claw Creeper (*Dolichandra unguis-cati*) and Small-leaved Privet (*Ligustrum sinense*), and by fencing off the riparian zone.

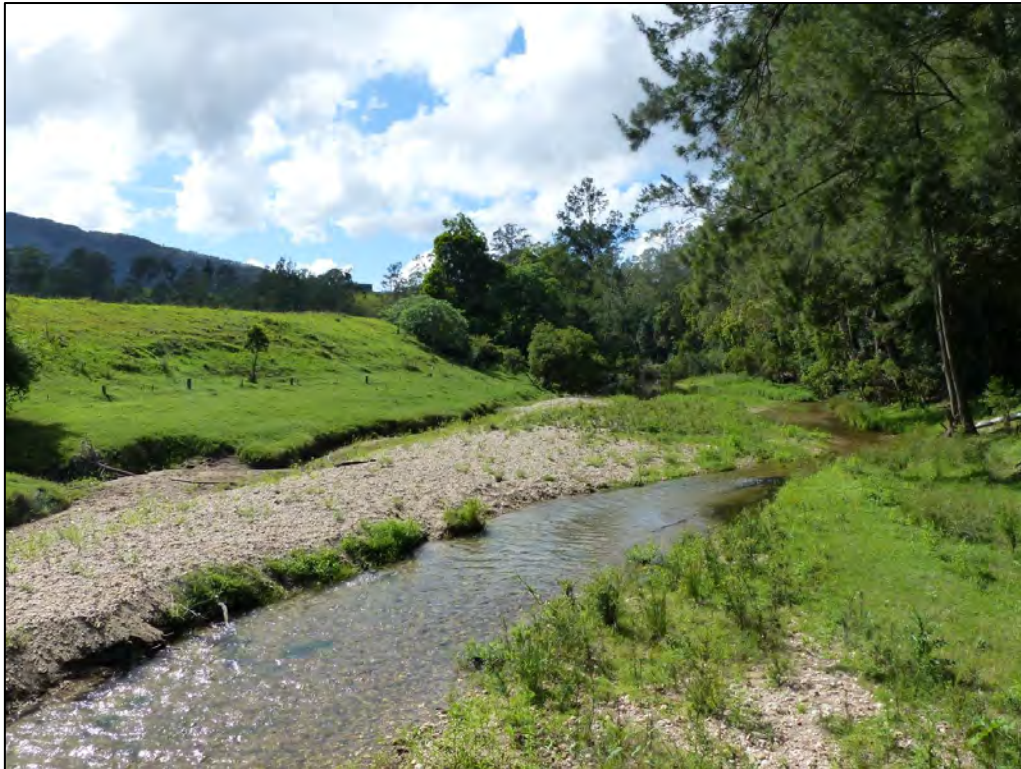
Plate 3.66 Riparian vegetation at NULC1 was highly disturbed. Riparian condition would be improved through control and removal of weed and noxious weed species such as *Lantana* (*Lantana camara*), *Small-leaved Privet* (*Ligustrum sinense*), and by fencing off the riparian zone.

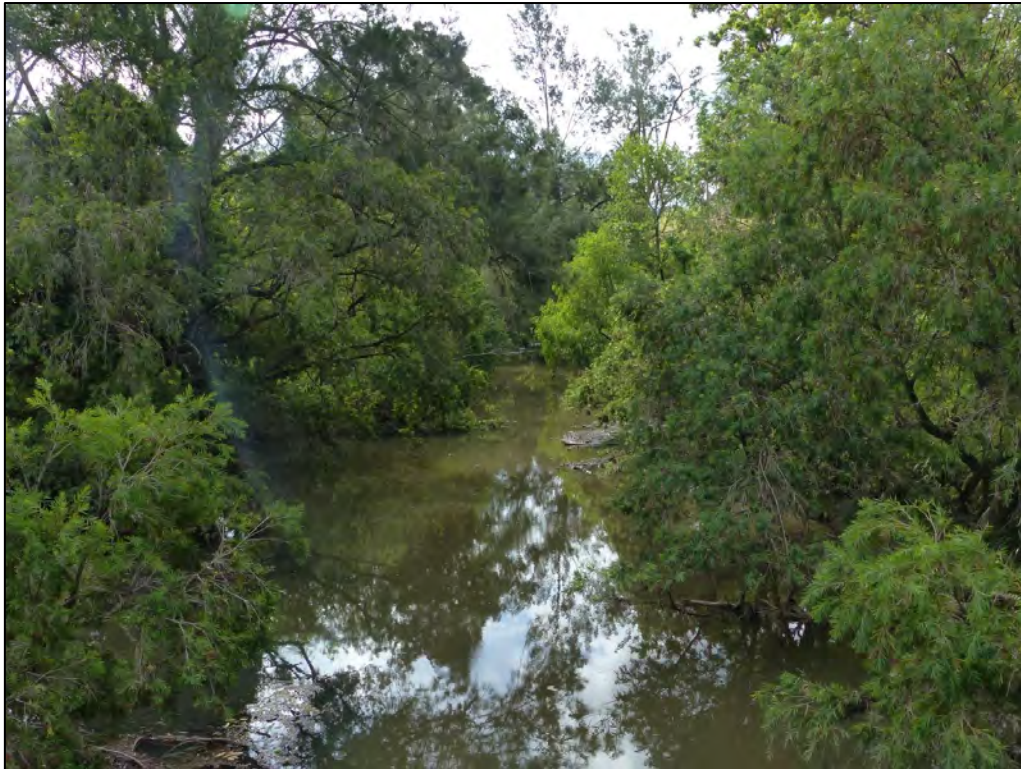
Plate 3.67 Riparian vegetation at WARB1 was of low disturbance. Riparian condition would be improved through control and removal of weed and noxious weed species specifically Cat's Claw Creeper (*Dolichandra unguis-cati*) and Lantana (*Lantana camara*), and by fencing off the riparian zone.

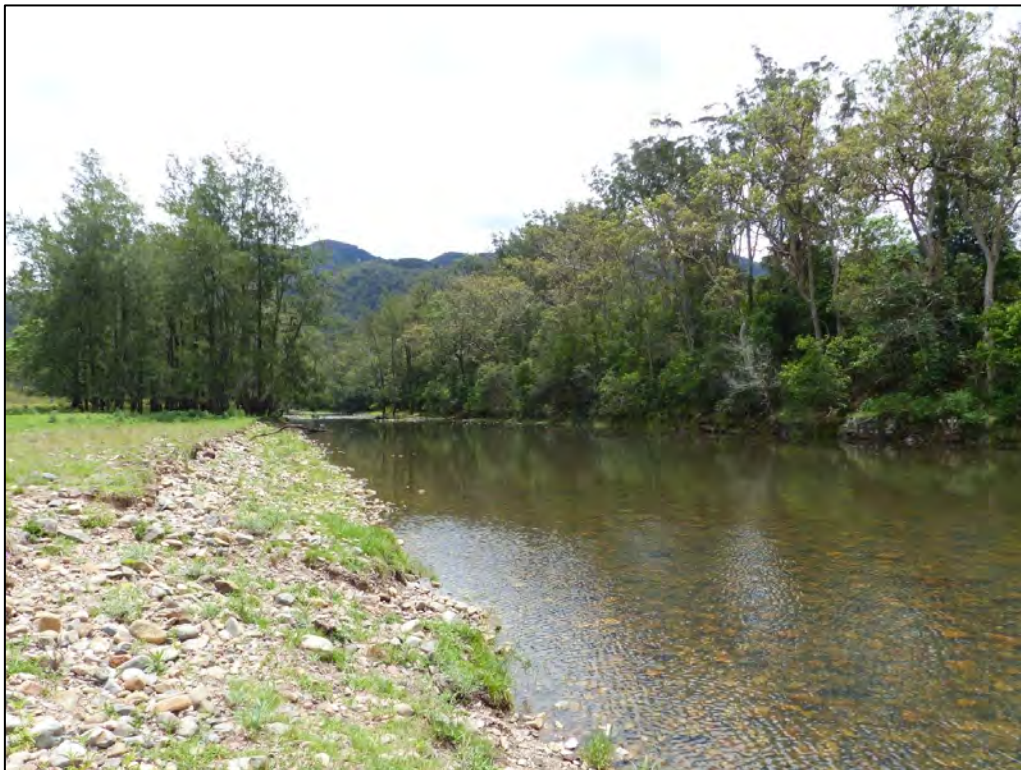
Plate 3.68 Riparian vegetation at TOOC3 was highly disturbed. Riparian condition would be improved through control and removal of weed and noxious weed species such as *Lantana* (*Lantana camara*), undertaking native plantings, introducing woody debris and by fencing off the riparian zone.

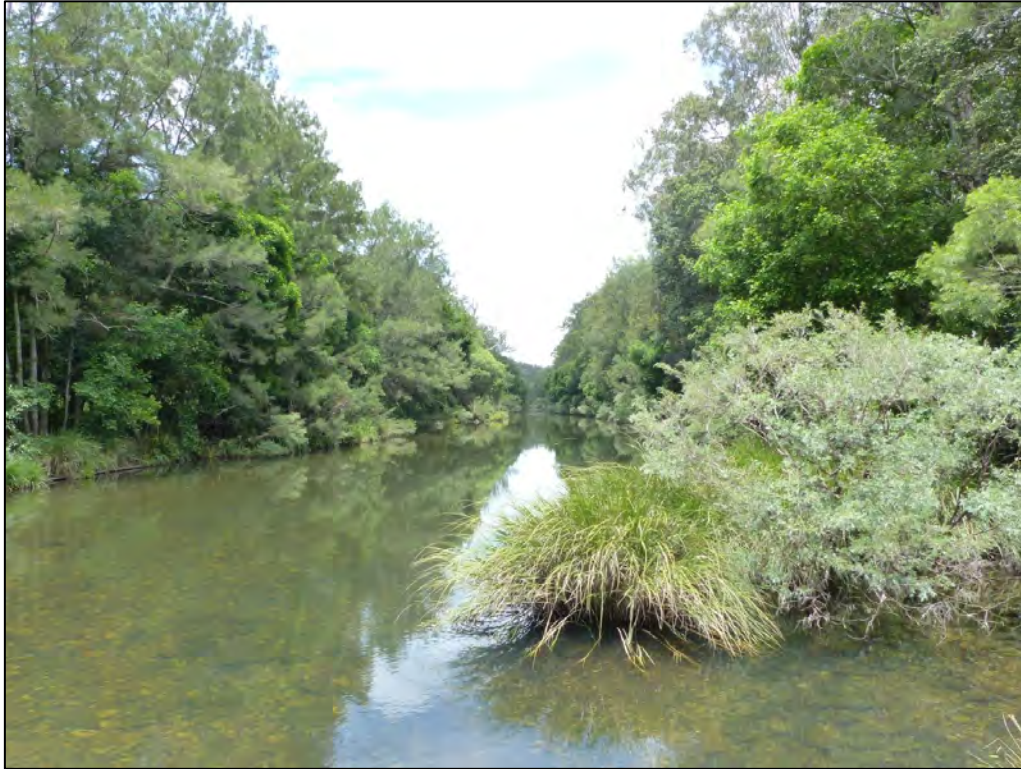
Plate 3.69 Riparian vegetation at TOOC2 was mildly disturbed. Riparian condition would be improved through control and removal of weed and noxious weed species such as *Lantana* (*Lantana camara*), and through the introduction of woody debris.

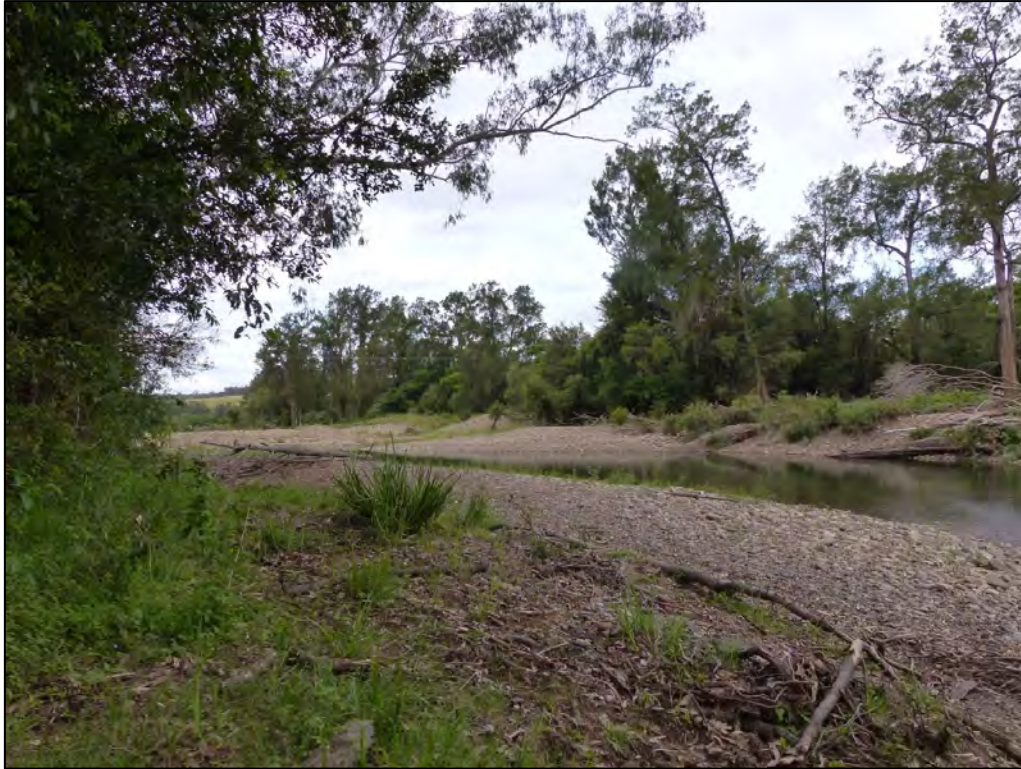
Plate 3.70 Riparian vegetation at TOOC1 was highly disturbed. Riparian condition would be improved through control and removal of weed and noxious weed species such as *Camphor Laurel* (*Cinnamomum camphora*), *Lantana* (*Lantana camara*), *Crofton Weed* (*Ageratina adenophora*) and by fencing off the riparian zone.

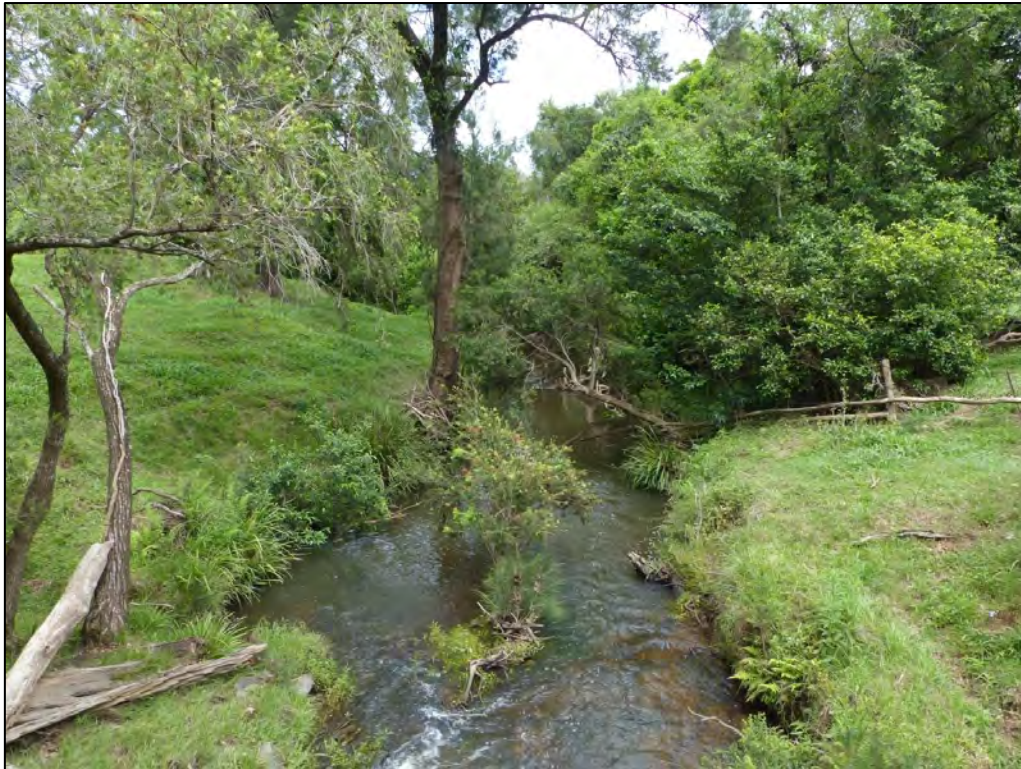
Summary: HICC1 was a moderately disturbed system of mixed-aged closed forest with a remnant canopy and mixed native and exotic species throughout the midstory and understory layers, in a predominantly cleared, partially forested landscape. The surrounding rural landuse was predominantly agricultural grazing land. Significant remnant stands of vegetation lie 2 km to the east-northeast in Collombatti State Forest. HICC1 scored well for Native Species and Cover, moderately for Habitat and Debris and poorly for Management subindices (Table 3.97) and retained representative elements of the remnant vegetation community in all structural layers. Riparian condition at HICC1 was impacted by poor habitat connectivity and the presence and regeneration of weed and noxious weed species, particularly in the midstory and understory structural layers. Reduced woody debris, inadequate riparian fencing and animal impact also contributed to the reduction in riparian grade at this site.

Plate 3.71 Riparian vegetation at HICC1 was moderately disturbed. Riparian condition would be improved through control and removal of weed and noxious weed species such as *Lantana* (*Lantana camara*), *Small-leaved Privet* (*Ligustrum sinense*), and by fencing off the riparian zone.

Management Recommendations: Riparian condition could be improved through the control and removal of weed and noxious weed species, particularly throughout the midstory and understory layers. Riparian fencing should exclude livestock, and allow for midstory and understory native species recovery and woody debris accumulation over time.

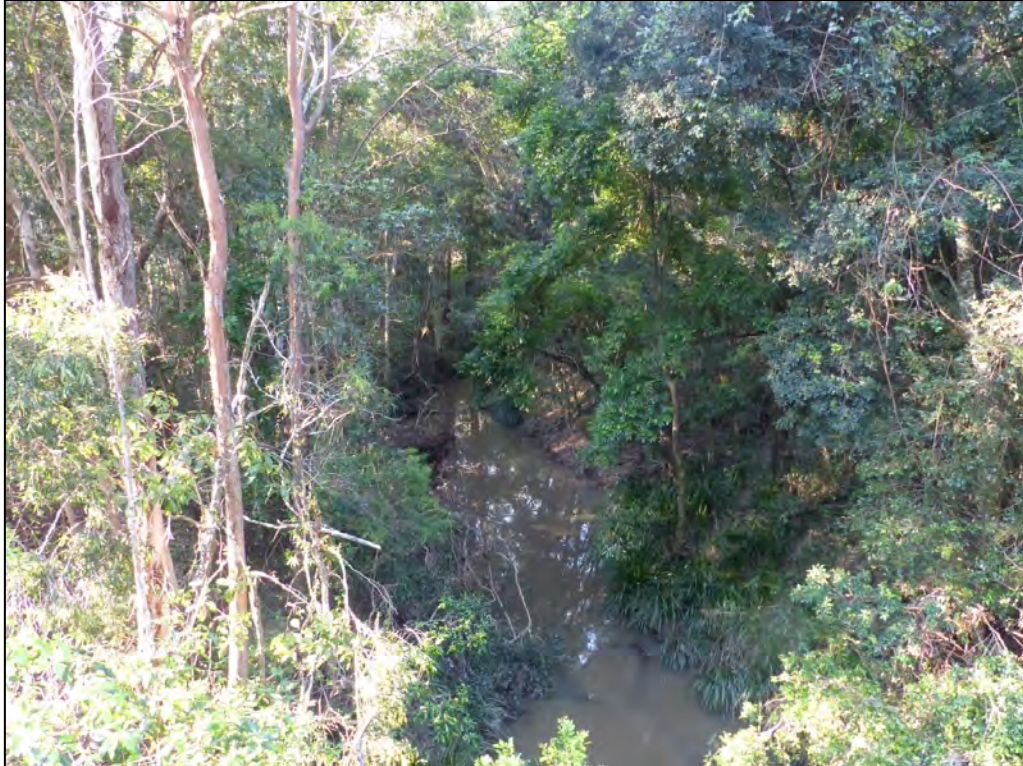
Summary: MUNC1 was a low disturbance system of mixed-aged closed forest with a remnant canopy and mixed native and exotic species throughout the midstory and understory layers, in a partially cleared, partially forested landscape. The surrounding rural landuse was a mixture of agricultural grazing land, Nature Reserve and State Forest. Significant remnant stands of vegetation lie 1.2km to the southeast in Skillion Nature Reserve and 1km northeast in private land, beyond which is Collombatti State Forest. MUNC1 received full marks for Habitat and Cover, scored well for Native Species and moderately for Debris and Management subindices (Table 3.100), retaining representative elements of the remnant vegetation community in all structural layers. Riparian condition at MUNC1 was impacted by the presence and regeneration of weed and noxious weed species, particularly Lantana (*Lantana camara*). Limited large woody debris, inadequate riparian fencing and animal impact also contributed to the reduction in riparian grade at this site.

Plate 3.72 *Riparian vegetation at MUNC1 was of low disturbance. Riparian condition would be improved through control and removal of weed and noxious weed species specifically Lantana (Lantana camara) and fencing off the riparian zone.*

Management Recommendations: Riparian condition could be improved through the control and removal of weed and noxious weed species, particularly throughout the midstory and understory layers. Completed riparian fencing should exclude livestock and allow for woody debris accumulation and midstory and understory native species recovery.

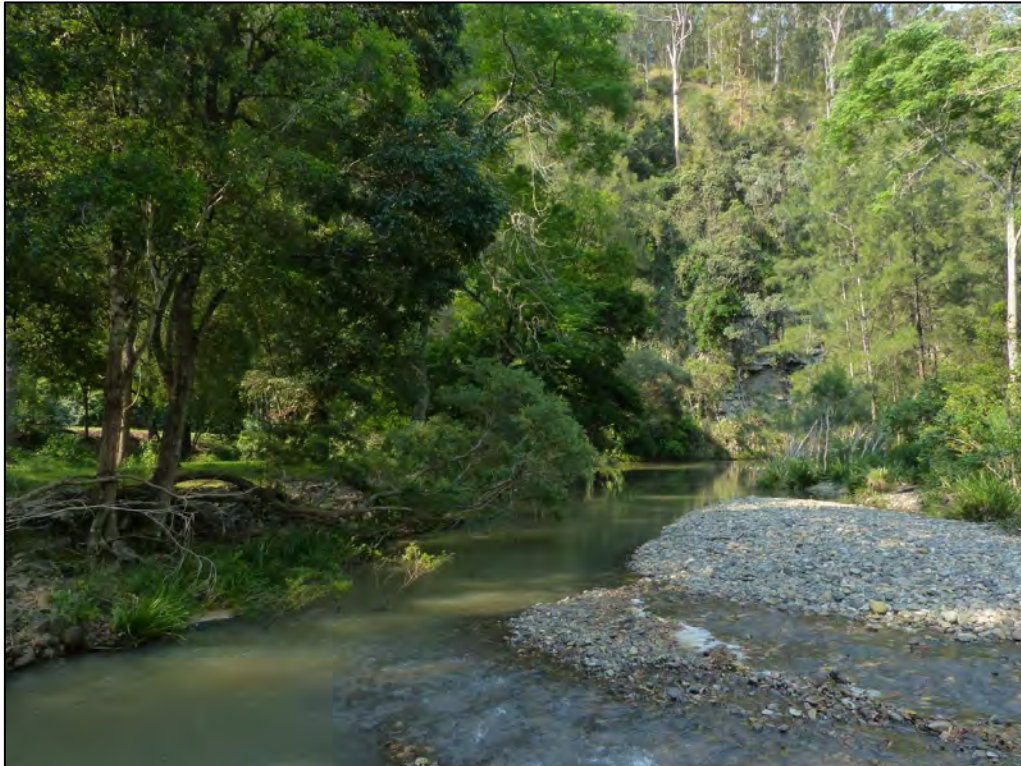
The original riparian vegetation community at DUNC3 (Plate 3.73) was described as 'River Oak forest and woodland wetland of the NSW South Western Slopes and South Eastern Highlands Bioregion', plant community type ID 85 (VIS, 2012), grading into 'Black Bean - Weeping Lilly Pilly - Water Gum riparian rainforest of the NSW North Coast Bioregion' plant community type ID 669 (VIS, 2012), broadly classed as 'Dry Rainforest' (Keith, 2004), a recognized TEC (VIS, 2012). DUNC3 received a good riparian condition score of 73.2, a grade of C+ (Table 3.101).

Summary: DUNC3 was a mildly disturbed system of mixed-aged closed forest with a remnant canopy and mixed native and exotic species throughout the midstory and understory layers, in a predominantly forested, partially cleared landscape. The surrounding rural landuse was a mixture of agricultural grazing land and State Forest. Significant remnant stands of vegetation lie 1.2km to the north in Boonanghi State Forest and 2.5km to the south in Yessabah State Forest. DUNC3 scored well for Habitat and Cover, and moderately for Native Species, Debris and Management subindices (Table 3.101), retaining representative elements of the remnant vegetation community in all structural layers. Riparian condition at DUNC3 was impacted by the presence and regeneration of weed and noxious weed species particularly in the midstory and understory structural layers. Limited habitat trees, large woody debris and inadequate riparian fencing and animal impact also contributed to the reduction in riparian grade at this site.

Plate 3.73 Riparian vegetation at DUNC3 was mildly disturbed. Riparian condition would be improved through control and removal of weed and noxious weed species specifically Lantana (*Lantana camara*) and by fencing off the riparian zone.

Management Recommendations: Obvious attempts at removing sections of Lantana had recently been made. Riparian condition could be improved through the control and removal of weed and noxious weed species, particularly throughout the midstory and understory layers. Riparian fencing should exclude livestock and allow for midstory and understory native species recovery and woody debris accumulation.

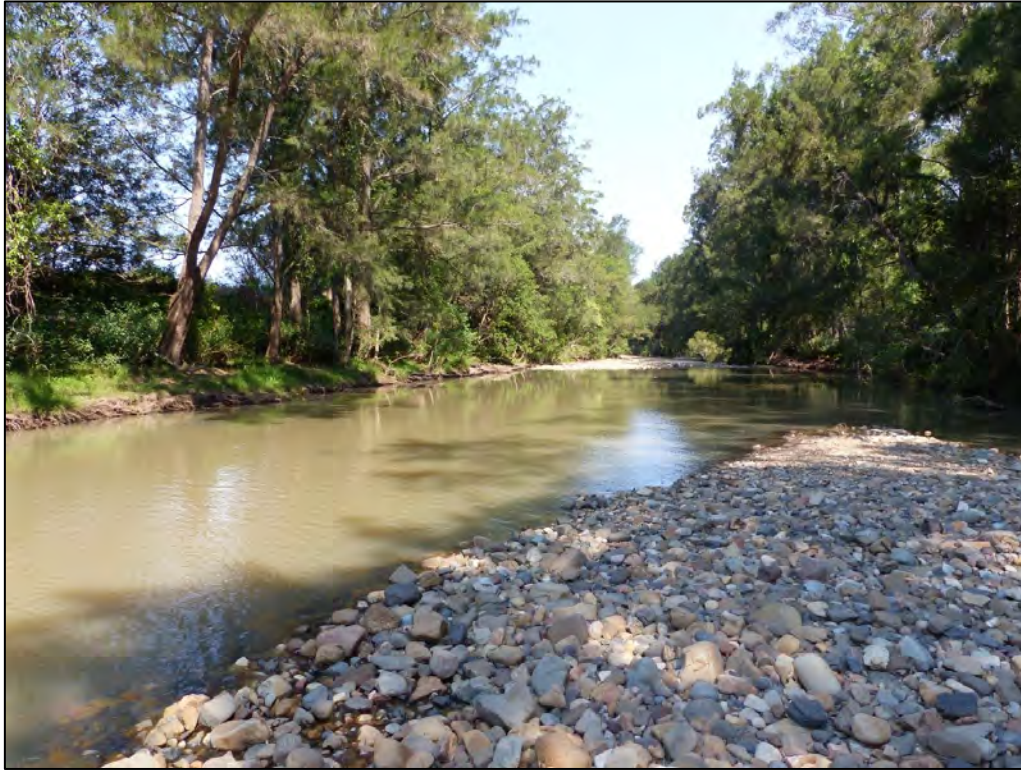
The original riparian vegetation community at DUNC2 (Plate 3.74) was described as 'River Oak forest and woodland wetland of the NSW South Western Slopes and South Eastern Highlands Bioregion', plant community type ID 85 (VIS, 2012), broadly classed as 'Eastern Riverine Forests' (Keith, 2004), grading into 'Black Bean - Weeping Lilly Pilly - Water Gum riparian rainforest of the NSW North Coast Bioregion' plant community type ID 669 (VIS, 2012), broadly classed as 'Dry Rainforest' (Keith, 2004). DUNC2 received a moderate riparian condition score of 65.4, a grade of C (Table 3.102).

Plate 3.74 Riparian vegetation at DUNC2 was moderately disturbed. Riparian condition would be improved through control and removal of weed and noxious weed species such as Willow (*Salix* sp.), Lantana (*Lantana camara*), Small-leaved Privet (*Ligustrum sinense*) and completing riparian fencing.

Management Recommendations: Riparian condition could be improved through the control and removal of weed and noxious weed species, particularly throughout the midstory and understory

layers. Completed riparian fencing should exclude livestock and allow for woody debris accumulation and midstory and understory native species recovery.

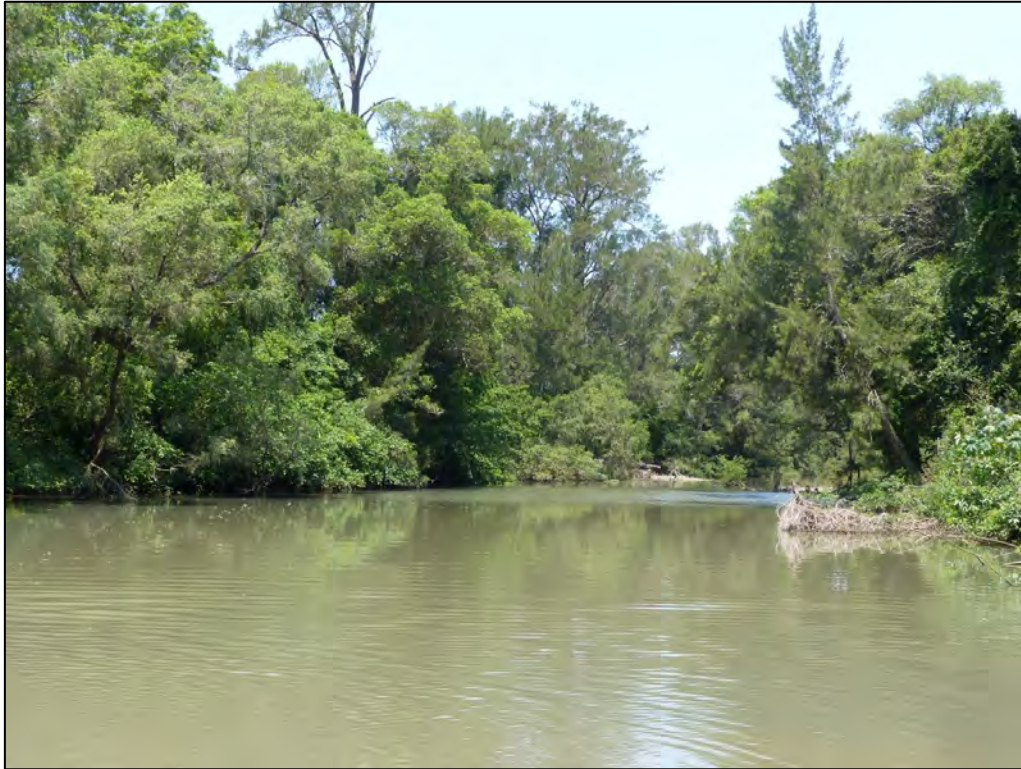
Plate 3.75 *Riparian vegetation at DUNC1 was moderately disturbed. Riparian condition would be improved through control and removal of weed and noxious weed species such as Camphor Laurel (Cinamomum camphora), Willow (Salix sp.) and Lantana (Lantana camara), and through the introduction of woody debris.*

Management Recommendations: Riparian condition could be improved through the control and removal of weed and noxious weed species, particularly throughout the midstory and understory

layers. The introduction of large woody debris back into this system using best practice techniques could stabilise river banks in the long term, promote niche habitats for native woody regeneration, provide habitat for native animal species, and as instream snags, can redirect or reduce water energy from banks, reducing bank erosion.

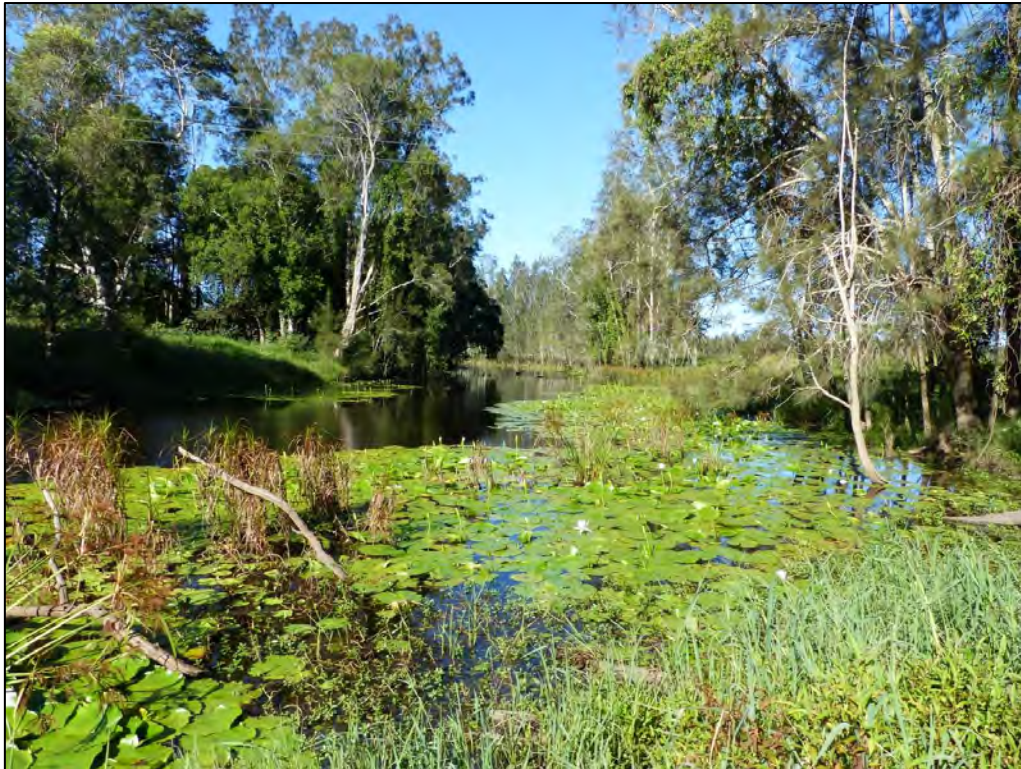
Summary: COLC1 was a moderately disturbed system of mixed-aged forest with mixed native and exotic species throughout the canopy and midstory layers and native species throughout the understory layer, in a predominantly cleared, partially forested rural landscape. The surrounding rural landuse was predominantly agricultural grazing land, private forested land and State Forest. Significant remnant stands of vegetation lie 1.2km north and 2.1km southwest of COLC1 in Tamban State Forest. COLC1 scored well for Cover and moderately for Habitat, Native Species, Debris and Management subindices (Table 3.106). Riparian condition at COLC1 was affected by reduced riparian vegetation width and continuity and poor habitat connectivity. The presence and regeneration of weed and noxious weed species particularly in the midstory and understory structural layers, reduced levels of woody debris and fringing vegetation, inadequate riparian fencing and animal impact contributed to the reduction in riparian grade at this site.

Plate 3.76 Riparian vegetation at COLC1 was moderately disturbed. Riparian condition would be improved through control and removal of weed and noxious weed species specifically Camphor Laurel (*Cinnamomum camphora*) and Lantana (*Lantana camara*), and by fencing off the riparian zone.

Management Recommendations: Riparian condition could be improved through the control and removal of weed and noxious weed species and by undertaking native plantings which phase-out and replace dominant canopy weed species and promote vegetation width, continuity, habitat connectivity and assist site regeneration of native species. Riparian fencing should exclude livestock, promote woody and non-woody debris accumulation and allow for canopy, midstory and understory native species recovery. If strategically implemented, riparian fencing could be used in combination with native plantings to increase riparian vegetation width, continuity and to improve proximity to intact remnant stands of vegetation.
