Macleay Ecohealth Project 2015-2016

Assessment of River and Estuarine Condition

Final Technical Report

December 2016

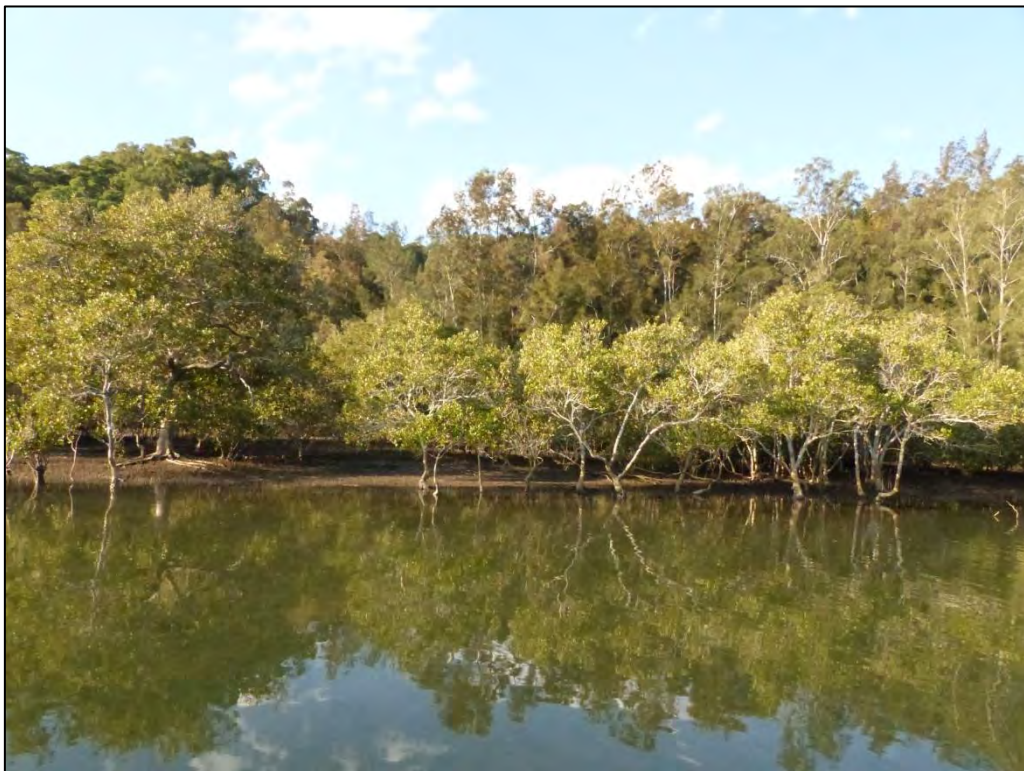
Plate 3.79 Site SPEC1 on Spencers Creek (looking at the right bank).

The River Style at Spencers Creek #1 (SPEC1) is laterally unconfined valley setting: continuous channel, tidal. Bed and bank sediments comprised fine grained sediment. The well vegetated right bank was in good geomorphic condition (Plate 3.79), with minimal undercutting within the intertidal zone and no slumping observed in the site reach. However, left bank was in poor geomorphic condition with severe (20-100m) erosion along the interface of the intertidal and riparian zones (Plate 3.85). SPEC1 scored 65, a grade of C- for BANK CONDITION. With an overall Ecohealth geomorphic condition of 65, a grade of C-, SPEC1 was assessed as being in moderate geomorphic condition. The desktop GIS assessment of subcatchment geomorphic condition found the Macleay estuary (including Spencers Creek) to be in moderate condition with a grade of C. The site-level grade for SPEC1 is slightly below the average subcatchment condition.

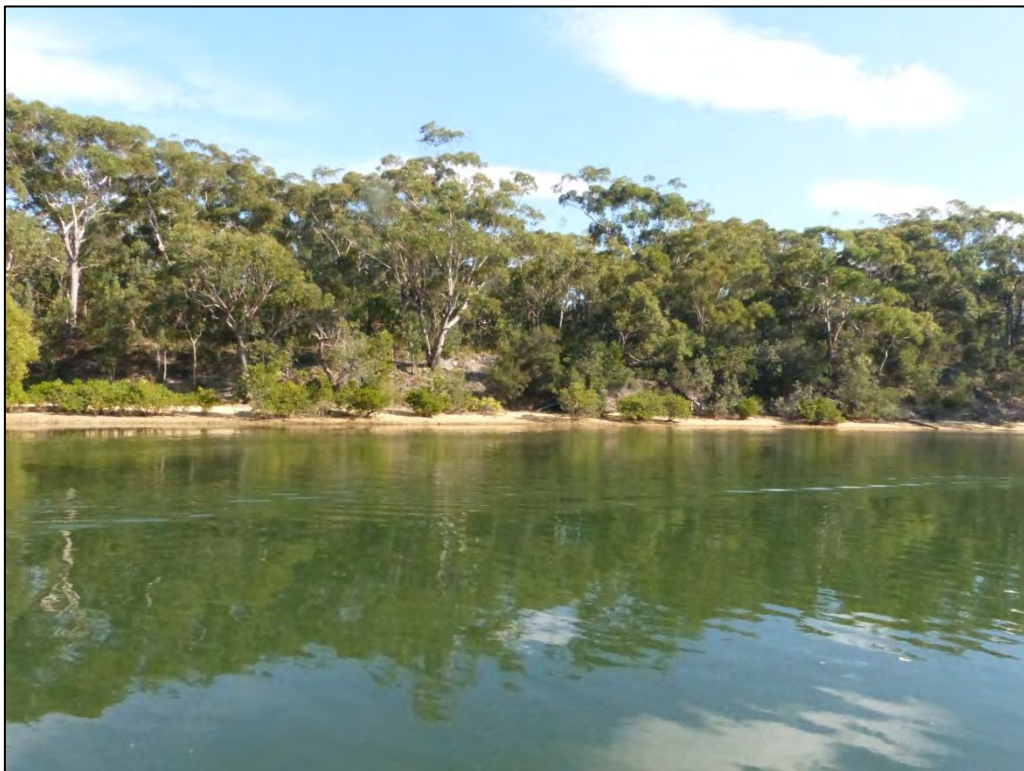
Plate 3.81 Site NAMR1 on the North Arm of the Macleay River (looking at the left bank).

The River Style at the North Arm Macleay River #1 (NAMR1) is laterally unconfined valley setting: continuous channel, tidal. Bed and bank sediments comprised sand. The well vegetated banks were in good geomorphic condition (Plate 3.81), with no bank erosion observed in the site reach. NAMR1 scored 78, a grade of B- for BANK CONDITION. With an overall Ecohealth geomorphic condition of 78, a grade of B-, NAMR1 was assessed as being in good geomorphic condition. The desktop GIS assessment of subcatchment geomorphic condition found the Macleay estuary (including the North Arm) to be in moderate condition with a grade of C. The site-level grade for NAMR1 is above the average subcatchment condition.

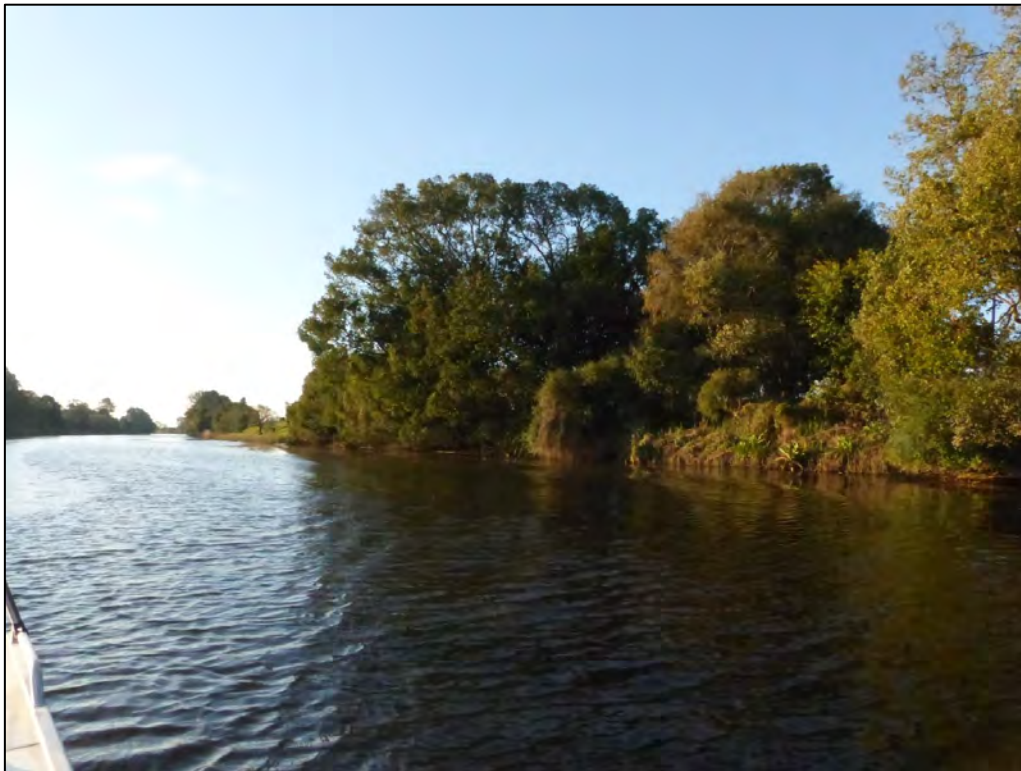
High historic disturbance at BELR1 (Plate 3.83) has resulted in a highly modified riparian zone that predominantly comprises exotic species. However, the original riparian vegetation community at BELR1 could have been described as 'Swamp Oak swamp forest fringing estuaries, Sydney Basin Bioregion and South East Corner Bioregion' plant community type ID 1234 (VIS, 2012), broadly classed as 'Coastal Floodplain Wetlands' (Keith, 2004), a recognized TEC (VIS, 2012). BELR1 received a poor riparian condition score of 45, a grade of D- (Table 3.109).

Summary: BELR1 was a very highly disturbed system of regrowth forest with mixed native and exotic species throughout all structural layers, in a predominantly cleared landscape. The surrounding rural landuse was agricultural grazing land, urban settlement and horticulture. A significant remnant stand of vegetation lies 5.2km east of BELR1 in Hat Head National Park. BELR1 scored moderately for Cover and poorly for all other subindices, Habitat, Native Species, Debris and Management (Table 3.109). Despite retaining native elements in all structural layers, riparian condition at BELR1 was affected by poor riparian vegetation width and habitat connectivity, by the dominance and regeneration of weed and noxious weed species in all structural layers, inadequate riparian fencing and animal impact. Reduced levels of cover across all but the macrophyte structural layer, limited native species regeneration, absence of habitat trees and reduced woody and non-woody debris contributed to the reduction in riparian grade at this site.

Plate 3.83 Riparian vegetation at BELR1 was very highly disturbed. Riparian condition would be improved through control and removal of weed and noxious weed species such as Coral Tree (*Erythrina x sykesii*), Camphor Laurel (*Cinnamomum camphora*), Lantana (*Lantana camara*), Broad-leaf Privet (*Ligustrum lucidum*), Small-leaved Privet (*Ligustrum sinense*) and Coastal Morning Glory (*Ipomoea cairica*), by undertaking native plantings and fencing off the riparian zone.

Management Recommendations: Riparian condition could be improved through the control and removal of weed and noxious weed species and by undertaking native plantings which phase-out and replace dominant canopy weed species and promote vegetation width, continuity, habitat connectivity and assist site regeneration of native species. The introduction of large woody debris back into this system using best practice techniques could stabilise river banks in the long term, promote niche habitats for native woody regeneration and for native animal species. Riparian fencing should exclude livestock, promote woody and non-woody debris accumulation and allow for canopy, midstory and understory native species recovery, and if strategically implemented could be used in combination with native plantings to increase riparian vegetation width, continuity and to improve proximity to intact remnant stands of vegetation.

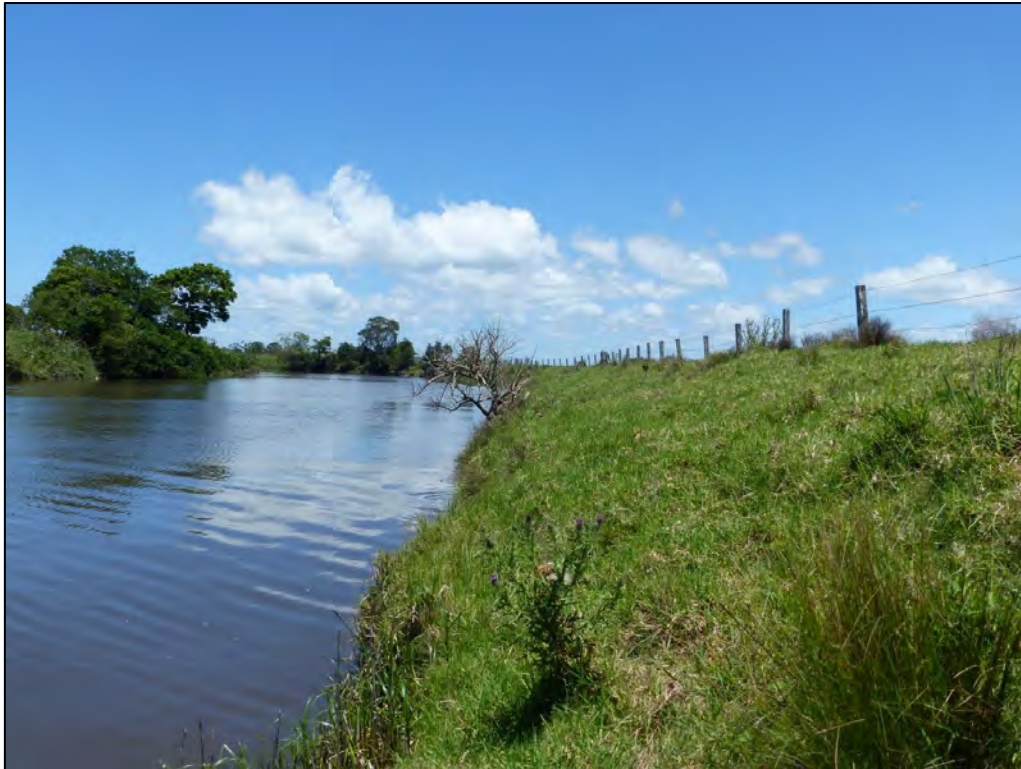
Summary: KINC1 was an extremely disturbed system of regrowth forest with mixed native and exotic species throughout all structural layers, in a cleared landscape. The surrounding rural landuse was agricultural grazing land, urban settlement and National Park. A significant remnant stand of vegetation lies 3.2km east of KINC1 in Hat Head National Park. KINC1 scored moderately for Management, poorly for Native Species, Cover and Debris, and very poorly for Habitat subindices (Table 3.112). Despite retaining native elements in all structural layers, riparian condition at KINC1 was affected by an absence of riparian vegetation width, continuity and habitat connectivity and by the dominance and regeneration of weed and noxious weed species in all structural layers. Low vegetation cover levels throughout all structural layers except understory, no woody native species regeneration, and an absence of habitat trees, woody and non-woody debris contributed to the reduction in riparian grade at this site.

Plate 3.84 Riparian vegetation at KINC1 was extremely disturbed. Riparian condition would be improved through control and removal of weed and noxious weed species such as Coral Tree (*Erythrina x sykesii*), a class 3 noxious weed, and Lantana (*Lantana camara*), Small-leaved Privet (*Ligustrum sinense*) Coastal Morning Glory (*Ipomoea cairica*), by undertaking native plantings and widening the fenced-off riparian zone.

Management Recommendations: Riparian condition could be improved through the control and removal of weed and noxious weed species and by undertaking native plantings which phase-out and replace dominant canopy weed species and promote vegetation width, continuity, habitat connectivity and assist site regeneration of native species. Structural works using best practice techniques such as rock revetment at the toe of the bank will improve bank stability. This may include the introduction of large woody debris which would also promote niche habitats for native woody regeneration and for native animal species. While existing riparian fencing excludes livestock and promotes woody and non-woody debris accumulation, an increase in riparian vegetation width should be considered due its direct relationship with the width of the creek channel. Increasing the width of this zone and planting it out with native species can allow for canopy and midstory recovery and if strategically implemented could be used to increase riparian vegetation continuity and to improve proximity to intact remnant stands of vegetation.

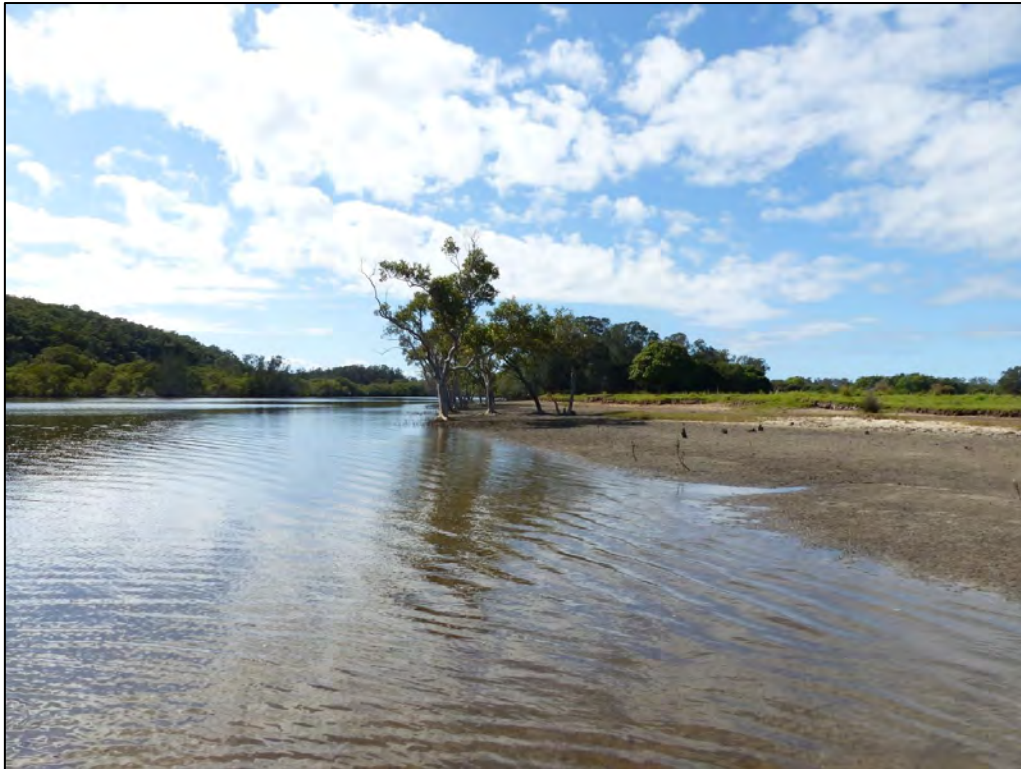
The original riparian vegetation community at SPEC1 (Plate 3.85) was described as 'Mangrove forest in estuaries of the Sydney Basin Bioregion and South East Corner Bioregion' plant community type ID 920 (VIS, 2012), broadly classed as 'Mangrove Swamps' (Keith, 2004), grading into 'Swamp Oak swamp forest fringing estuaries, Sydney Basin Bioregion and South East Corner Bioregion' plant community type ID 1234 (VIS, 2012), broadly classed as 'Coastal Floodplain Wetlands' (Keith, 2004), a recognized TEC (VIS, 2012). SPEC1 received a poor riparian condition score of 47.3, a grade of D- (Table 3.113).

Plate 3.85 Riparian vegetation at SPEC1 was very highly disturbed. Riparian condition would be improved through control and removal of weed and noxious weed species such as Sharp Rush (*Juncus acutus*), by undertaking native plantings and fencing-off the riparian zone.

Management Recommendations: Riparian condition could be improved through the control and removal of weed and noxious weed species and by undertaking native plantings which phase-out and replace dominant canopy weed species and promote vegetation width, continuity, habitat connectivity and assist site regeneration of native species. Structural works using best practice techniques such as rock revetment at the toe of the bank will improve bank stability. This may include the introduction of large woody debris which would also promote niche habitats for native woody regeneration and for native animal species, and as instream snags, can redirect or reduce water energy from banks, reducing bank erosion. Riparian fencing should exclude livestock, promote woody and non-woody debris accumulation and allow for canopy, midstory and understory native species recovery. If strategically implemented riparian fencing could be used in combination with native plantings to increase riparian vegetation width, continuity and to improve proximity to intact remnant stands of vegetation.

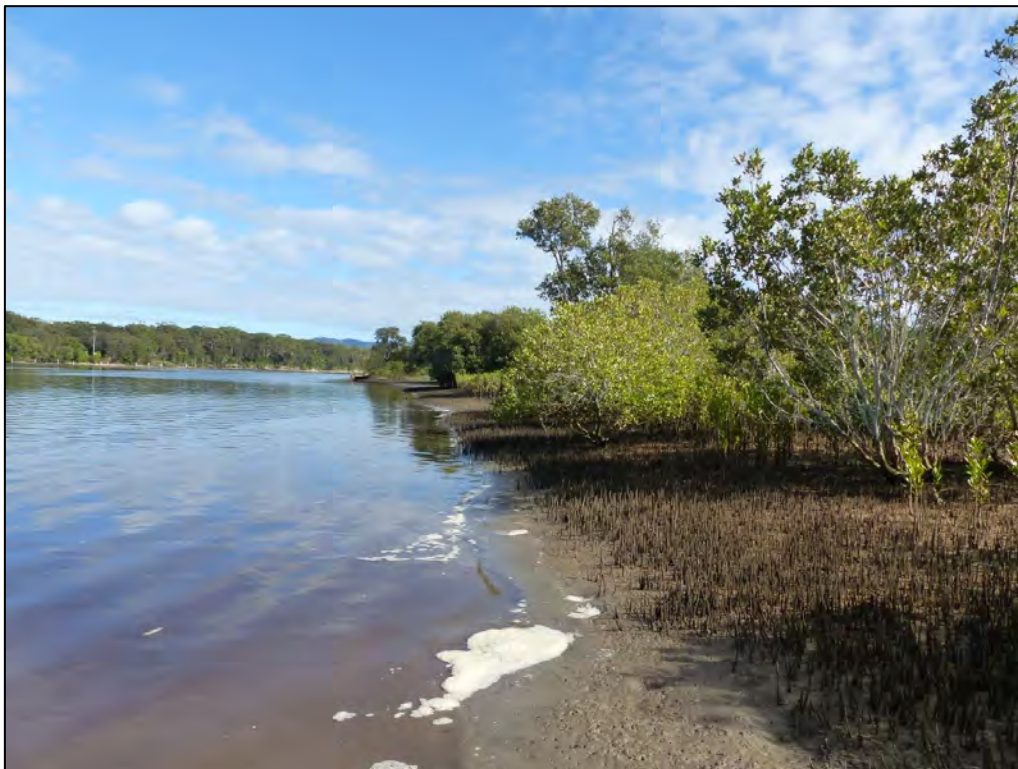
partially cleared, partially forested landscape. The surrounding landuse was a mix of historic grazing, oyster farming, horticulture, urban settlement and forested land. Significant remnant stands of vegetation lie on neighbouring islands 200m to the south, 200m to the west and 1km further west on crown land. CLYC1 scored well for Native Species and Cover, and moderately for Habitat, Debris and Management subindices (Table 3.114). Riparian condition at CLYC1 was impacted by reduced riparian vegetation width and continuity, cover throughout the canopy layer and the presence of weed and noxious weed species in the mid and understory layer. Historic clearing, a reduction in large trees and habitat trees, fewer woody debris, inadequate riparian fencing and animal impact contributed to the reduction in riparian grade at this site.

Plate 3.86 Riparian vegetation at CLYC1 was mildly disturbed. Riparian condition would be improved through control and removal of weed and noxious weed species such as Coastal Morning Glory (*Ipomoea cairica*), undertaking native plantings and by fencing-off the riparian zone.

Management Recommendations: Riparian condition could be improved through the control and removal of weed and noxious weed species. Riparian condition could be improved by strategically implementing riparian fencing that could be used in combination with native plantings to increase riparian vegetation width, continuity, proximity to intact remnant stands of vegetation and to assist with site regeneration of native species. Riparian fencing excludes livestock, promotes woody and non-woody debris accumulation and allows for canopy, midstory and understory native species recovery.

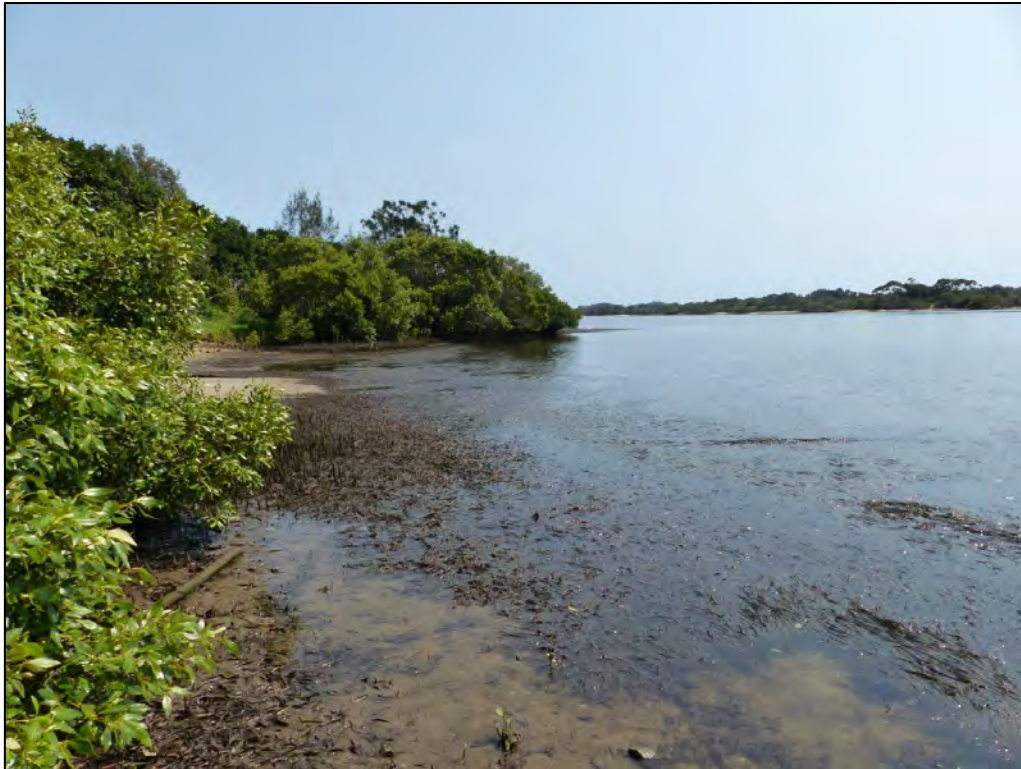
The original riparian vegetation community at NAMR2 (Plate 3.87) was described as 'Mangrove forest in estuaries of the Sydney Basin Bioregion and South East Corner Bioregion' plant community type ID 920 (VIS, 2012), broadly classed as 'Mangrove Swamps' (Keith, 2004), grading into 'Saltmarsh in estuaries of the Sydney Basin Bioregion and South East Coast Bioregion' plant community type ID 1126 (VIS, 2012), broadly classed as 'Saltmarsh' (Keith, 2004), a recognized TEC (VIS, 2012), grading into 'Swamp Oak swamp forest fringing estuaries, Sydney Basin Bioregion and South East Corner Bioregion' plant community type ID 1234 (VIS, 2012), broadly classed as 'Coastal Floodplain Wetlands' (Keith, 2004), also a recognized TEC (VIS, 2012). NAMR2 received a low riparian condition score of 59.1, a grade of D+ (Table 3.116).

Summary: NAMR2 was a high disturbance system of mixed-aged forest with mixed native and exotic species throughout all structural layers, in a partially cleared, partially forested landscape. The surrounding landuse was a mixture of urban settlement, horticulture, recreation, periodically inundated mangrove and saltmarsh tidal flats and forested land. Significant remnant stands of vegetation lie 1km southwest on crown land, and 1.9km west in Way Way State Forest. NAMR2 scored well for Cover, moderately for Habitat, Native Species and Debris and poorly for Management subindices (Table 3.116). Riparian condition at NAMR2 was impacted by reduced riparian vegetation width and continuity and the presence and regeneration of weed and noxious weed species, particularly in the midstory and understory structural layers. A reduction in large trees and habitat trees and woody debris, historic clearing and inadequate riparian fencing contributed to the reduction in riparian grade at this site.

Plate 3.87 Riparian vegetation at NAMR2 was highly disturbed. Riparian condition would be improved through control and removal of weed and noxious weed species such as Camphor Laurel (*Cinnamomum camphora*), Lantana (*Lantana camara*), Bitou Bush (*Chrysanthemoides monilifera* subsp. *Rotundata*), Asparagus Fern (*Asparagus aethiopicus*) and Coastal Morning Glory (*Ipomoea cairica*), by undertaking native plantings and fencing-off the riparian zone.

Management Recommendations: Riparian condition could be improved through the early control and removal of weed and noxious weed species, which reduces the likelihood of potential exotic weed infestations which may otherwise degrade a vegetation community by outcompeting native species. In high traffic areas riparian fencing can exclude anthropogenic disturbances that may otherwise impact on native vegetation. The strategic implementation of riparian fencing in combination with native plantings would increase riparian vegetation width and continuity, assist with site regeneration of native canopy, midstory and understory species and promote the accumulation of woody and non-woody debris which through the provision of niche habitats supports native woody regeneration and native animal species.

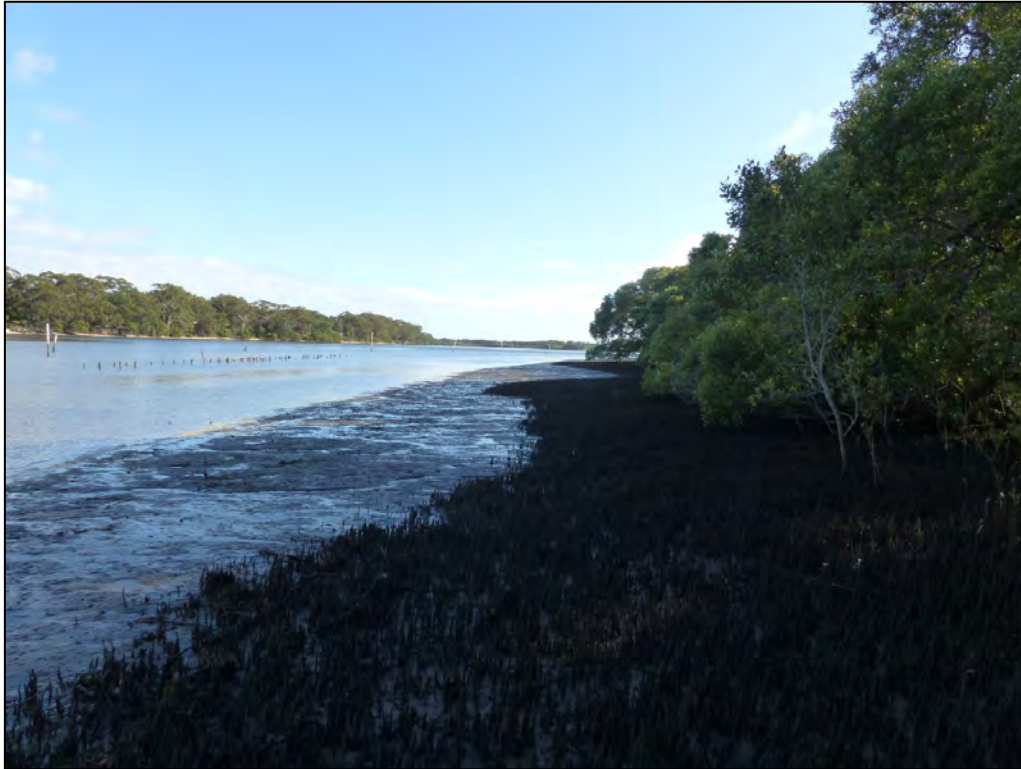
The original riparian vegetation community at NAMR1 (Plate 3.88) was described as 'Mangrove forest in estuaries of the Sydney Basin Bioregion and South East Corner Bioregion' plant community type ID 920 (VIS, 2012), broadly classed as 'Mangrove Swamps' (Keith, 2004), grading into 'Saltmarsh in estuaries of the Sydney Basin Bioregion and South East Coast Bioregion' plant community type ID 1126 (VIS, 2012), broadly classed as 'Saltmarsh' (Keith, 2004), a recognized TEC (VIS, 2012), grading into 'Swamp Oak swamp forest fringing estuaries, Sydney Basin Bioregion and South East Corner Bioregion' plant community type ID 1234 (VIS, 2012), broadly classed as 'Coastal Floodplain Wetlands' (Keith, 2004), also a recognized TEC (VIS, 2012). NAMR1 received a very good riparian condition score of 80.5, a grade of B (Table 3.117).

Noxious weed species observed onsite were Groundsel Bush (*Baccharis halimifolia*), a class 3 noxious weed; and Lantana (*Lantana camara*), Bitou Bush (*Chrysanthemoides monilifera* subsp. *Rotundata*) and Coastal Morning Glory (*Ipomoea cairica*), all class 4 noxious weed species.

Plate 3.88 Riparian vegetation at NAMR1 was of low disturbance. Riparian condition would be improved through control and removal of weed and noxious weed species such as Groundsel Bush (*Baccharis halimifolia*), *Lantana* (*Lantana camara*), *Groundsel Bush* (*Baccharis halimifolia*), *Bitou Bush* (*Chrysanthemoides monilifera* subsp. *Rotundata*) and *Coastal Morning Glory* (*Ipomoea cairica*) and by excluding stock.

Management Recommendations: Riparian condition could be improved through the early control and removal of weed and noxious weed species, which reduces the likelihood of potential exotic weed infestations which may otherwise degrade a vegetation community by outcompeting native species. Riparian fencing excludes livestock, promotes woody and non-woody debris accumulation

and allows for canopy, midstory and understory native species recovery. Riparian fencing could be strategically implemented towards the northern end of Mackenzies Island to increase riparian vegetation width, assist with site regeneration of native species and to maintain the current riparian condition.
